Re: 2015 Bridge Inspections

**2015
BRIDGE INSPECTION
AND
MAINTENANCE REPORT**

CITY OF WAVERLY, IOWA

2013 ROADWAY BRIDGE INSPECTION

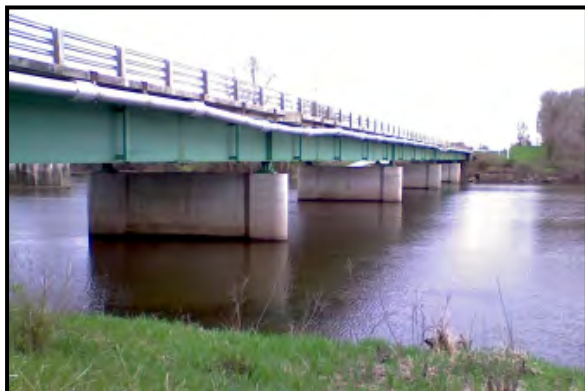
1st Street NW (Adams Pkwy) - FHWA No. 12240

Deck and Joints: There are some areas in the top of deck with small spalls and transverse cracks. The spalling is more pronounced adjacent to the joints at each abutment. Approximately 2% of the top of deck was delaminated; however the rate of increase is minimal, when compared to previous inspections. Most of the delamination occurs adjacent to the abutment expansion joints and above the piers where there is high negative flexure. We consider the deck to be in fair condition with some minor cracking and spalling.

Curb and Sidewalk: The curb along the full length of the bridge has some spalling and deterioration, however is quite minor.

Abutments and Berms: The bearings at each abutment are rusty. The base plates under the bearings at the south abutment have some pack rust with minor section loss (*See Figure 2 in Appendix A*). The base plates and bearings at the north abutment are also rusty but not as bad as the south abutment. There are a few hairline vertical cracks in abutments.

Piers: All piers have minor vertical cracks, particularly at the top and center of each pier, with up to 1/16" separation at the top, narrowing to just hairline at the waterline. Form tie holes in the piers either were not filled in or the grout has fallen out.

Superstructure: Due to the development of previous fatigue cracks, dual sets of holes have been drilled in the top of the girder webs near the transverse stiffeners directly over the piers and at each inflection point. The original fatigue cracks are still apparent between the dual holes, but no further cracking is apparent. The exterior side of the east girder has some surface rust spots in spans 1 and 2, possibly caused by rocks thrown at the bridge. Two top bolts in 2nd floor beam north of pier 3 at the inside of the West girder are missing, but likely not placed at construction.

We anticipate the need for a concrete overlay and new deck expansion joints within the next 5 to 10 years.

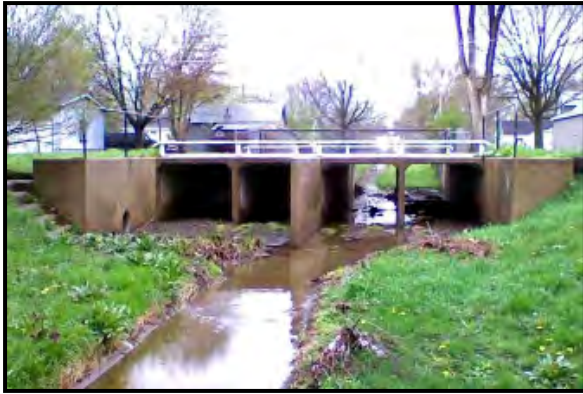
2nd Ave. NW - FHWA No. 502260

The top of deck is pitted with minor cracking. There are hairline cracks in the walls with some leaching. On the north end, there are cracks and some minor spalling where the wings meet the barrel of the culvert. The sidewalk slab bridge has a transverse crack near the center support and additional cracks at the east support under the rail posts. There is visible deflection of the sidewalk slab due to concrete creep. All barrels have minor silt in them.

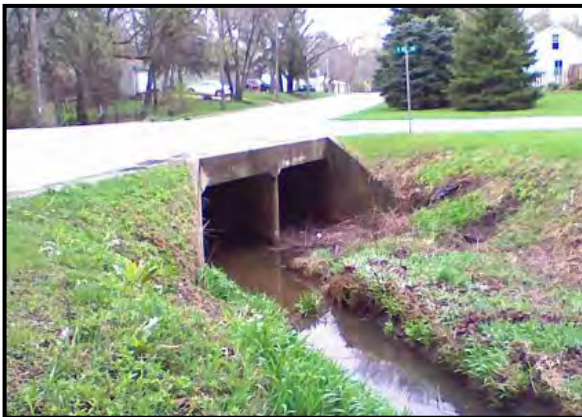
2nd Street SW - FHWA No. 502300

There are hairline cracks in walls. The SE headwall has cracks with leaching and spalling on the roadway face that extend all the way through the headwall. The asphalt roadway near the NW headwall is broken up and has some depressions. There is a 3/8" wide crack at the south end of the NW headwall. There are cracks with leaching at the construction joints. There is minor settlement of the approaches adjacent to the culvert. Both barrels have minor silt in them.

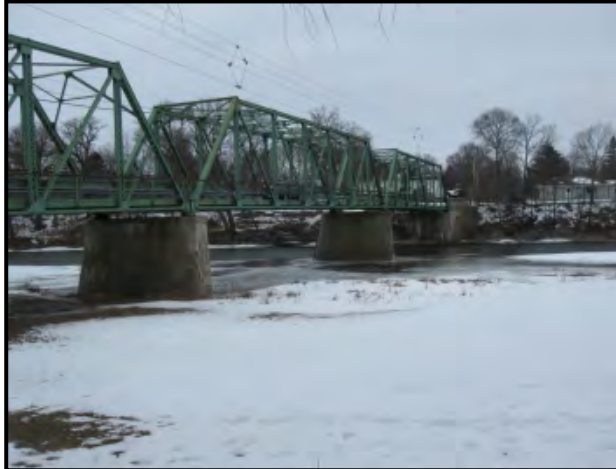
3rd Street SE - FHWA No. 12250

Posting: The bridge is posted 5 tons, One Lane Bridge, and Low Clearance 8'-0 at both ends. Bridge was closed with signs and barricades at both ends following the inspection.

Deck: The deck is in satisfactory condition with some areas showing minor deterioration. The south pier joint cover plate on the top of the deck is loose and is vibrating the deck when traffic crosses.

Superstructure: There is significant pack rust typical at many connections. Pack rust is causing distortion of plates built up near bearings and

bulging of pins. There is also significant section loss (including through holes) of plates adjacent to the pins, and the connection has failed at the southeast and northwest bearings of the south truss resulting in some settlement of the truss, the southwest bearing is near failure. Two additional plates were welded to the gusset plates directly above the bearing pin, at the east side of the south abutment, during the 2006 repair in order to temporarily alleviate the potential for failure. Member U1-L2 on the east side of the south truss has slight sweep (out of plane bending) that is likely due to differential settlement of the truss at the failed bearings. There is section loss on some anchor bolts and nuts are not tight at several locations. The bearings are also tipped outward which is the opposite direction based on the current temperature.

At the bottom of the diagonals, pack rust is causing distortion of up to approx. 3/8" of the connection angles and up to approx. 1/8" section loss. Pack rust is causing up to approx. 1/4" distortion of the tie plates on the diagonal members. The repair performed at several verticals along the west side is deteriorating. There is pack rust between the original and repair materials indicating failure of the welds. There is pack rust between the angles in the west bottom chord between panel points two and five causing distortion and section loss. The overhead bracing members have minor pack rust as well. There is a loose bolt at the bottom chord connection to vertical six in the center truss, west side. Several other bottom chord connections have heavy pitting including on the fasteners. There is impact damage to diagonal L4-U5 on the west side of the center truss, diagonal L3-U4 on the east side of the center truss, and minor impact damage to tie plates at other locations. There are several discrete locations of leaf rust and other deformation to tie plates.

There is heavy pitting and significant section loss on floor beams and stringers. The flanges of the floor beams have the heaviest loss at the connections to the truss, but much of the section loss is not active and has been painted over. The webs have heavy pack rust and section loss at the connection angles to the stringers. The stringers have significant section loss in the flanges with some through holes. The webs have significant section loss especially at the connections to the floor beams. There are two stringers in the south truss that have serious section loss at the web connection to the floor beam, one that is cracked and the other with a crack initiating. Many of the locations that were repaired have pack rust between the original repair materials indicating failure of the webs and new section loss. There is significant deterioration of the stringer to floor beam connection angles, especially those with fasteners replaced by welds.

This bridge should remain closed to vehicular and pedestrian traffic due to the advanced deterioration of multiple aspects of this structure.

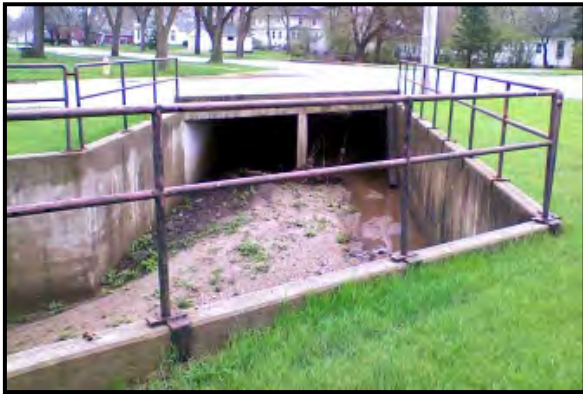
4th Ave. SW & 3rd Street SW – FHWA # 502250

There are minor transverse cracks with leaching in top of barrel near middle of NE barrel. There are minor cracks in the wingwalls. There is minor silting in both barrels. There is minor settlement of the approaches adjacent to the structure.

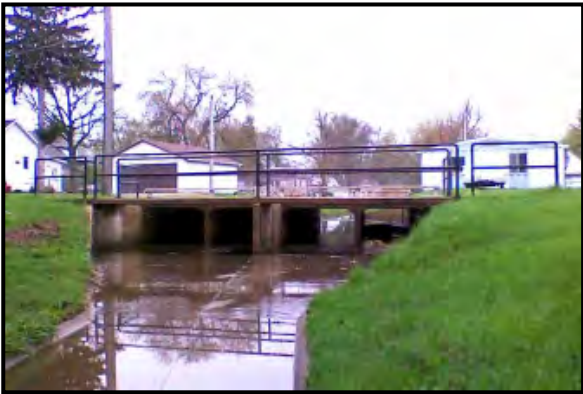
5th Ave. NW – FHWA # 502270

There are spalls in the south end of the 3rd wall from the west with reinforcing steel exposed. There are vertical cracks in the south corners of the culvert with reinforcing steel exposed. The sidewalk slab bridge has a transverse crack near the center support. There is visible deflection of the sidewalk slab due to concrete creep.

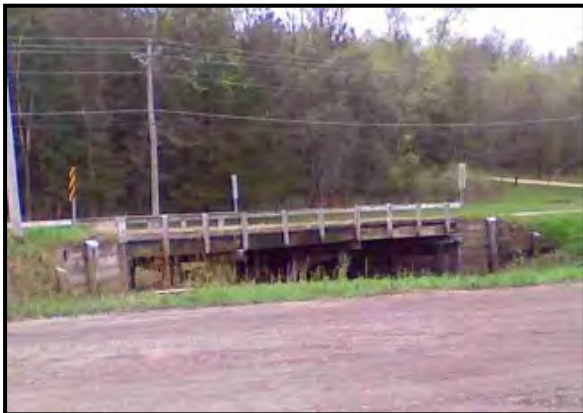
12th Street SE – FHWA # 79040

The bridge is posted "Semi Traffic Prohibited" on the north end. There are seven inches of asphalt and gravel with a chip seal surface on the bridge. The ends of all caps are split and some of them have begun to rot. The east end of the north abutment pile cap has rotted extending approximately 12" +/- deep. Piles in the south abutment are leaning in slightly. The 1st pile from the East leans approximately 6" in 6', but movement seems stable from past inspections. Many piles have minor vertical splits in them. There is minor section loss of some stringers but is minor There is minor section loss in the 3rd pile

from the east in the north pier.

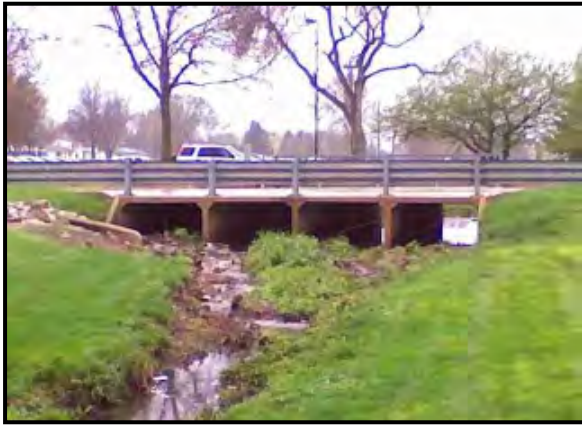
12th Street NW – FHWA # 12220

There are minor cracks with leaching in the walls and the top of the barrels. There is minor silting in all barrels. There is minor cracking and pitting on top of deck. The east end of the third wall from the south is spalled with some reinforcing steel exposed and starting to rust. There is some minor spalling at the northwest corner. Both approaches have minor settlement.

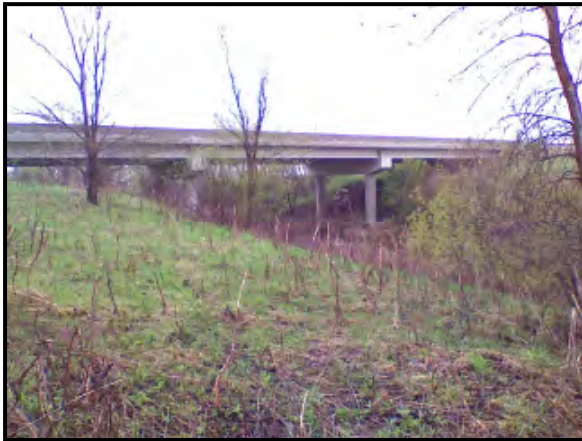
35th St. NW (Over Abandoned RR) – FHWA # 15511

There are minor hairline cracks in the top of deck and two small areas with exposed reinforcing near the center of the deck. There are minor diagonal cracks with leaching in bottom of deck at all four corners. The north approach is beginning to deteriorate near the joint. There is minor spalling in the concrete at some of the pier diaphragms.

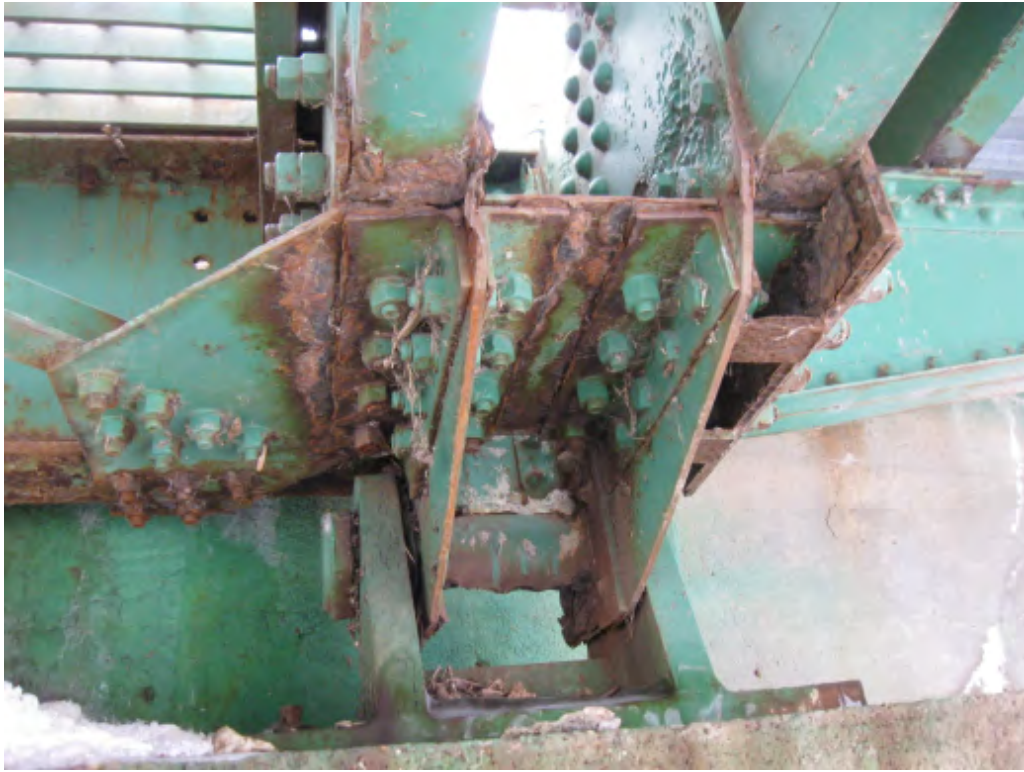
Figure 1 - Example Deterioration around Bearing

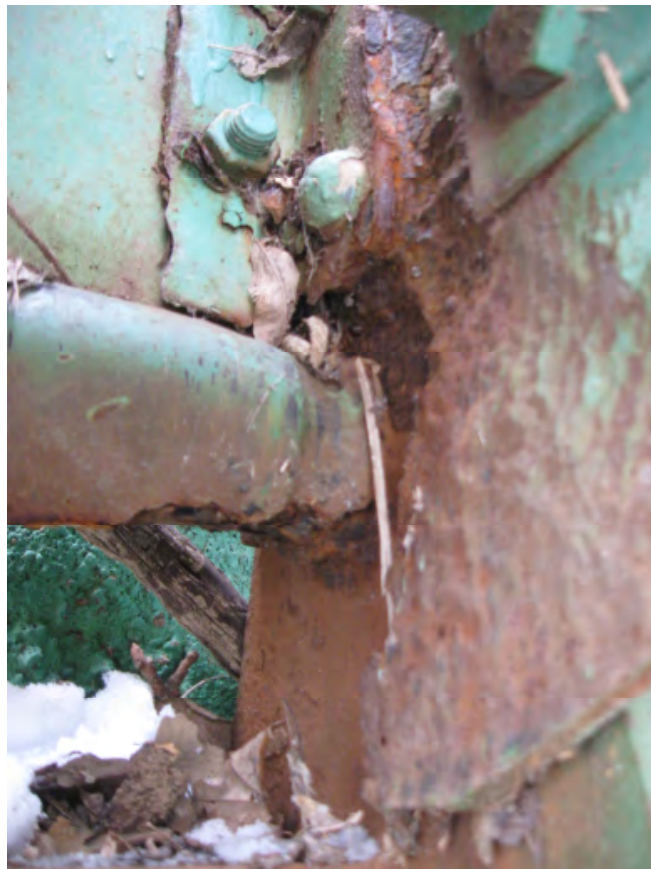
Figure 2 - Example Deterioration at Bearing

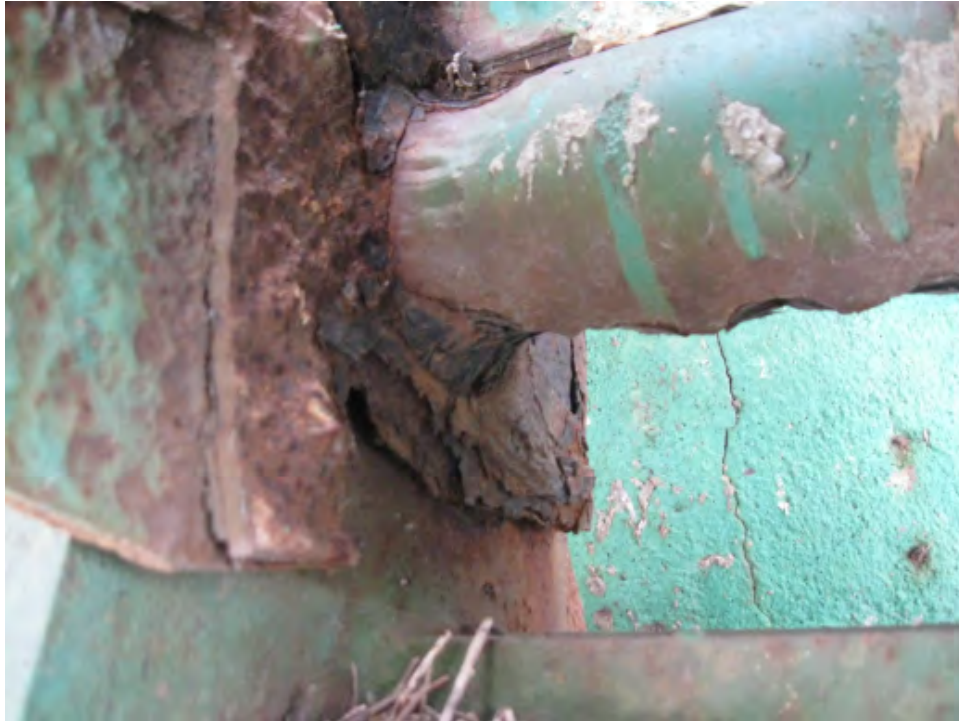
Figure 3 - Example Deterioration at Bearing

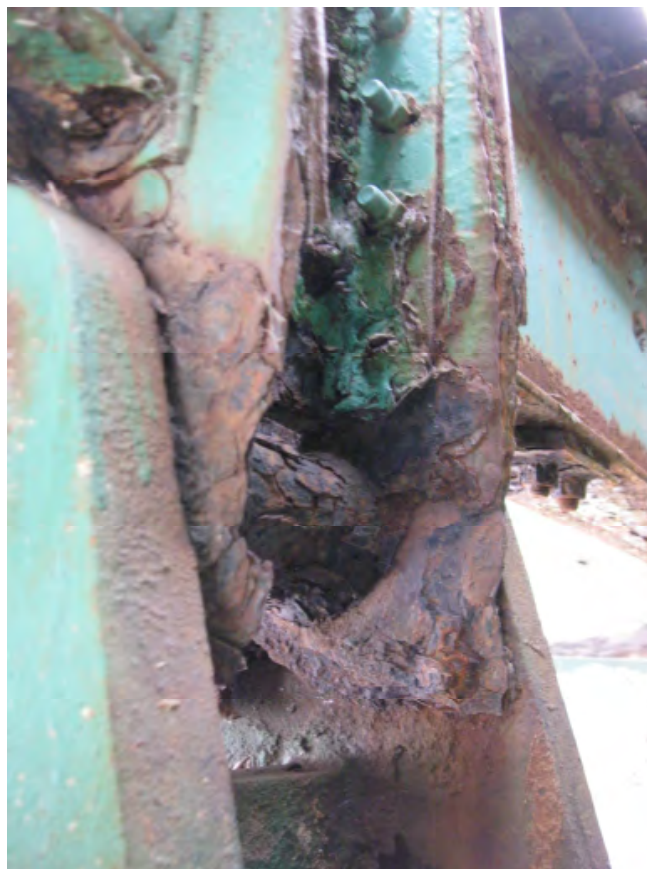
Figure 4 - Example Deterioration at Bearing

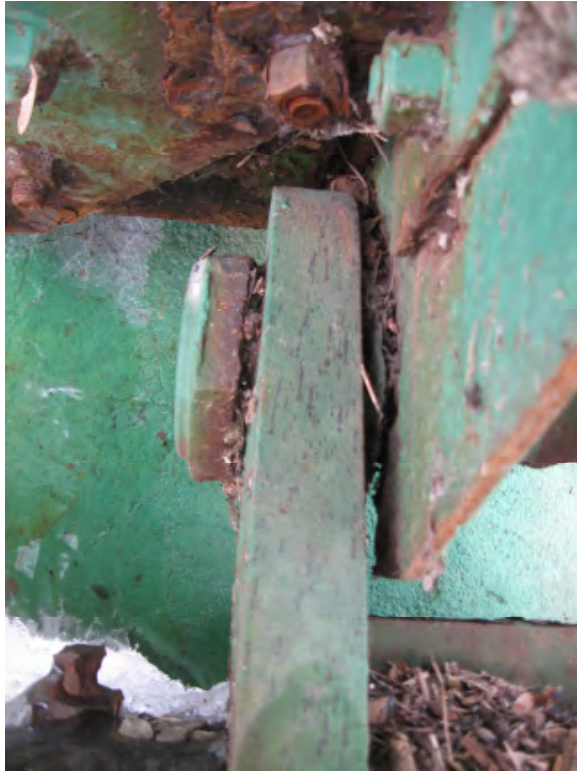
Figure 5 - Example Deterioration at Bearing

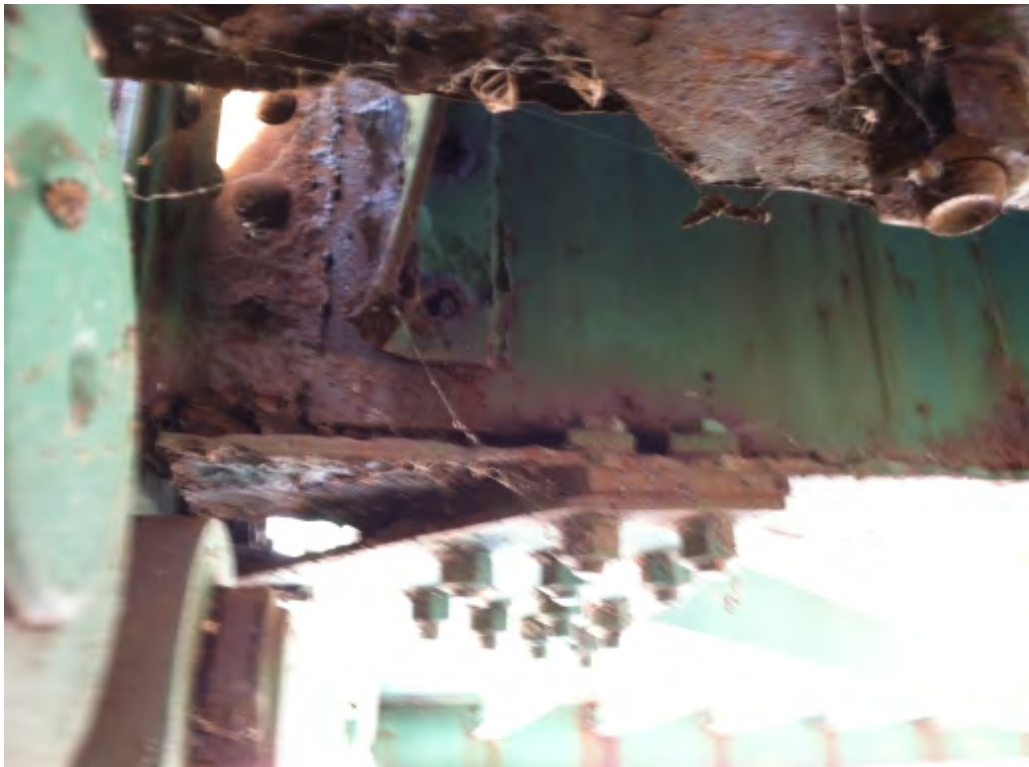
Figure 6 - Example Deterioration at Bearing (2013 Photo)

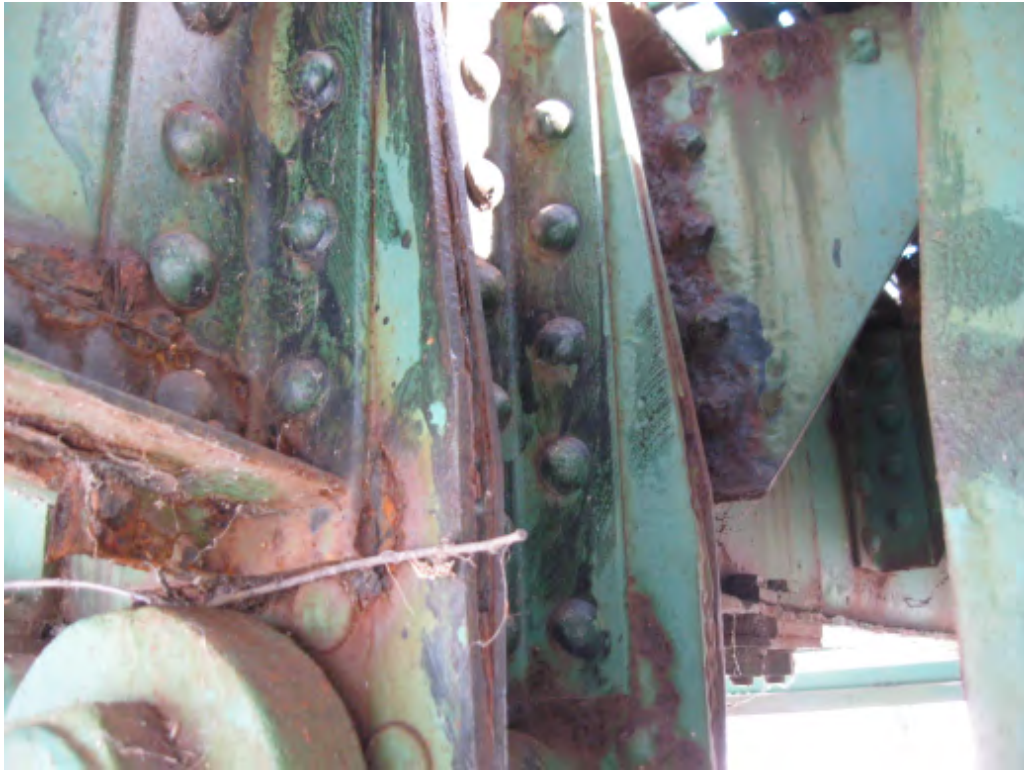
Figure 7 - Example Deterioration Above Bearing

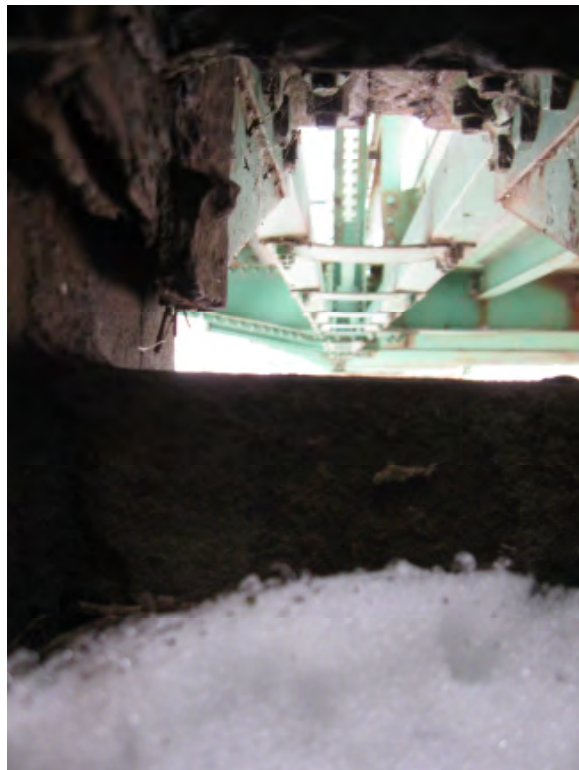
Figure 8 - Example Deterioration Above Bearing

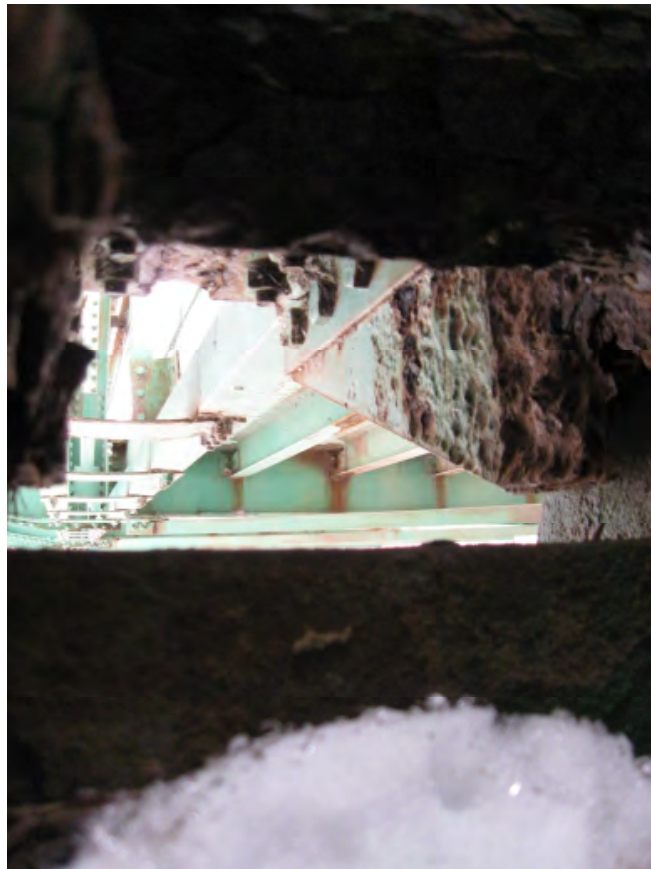
Figure 9 - Example Deterioration Above Bearing

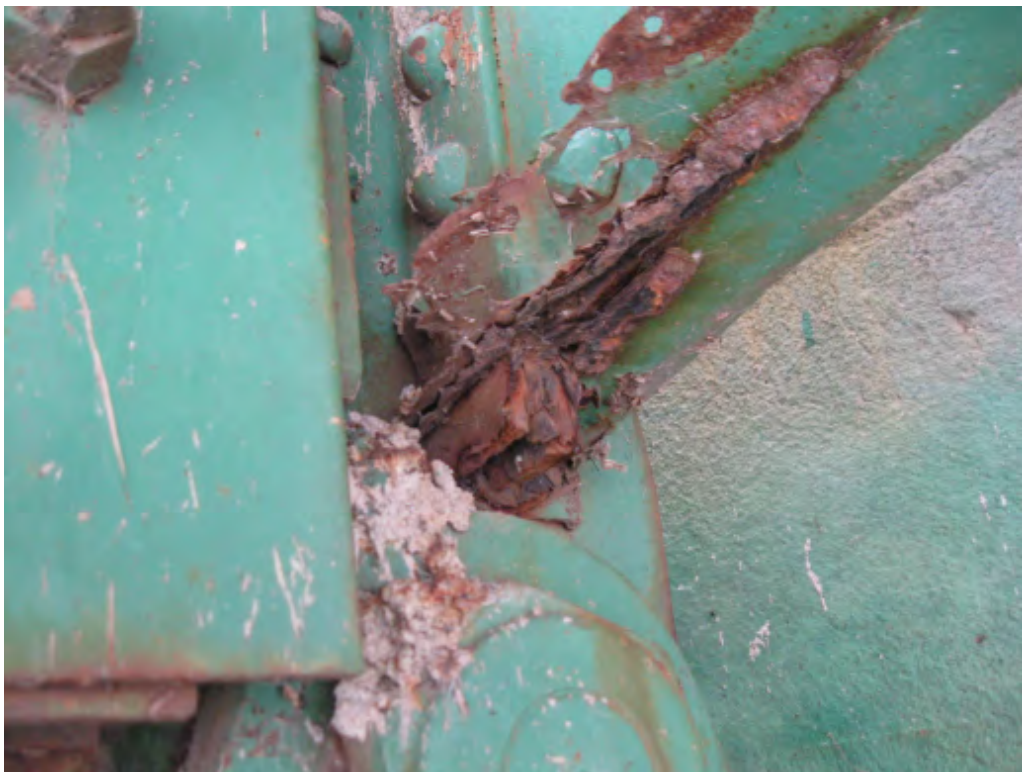
Figure 10 - Example Deterioration Above Bearing

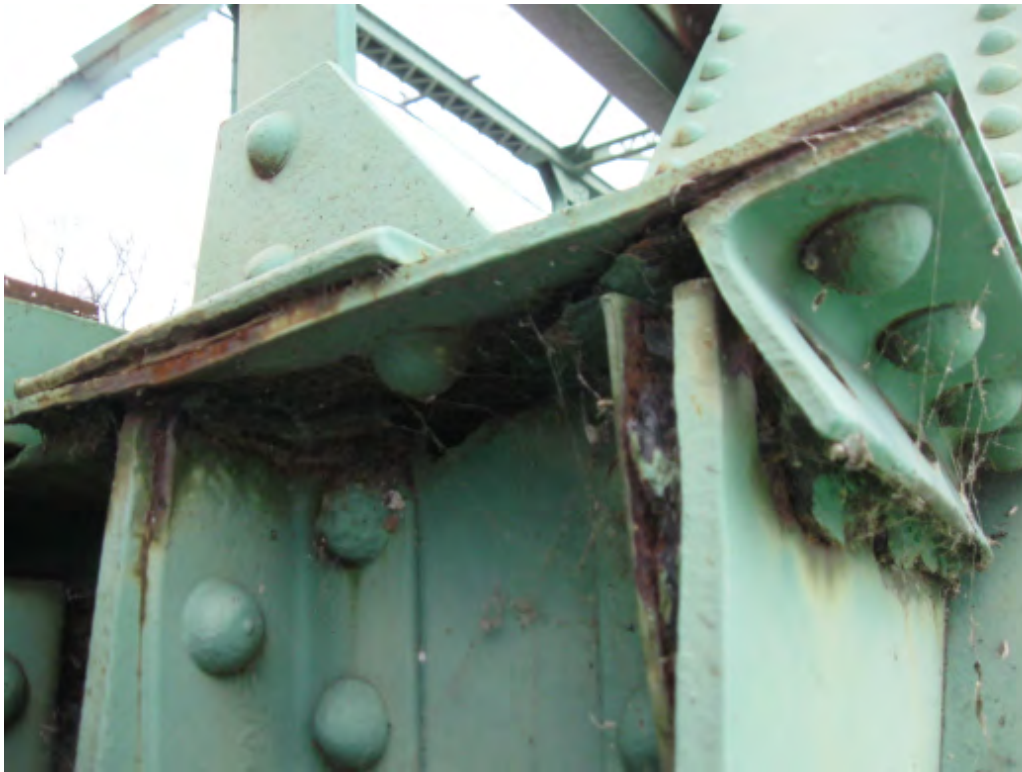
Figure 11 - Example Deterioration Above Bearing

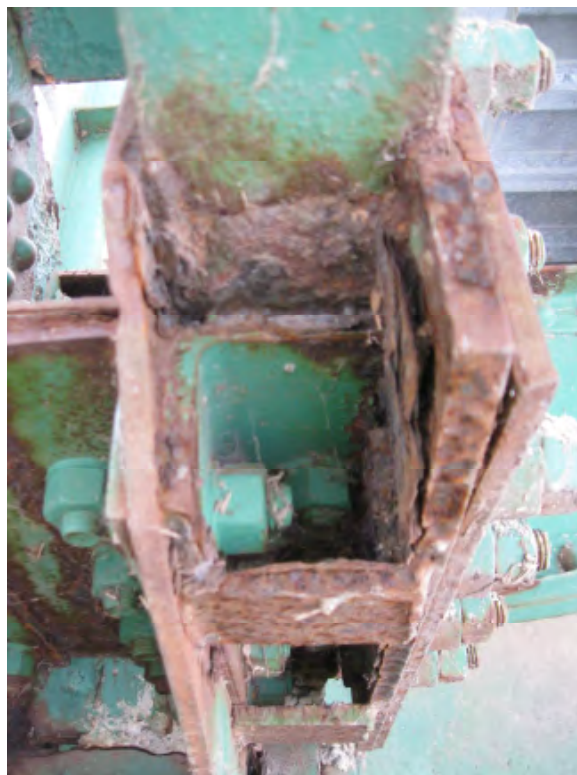
Figure 12 - Example Deterioration at Bottom Chord

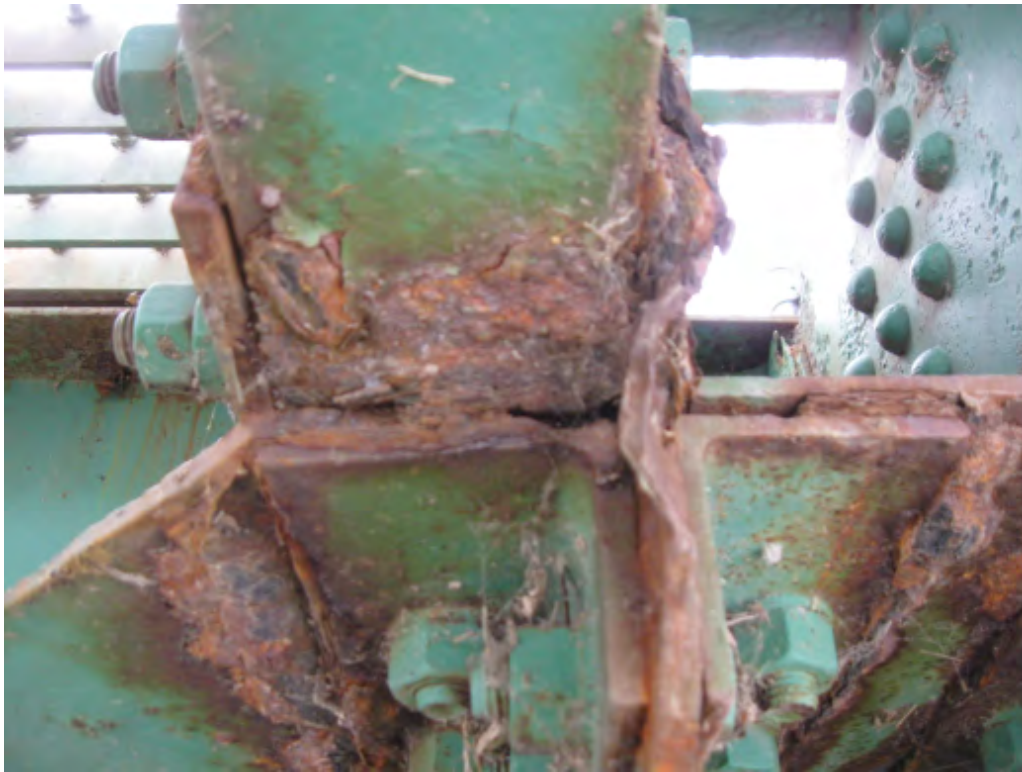
Figure 13 - Example Deterioration at Bottom Chord

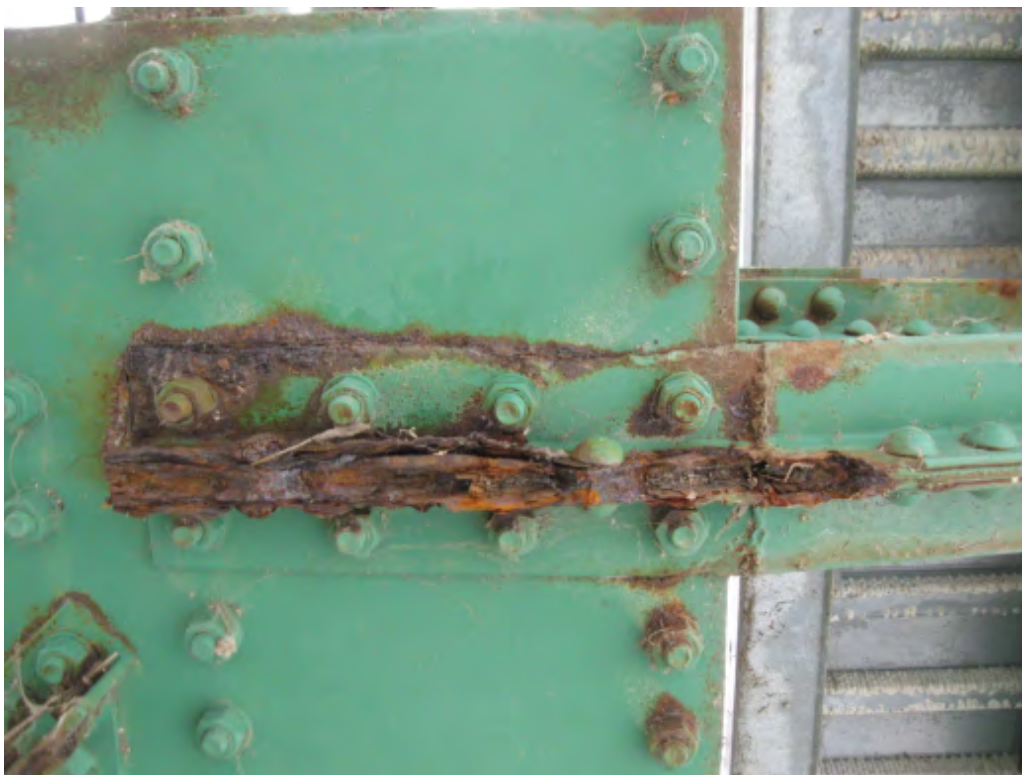
Sidewalk: Pack rust has caused significant section loss in the bottom members of the sidewalk overhang bracket resulting in some through holes at the bottom of the web. The top plate of the

sidewalk overhang bracket is rusted through in some locations as well. The overhang bracket has significant section loss on the flanges with through holes in some areas. There is heavy leaf rust on the top flange of stringers under the sidewalk. There is heavy “white rust” on the bottom of the sidewalk pan. See Figures 14 to 16 in Appendix A for photos of sidewalk connection deterioration.

Figure 14 - Example Deterioration at Lower Sidewalk Connection

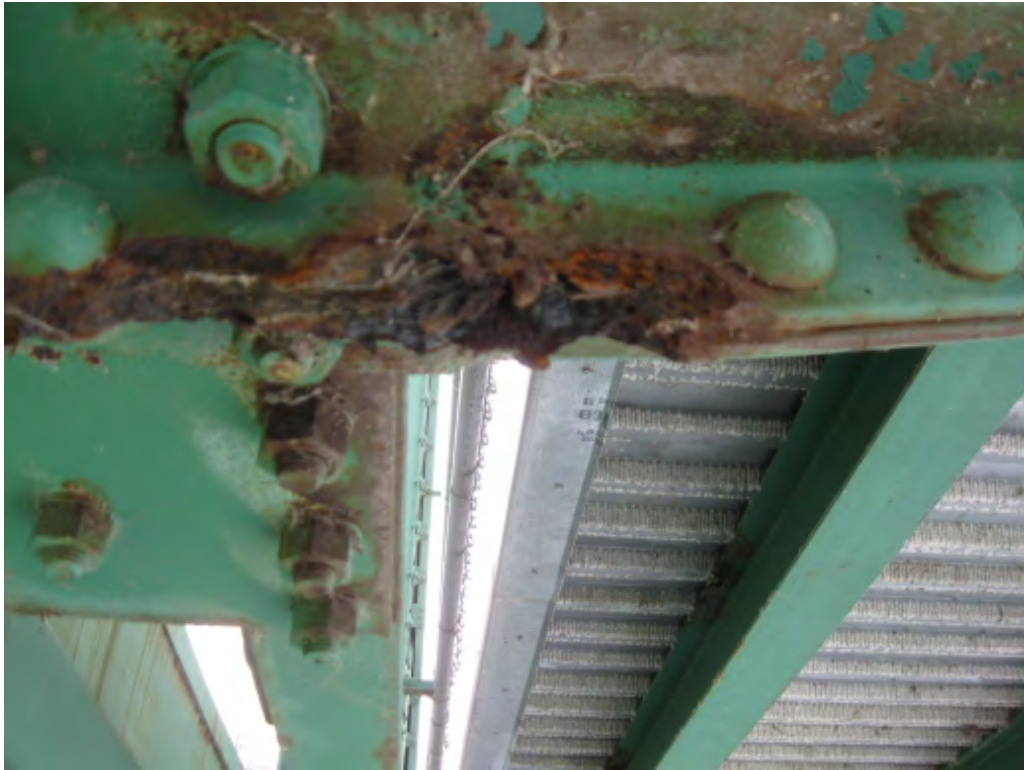
Figure 15 - Example Deterioration at Lower Sidewalk Connection

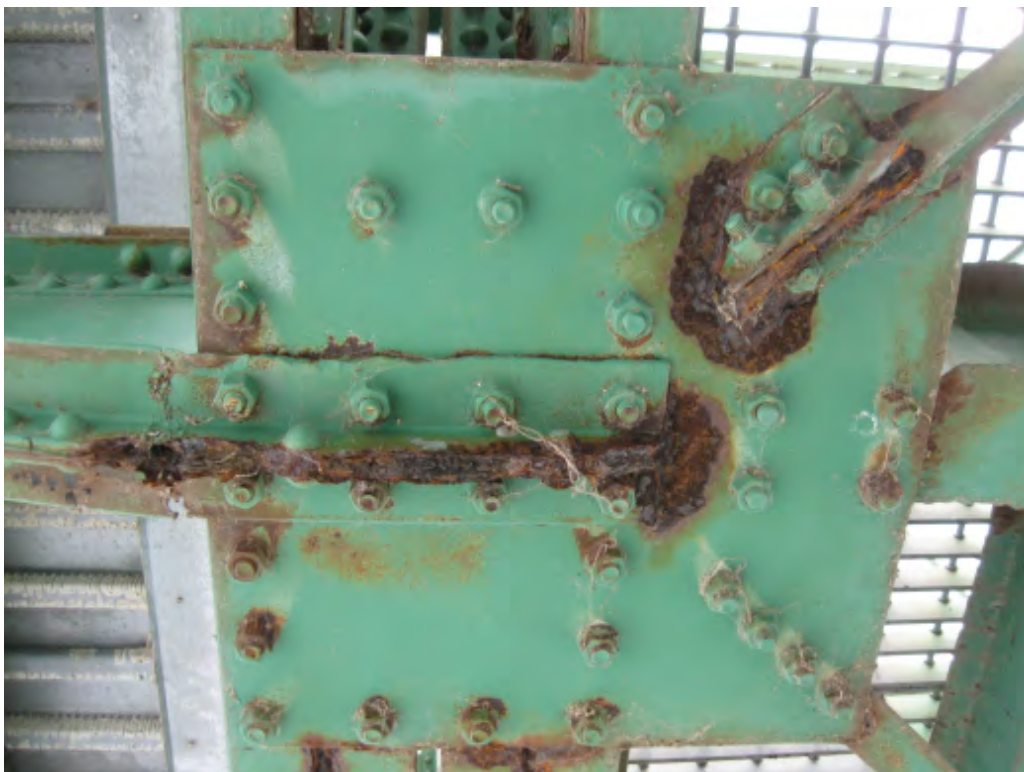
Figure 16 - Example Deterioration at Lower Horizontal Gusset Plate

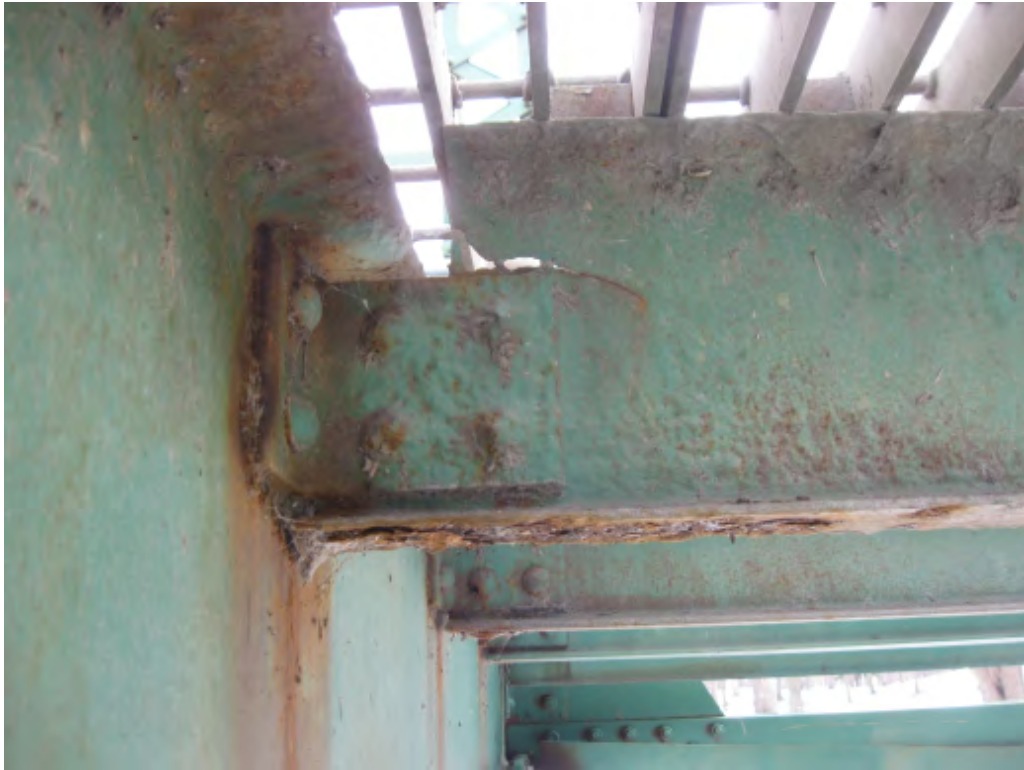
Figure 17 - Crack Progression in Stringer Web

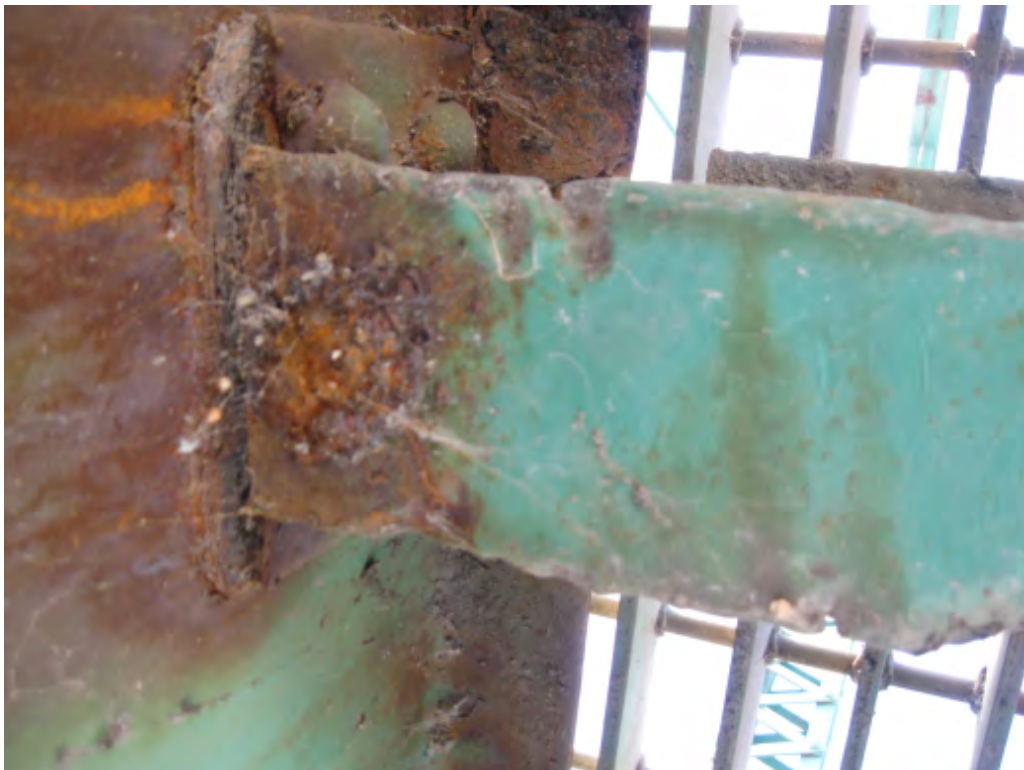
Figure 18 – Example Deterioration at Stringer Connection

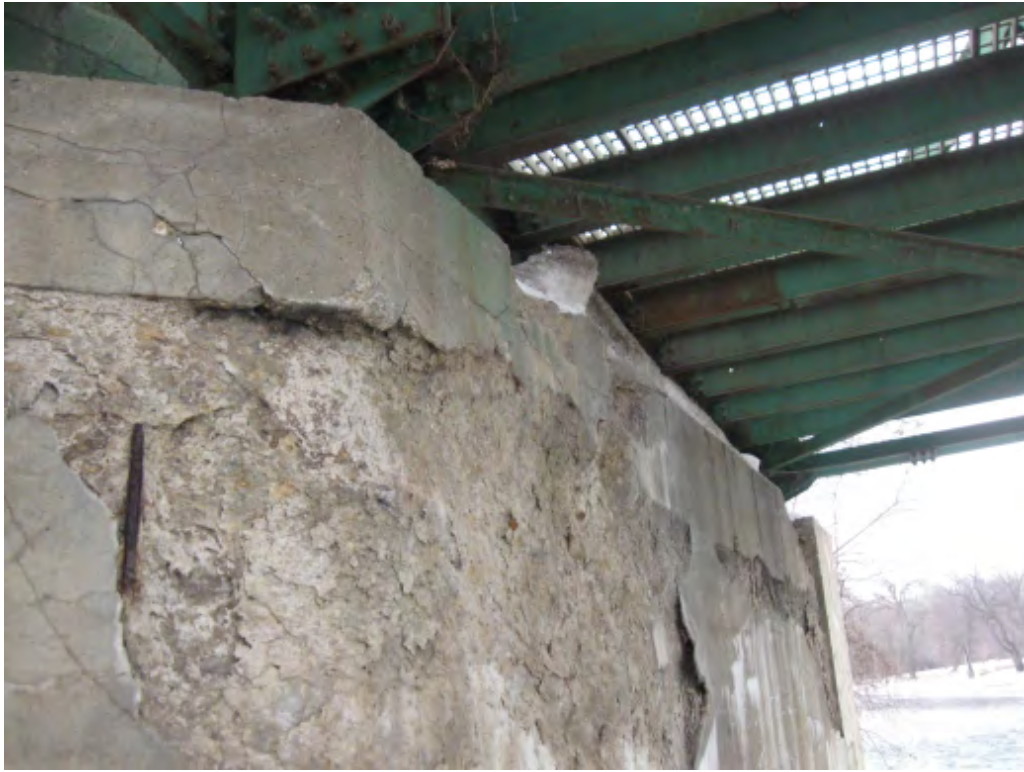
Abutments: Both abutments have vertical cracks with leaching. The north abutment has a large area that has been previously repaired, but is cracked and leaching again. There is significant delamination and spalling with some reinforcing exposed and corroded. The north backwall is cracked at the roadway adjacent to the bridge and appears to be crumbling. See Figures 19 and 20 in Appendix A for photos of abutment deterioration.

Figure 19 – Deterioration at North Abutment

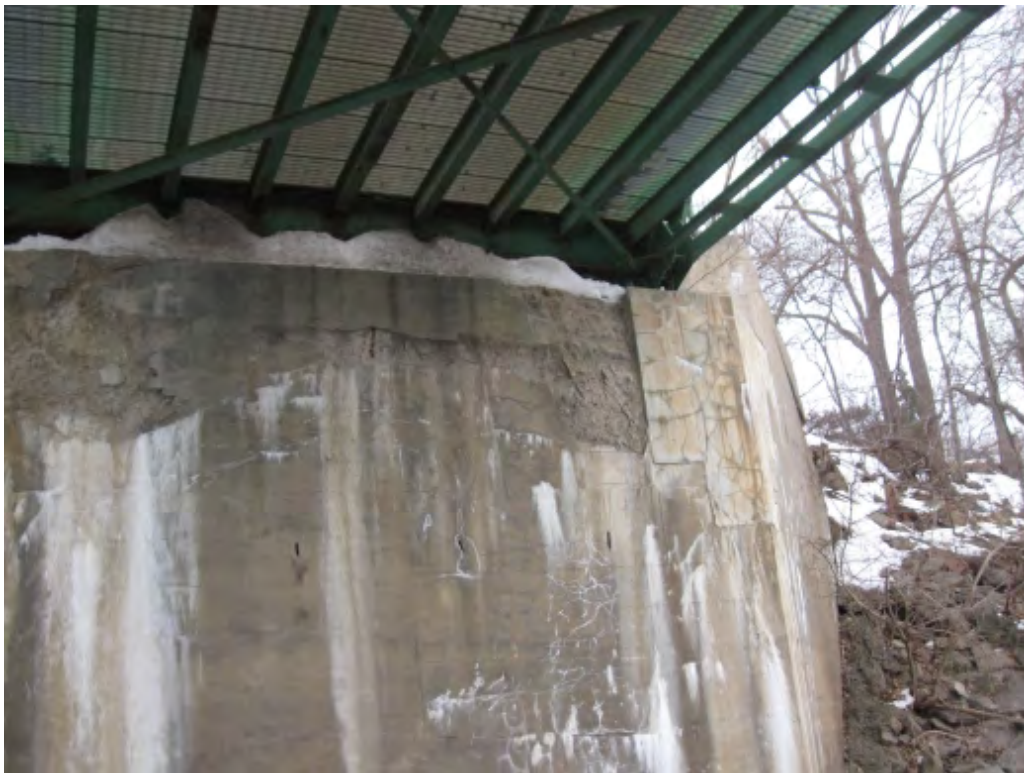
Figure 20 – Deterioration at North Abutment

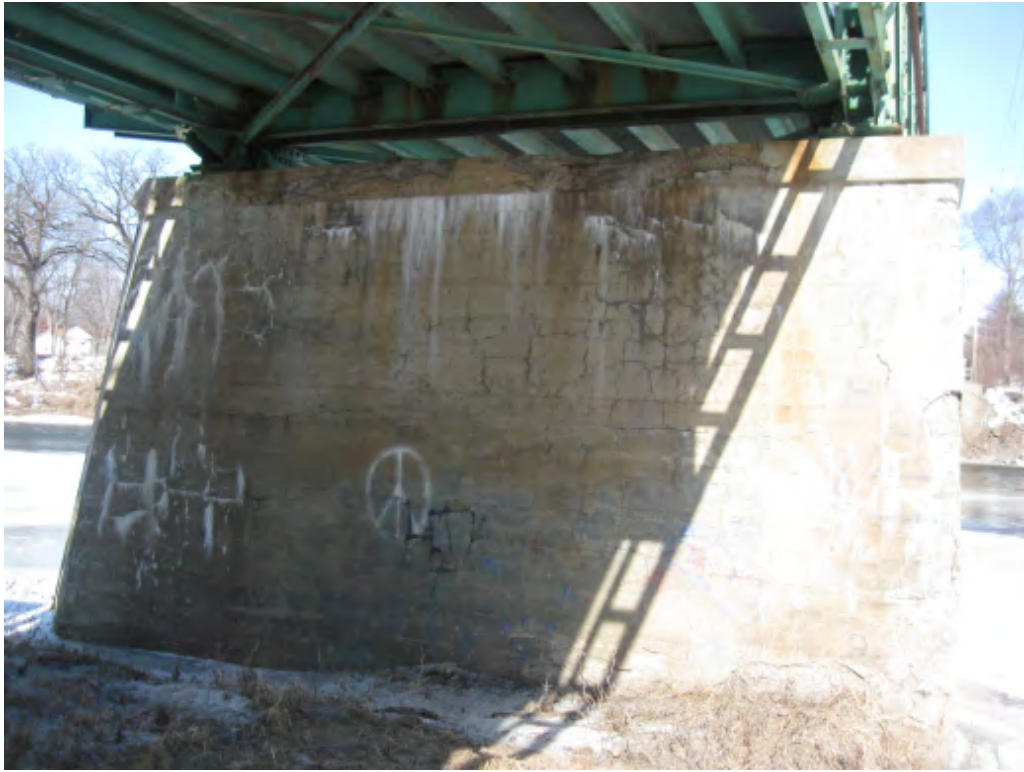
Piers: Areas of both piers near the waterline have large spalls, including a large spall in the north pier on the west end below the ice guard. The south pier has significant map cracking with leaching and the east end is spalling. The bridge seats are deteriorating especially on the south pier at the west bearing. See Figures 21 to 23 in Appendix A for photos of pier deterioration.

Figure 21 – Deterioration at South Pier

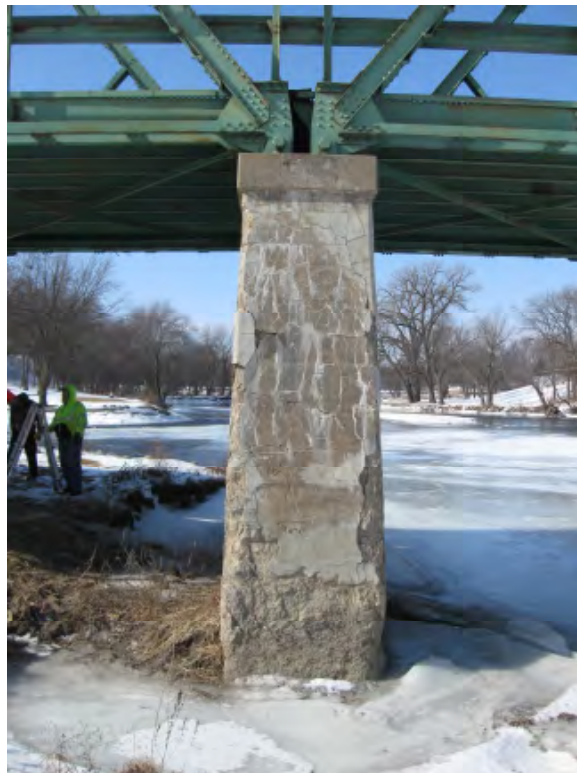
Figure 22 – Deterioration at South Pier

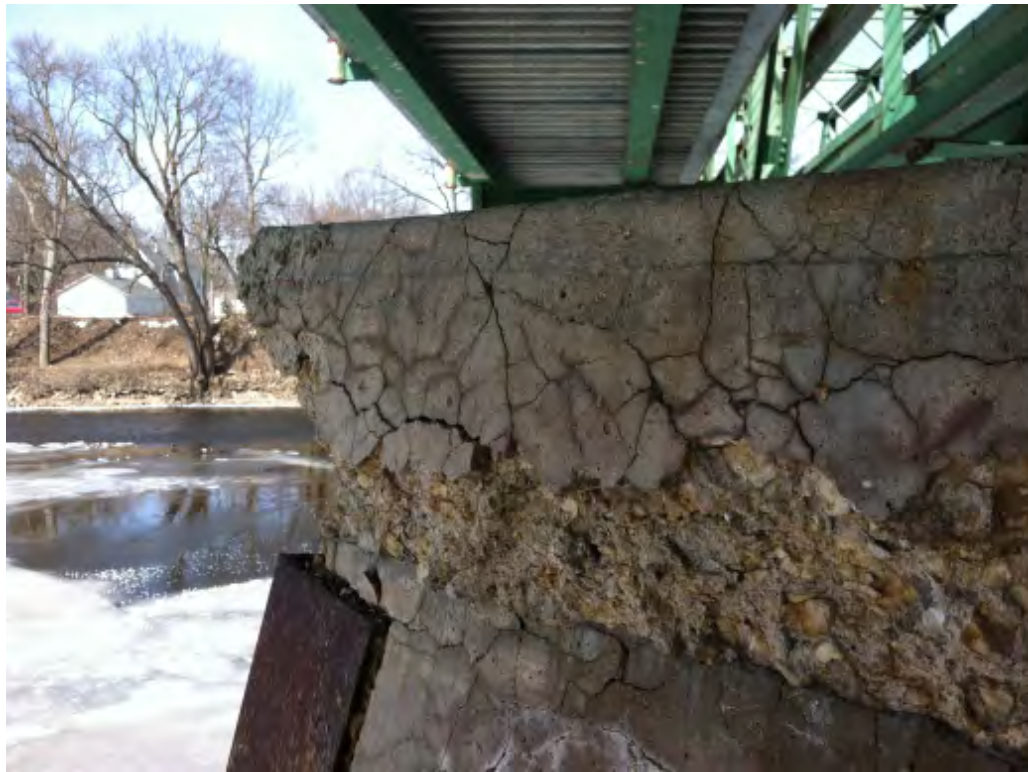
Figure 23 – Deterioration at South Pier (2013 Photo)

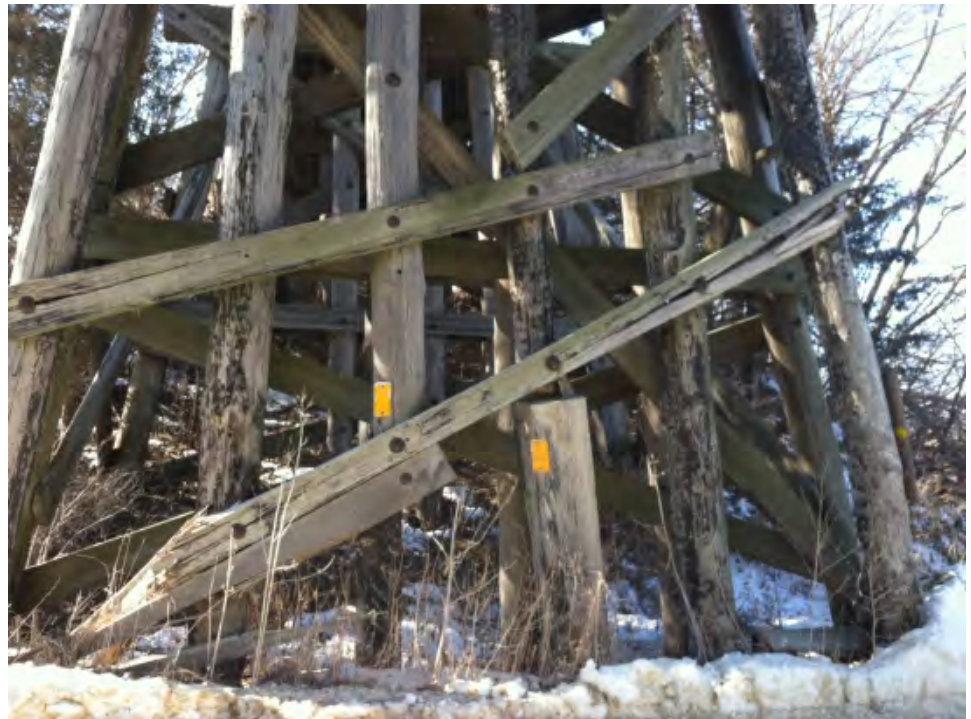
Photo No. 1 – Ivanhoe Pier 3

The approach asphalt has settled approximately 3 inches and has been patched adjacent to the bridge. The asphalt on the bridge deck has some transverse cracks. Two piles adjacent to the west side of the gravel road in Pier 3 were damaged by vehicular collision some time ago and repaired. The repair job on these piles has failed and the piles now carry no support (See Photo 1). Load rating calculations show that the pile cap is sufficient to carry the current loading on the bridge. However, if the bridge is subject to heavier loading in the future (potentially for trail reconstruction) then repair work will need to be done to this structure.

Recommendation: Consider repairing damaged piling in Pier 3.

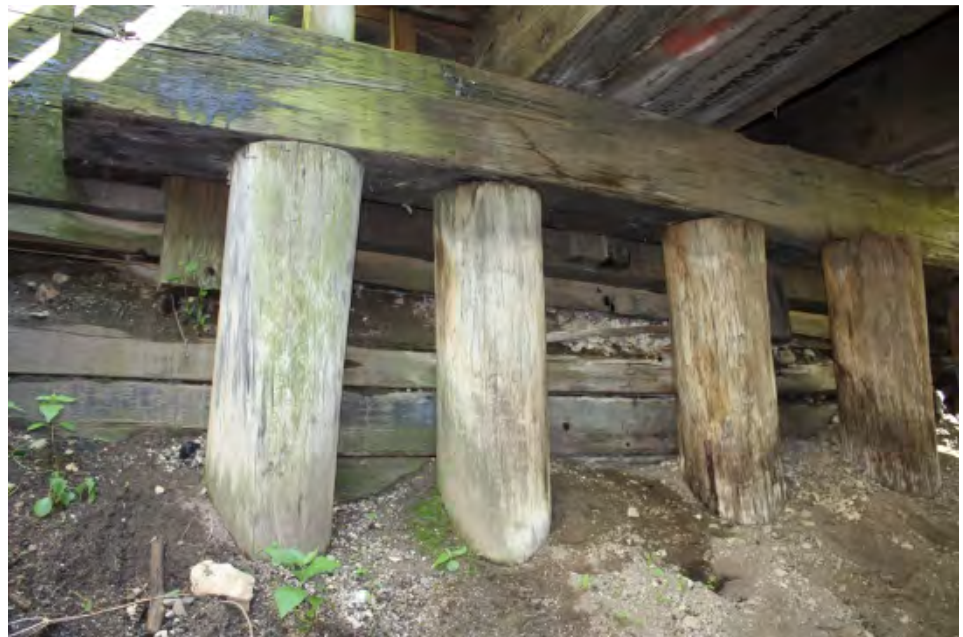
Photo No. 2 – Prairie Run East Abut (2011 Photo)

The approach asphalt has settled. The asphalt on the bridge deck has some transverse cracks. The hole in the east approach asphalt has been patched; however, the broken backwall has not been repaired (See Photo 2). There is some asphalt under the bridge next to the west abutment, which flowed through the backwall during construction. A few piles (mainly located in the creek) have some deterioration and sound hollow.

Repair the backwall on the east abutment.
