Re: 2015 Bridge Inspections

**2015
BRIDGE INSPECTION
AND
MAINTENANCE REPORT**

CITY OF WAVERLY, IOWA

2013 ROADWAY BRIDGE INSPECTION

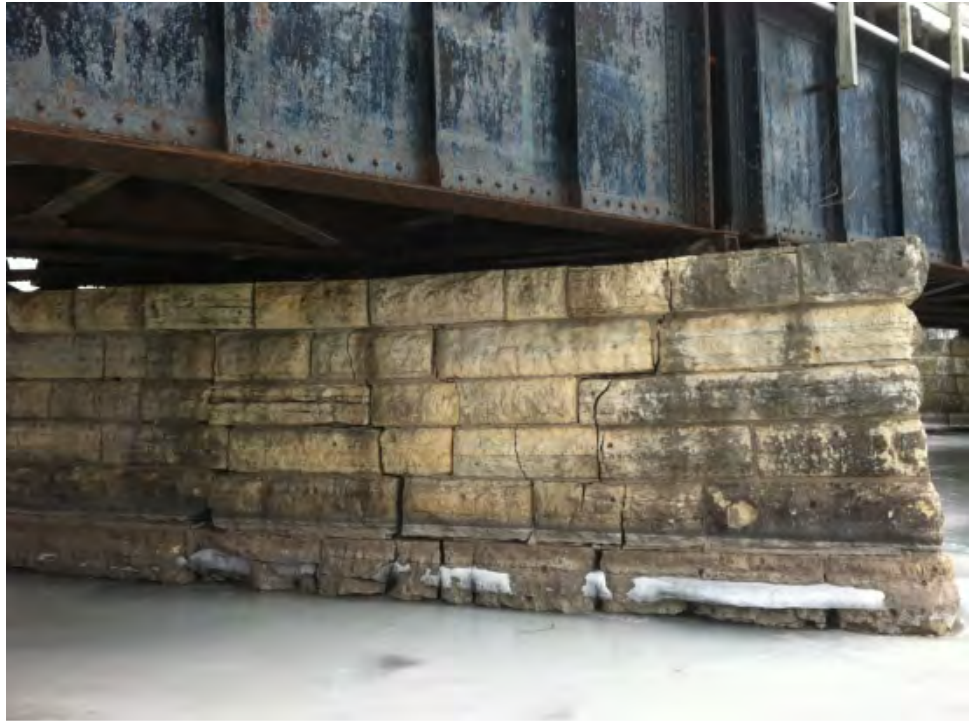
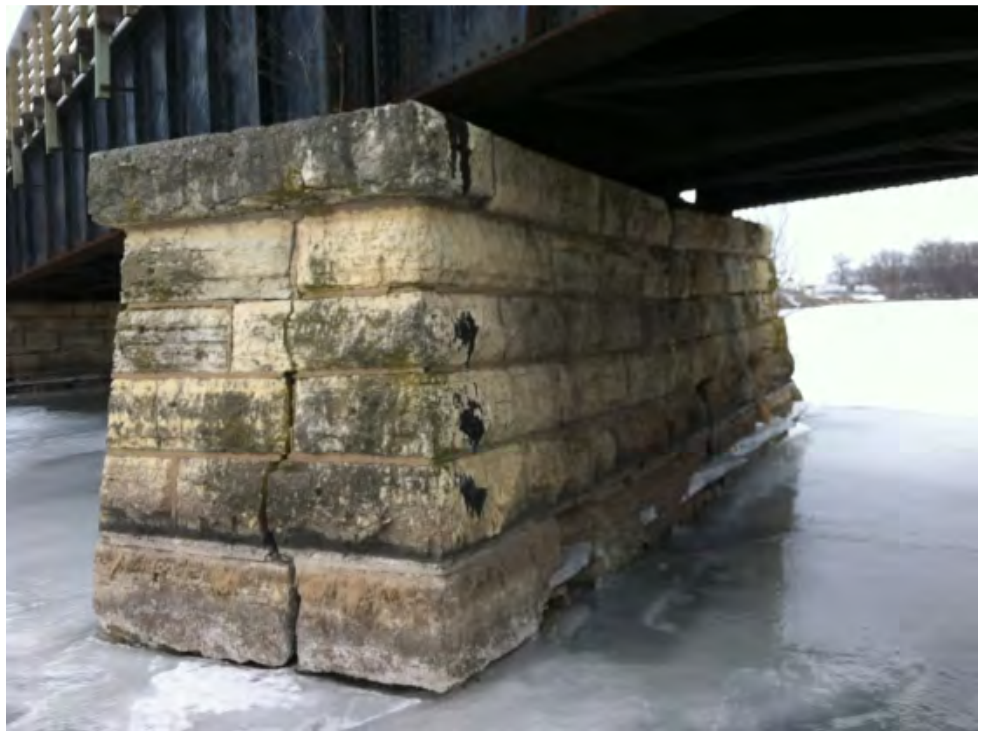
Note: In general, the condition of the limestone blocks at the piers and abutments has reduced their structural capacity; however, it is our opinion that they are still structural sufficient for the current loading. We do recommend that the piers be closely monitored for additional settlement especially following a significant flooding event.

Photo No. 3 – Cedar River Pier

Photo No. 4 – Cedar River Pier

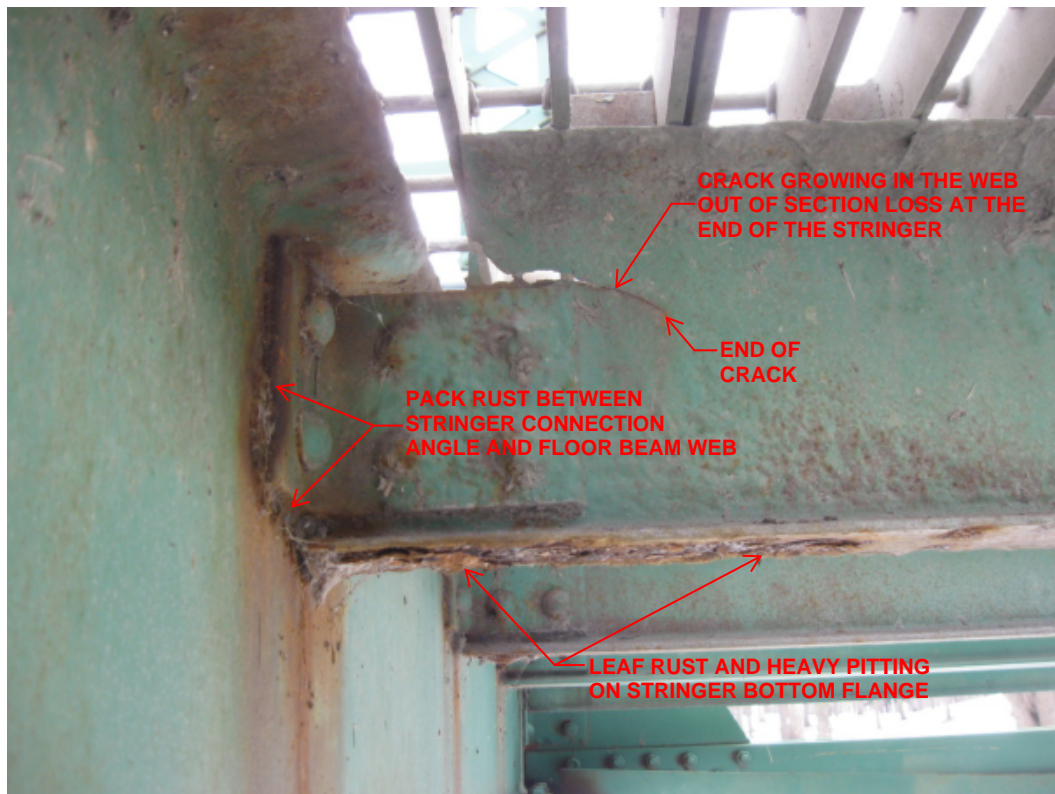
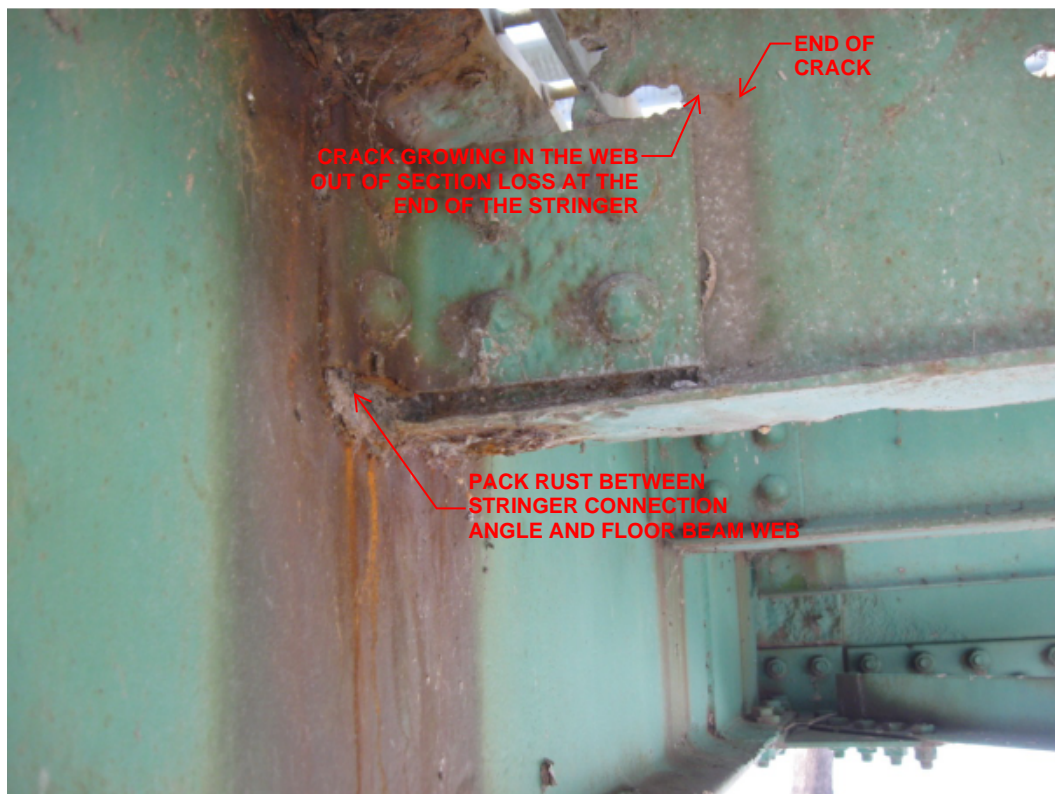
Failure of one stringer would result in the metal decking spanning a space between the adjacent stringers twice as large as it was designed for. As a result the decking would likely sag, if it could sustain the load at all, which could cause a dangerous driving surface which could cause drivers to lose control and have an accident.

The adjacent stringers would also be subject to greater forces as a result of the failure of one stringer. The general condition of the bridge is poor, and the adjacent stringers may not be able to support the additional load in their deteriorated condition.

Figure 1: Crack at Stringer End

Figure 2: Crack at Stringer End

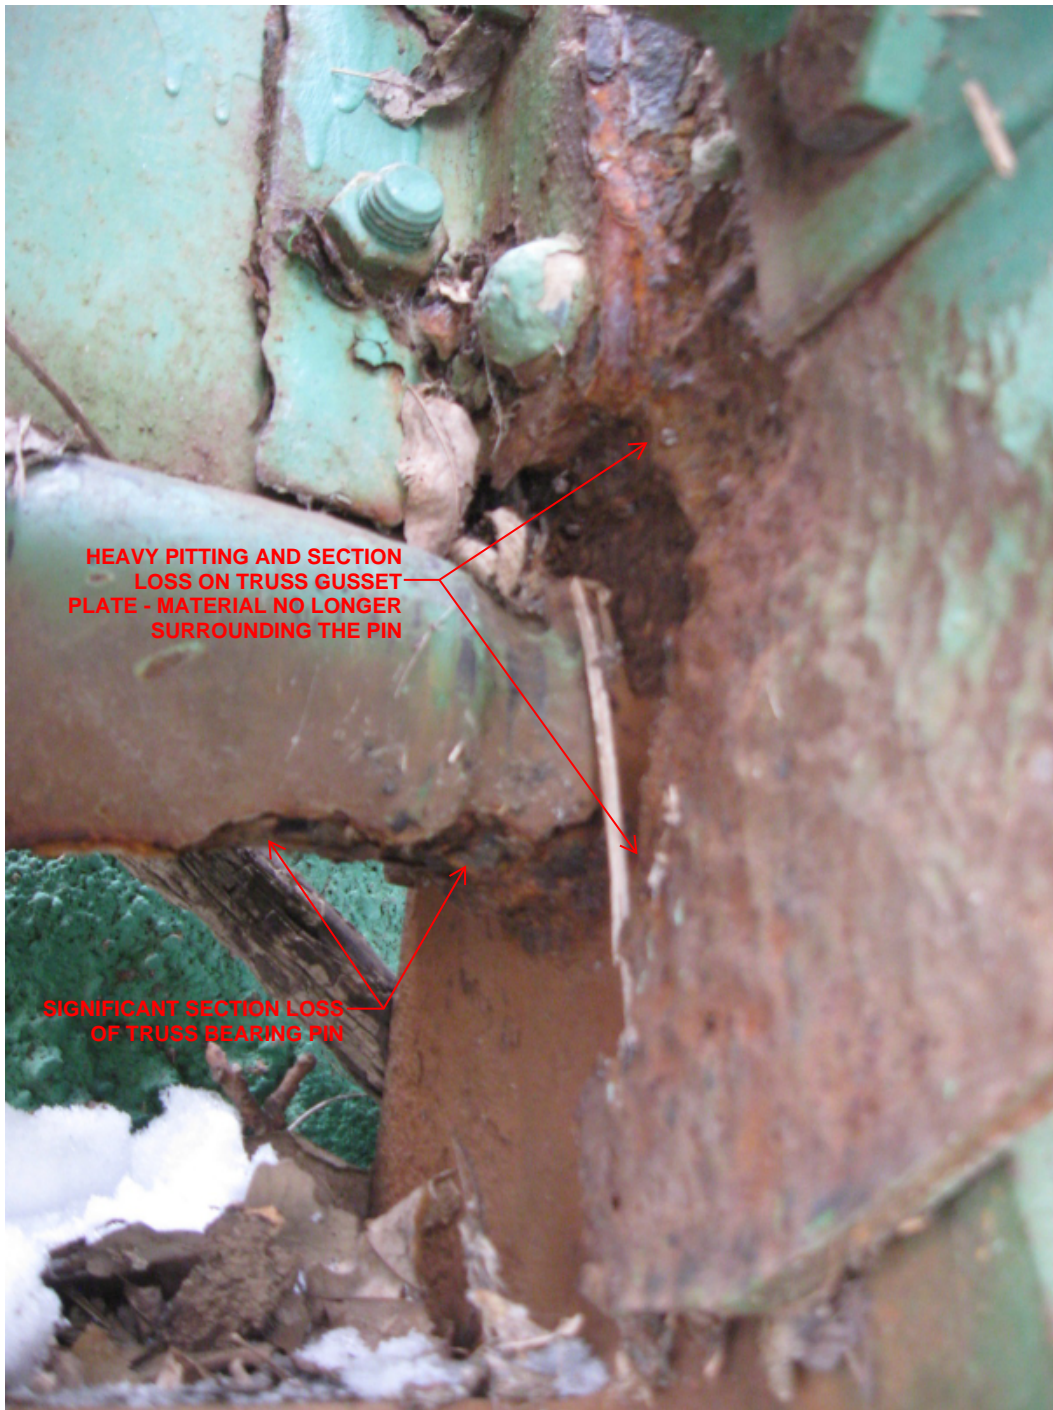
displacement at one corner. If a truss member failed because these additional forces were too large for to sustain, the entire truss system could fail.

Figure 3: Deterioation at Bearing - Truss Gusset Plate Not Connected to Pin

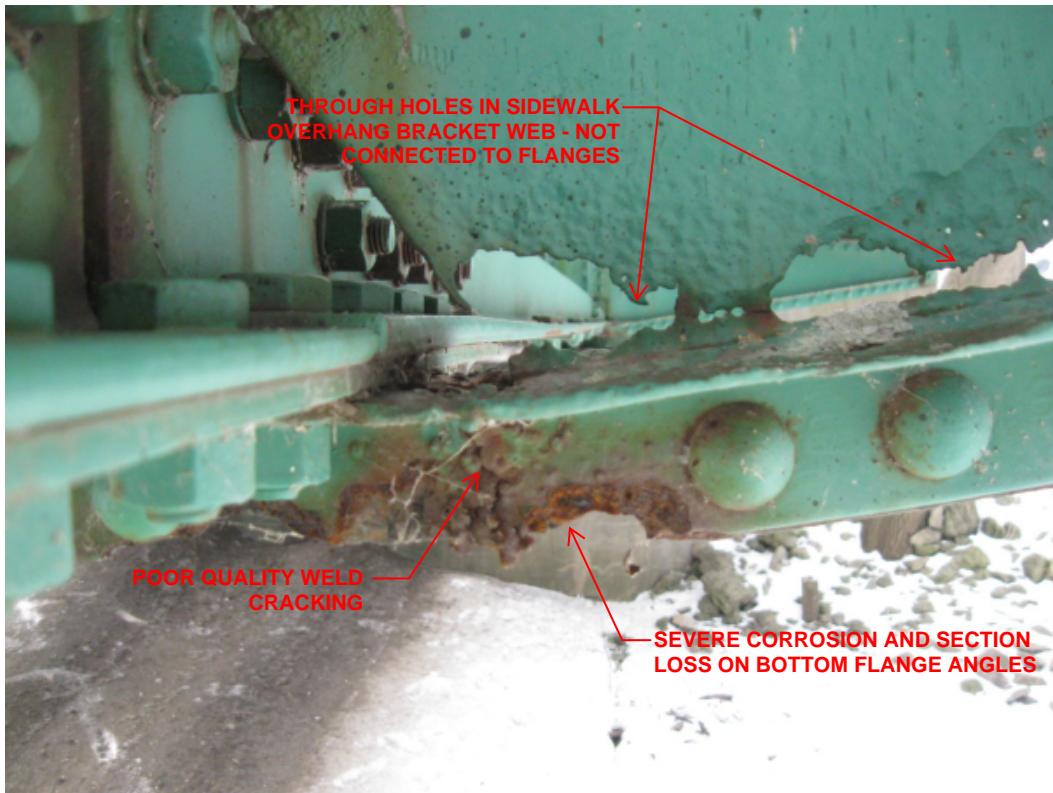
Figure 4: Side View of Sidewalk Overhang Bracket Deterioration

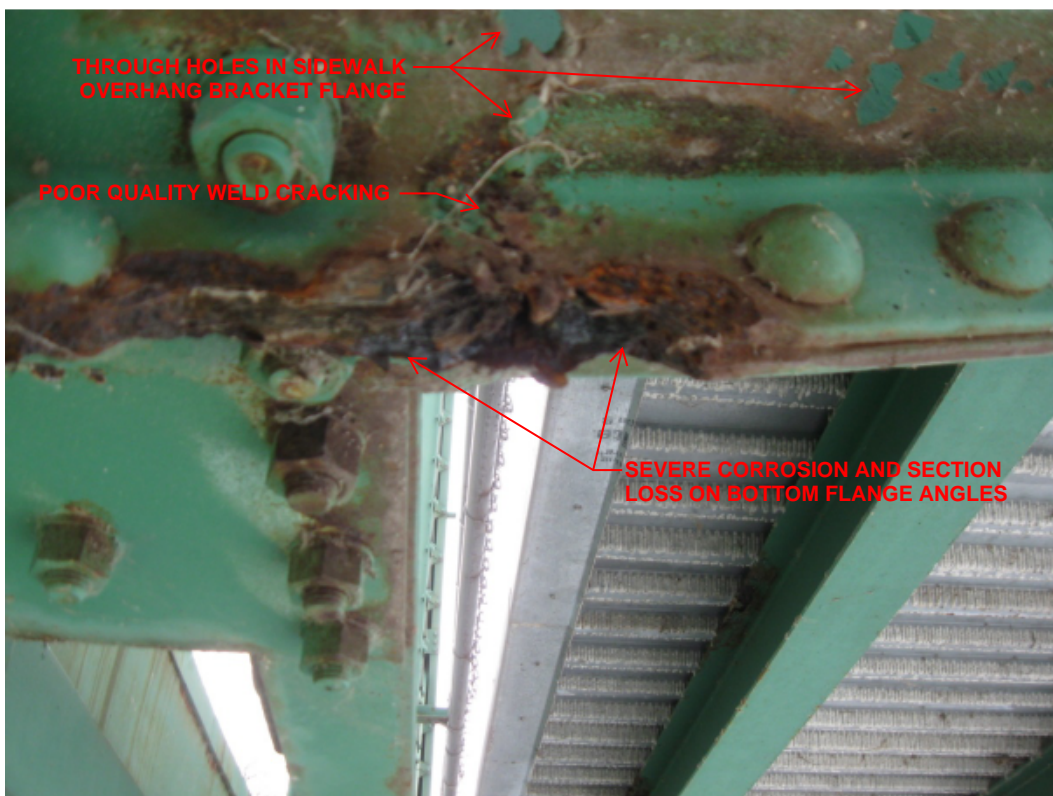
Figure 5: Bottom View of Sidewalk Overhang Bracket
