Re: 2015 Bridge Inspections

**2015  
BRIDGE INSPECTION  
AND  
MAINTENANCE REPORT**

CITY OF WAVERLY, IOWA

# CITY OF WAVERLY 2013 ROADWAY BRIDGE INSPECTION

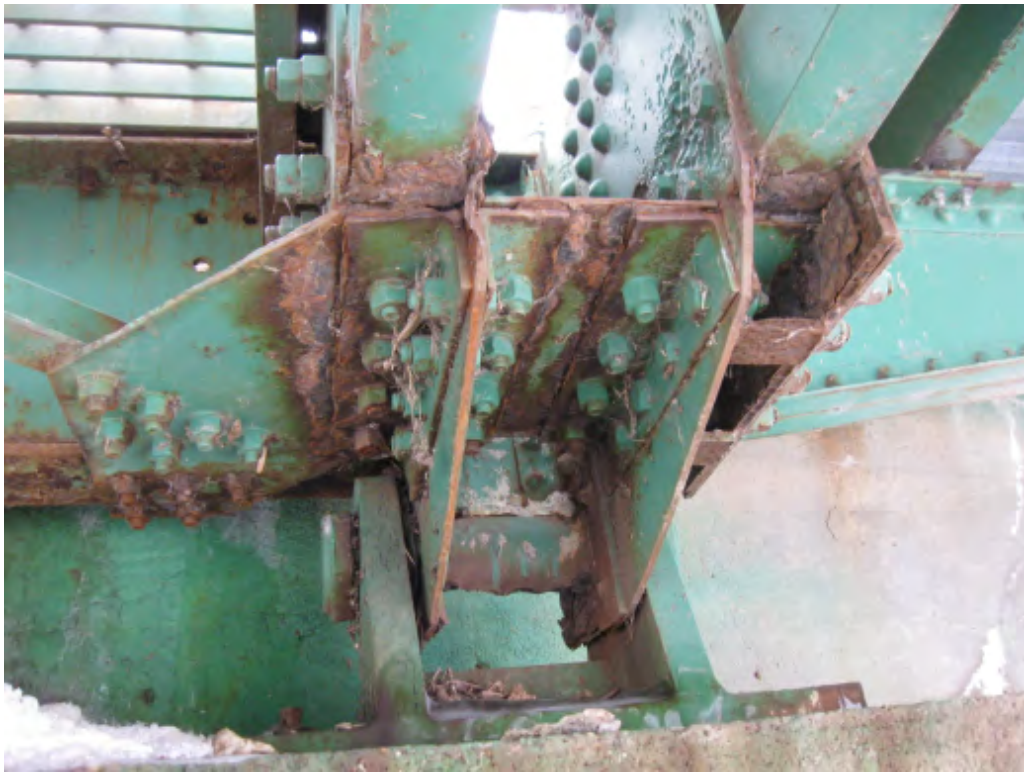
**Figure 1 - Example Deterioration around Bearing**

**Superstructure:** There is significant pack rust typical at many connections. Pack rust is causing distortion of plates built up near bearings and

bulging of pins. There is also significant section loss (including through holes) of plates adjacent to the pins, and the connection has failed at the southeast and northwest bearings of the south truss resulting in some settlement of the truss, the southwest bearing is near failure. Two additional plates were welded to the gusset plates directly above the bearing pin, at the east side of the south abutment, during the 2006 repair in order to temporarily alleviate the potential for failure. Member U1-L2 on the east side of the south truss has slight sweep (out of plane bending) that is likely due to differential settlement of the truss at the failed bearings. There is section loss on some anchor bolts and nuts are not tight at several locations. The bearings are also tipped outward which is the opposite direction based on the current temperature.

**This bridge should remain closed to vehicular and pedestrian traffic due to the advanced deterioration of multiple aspects of this structure.**

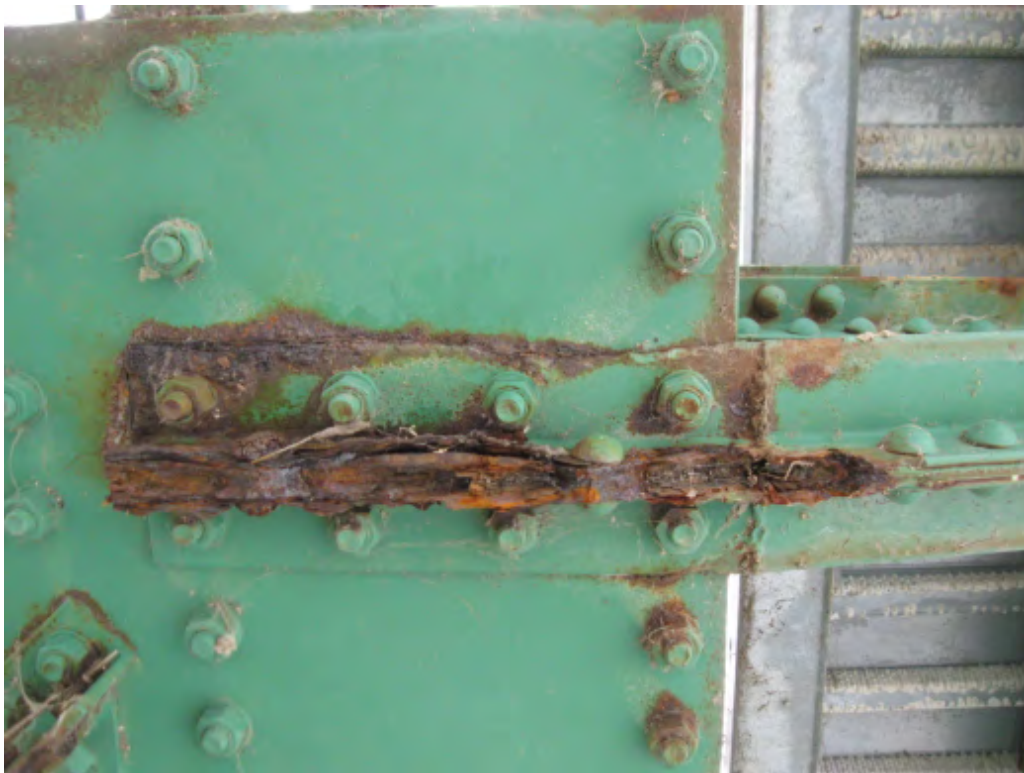
**Figure 14 - Example Deterioration at Lower Sidewalk Connection**

**Sidewalk:** Pack rust has caused significant section loss in the bottom members of the sidewalk overhang bracket resulting in some through holes at the bottom of the web. The top plate of the

sidewalk overhang bracket is rusted through in some locations as well. The overhang bracket has significant section loss on the flanges with through holes in some areas. There is heavy leaf rust on the top flange of stringers under the sidewalk. There is heavy “white rust” on the bottom of the sidewalk pan. See Figures 14 to 16 in Appendix A for photos of sidewalk connection deterioration.
