# Fracture Critical Bridge Inspection

**Presented by MN/DOT Bridge Safety Inspections**

MN/DOT's fracture critical bridge inspection team performs in-depth and special inspections for State, County and City owned bridges throughout Minnesota. All inspectors are certified for bridge inspection in accordance with Federal Highway Administration regulations. In addition, there are 3 inspectors nationally certified in nondestructive testing.

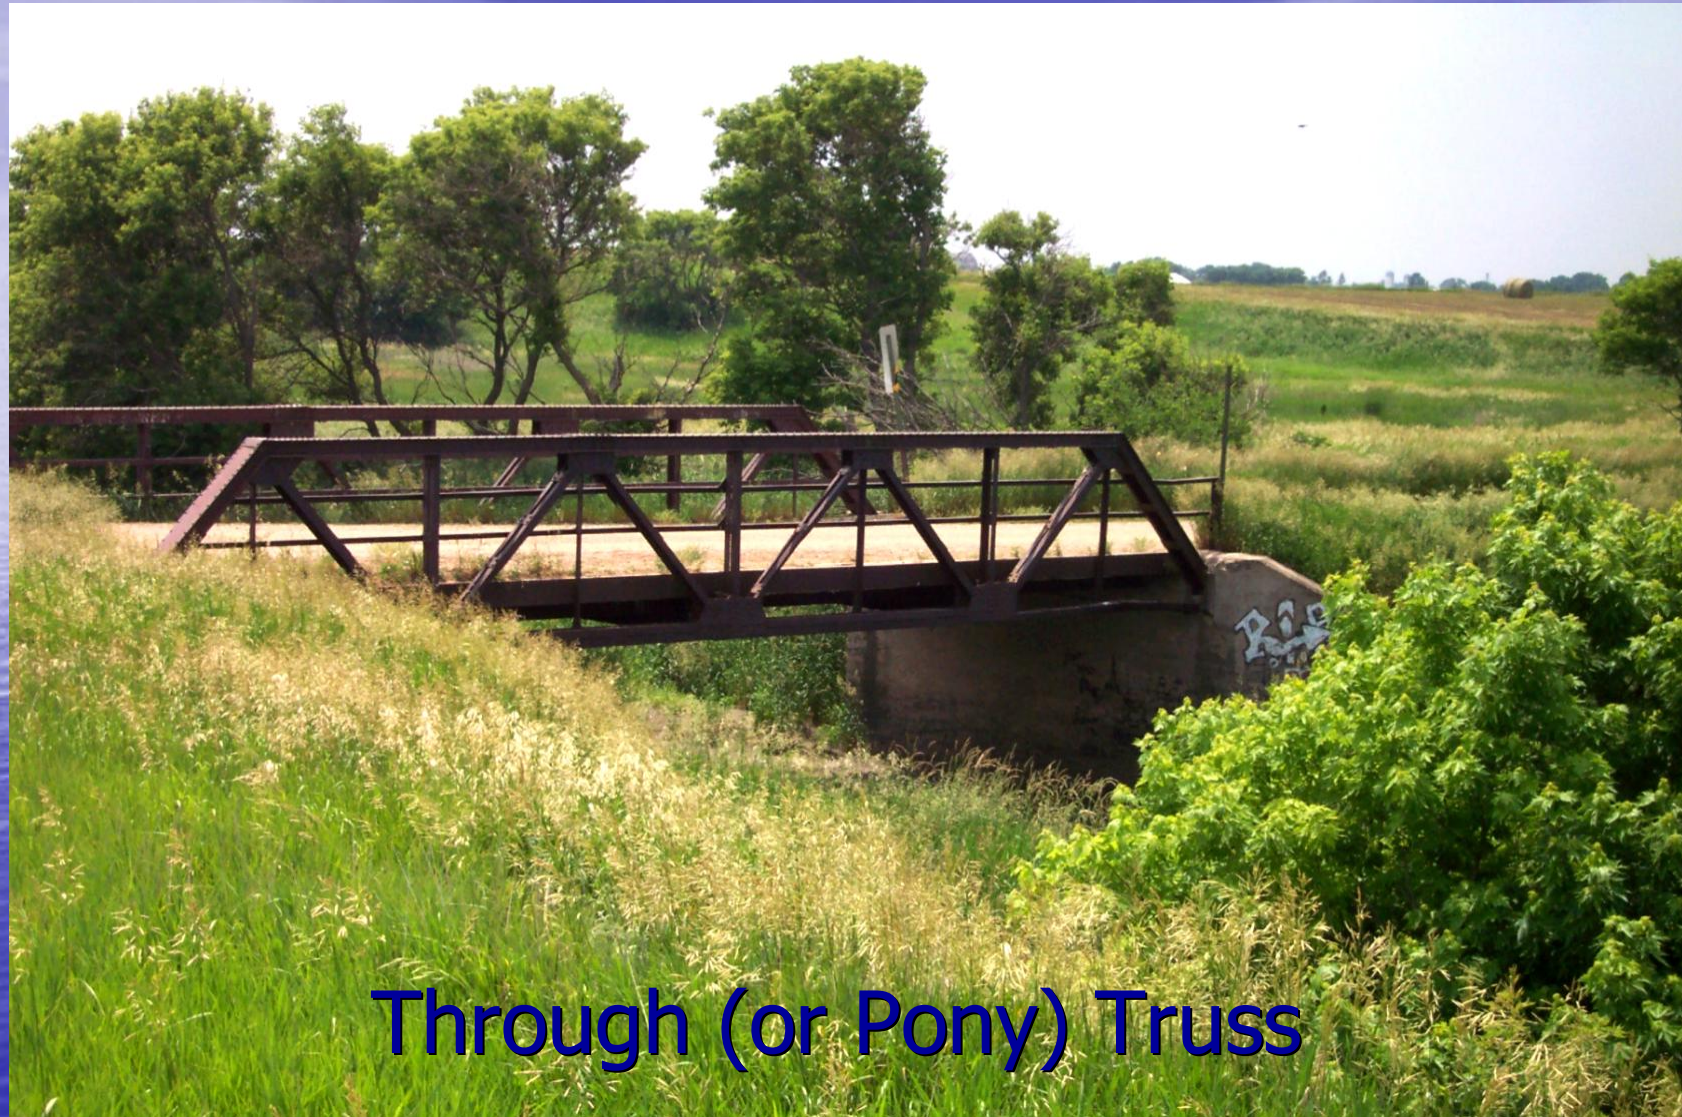
Through (or Pony) Truss

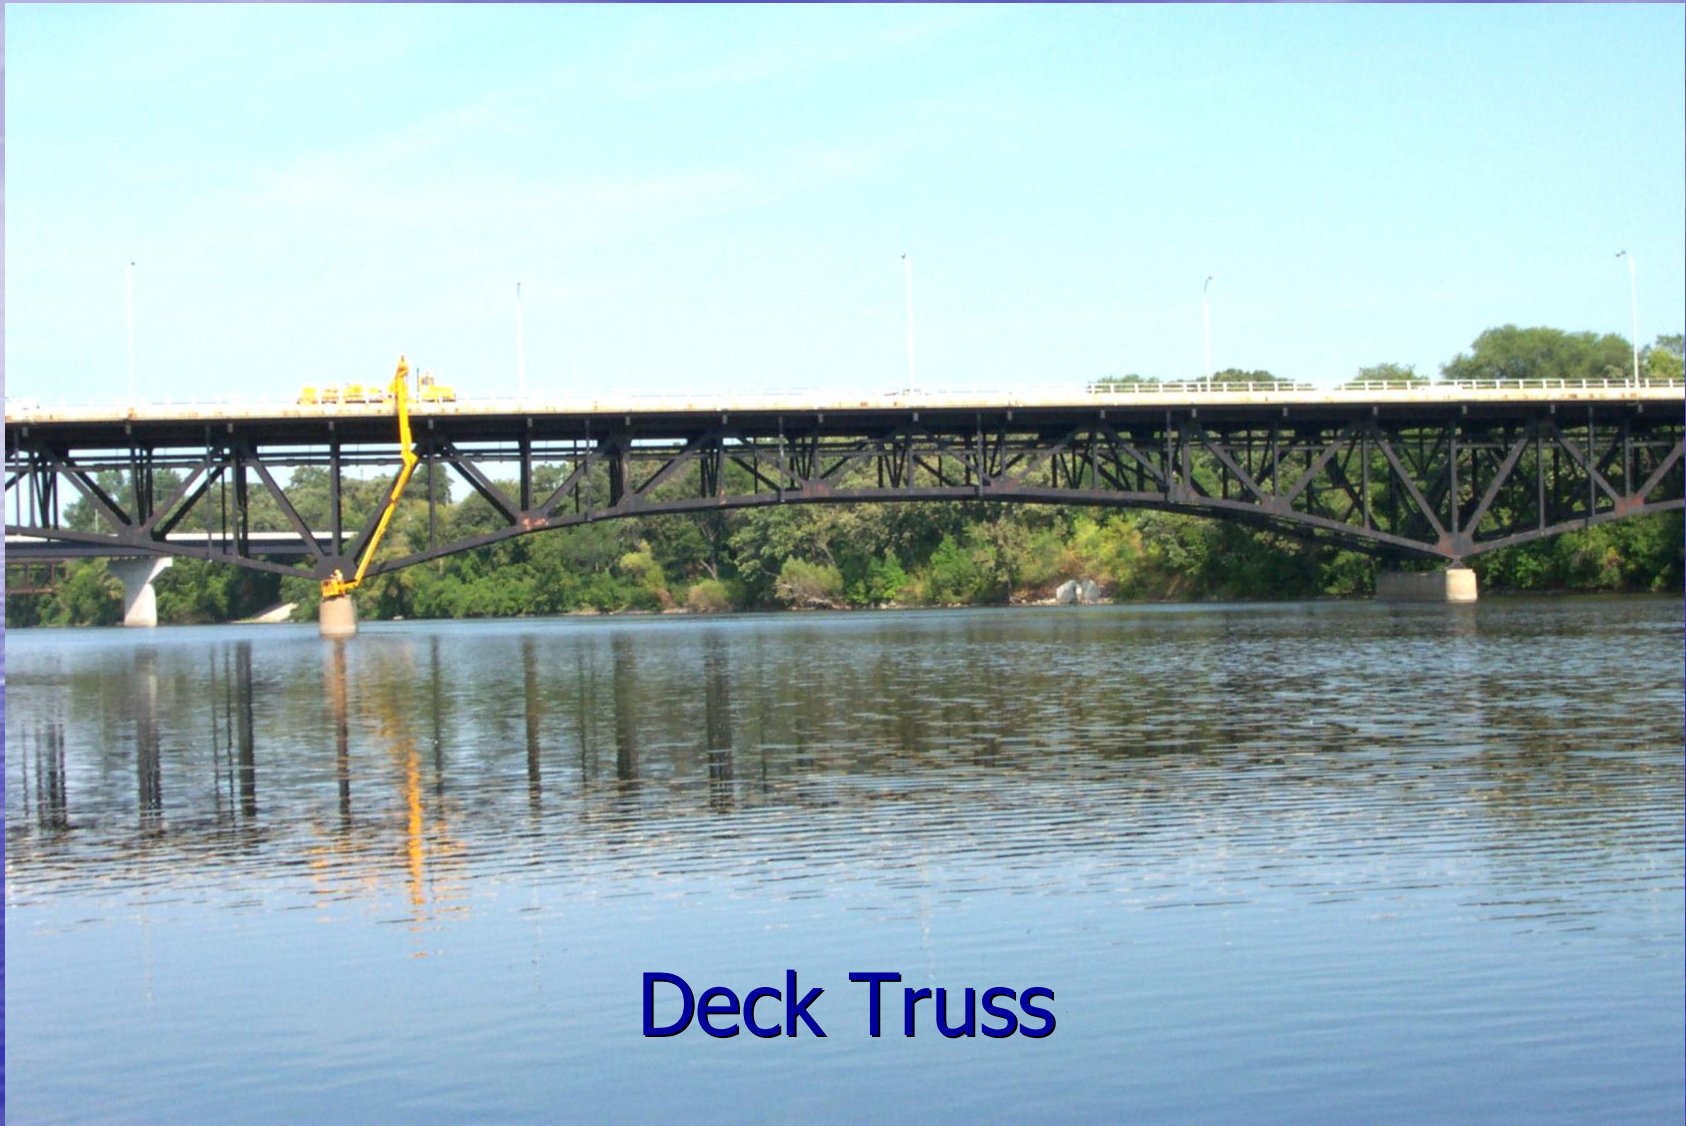
Deck Truss

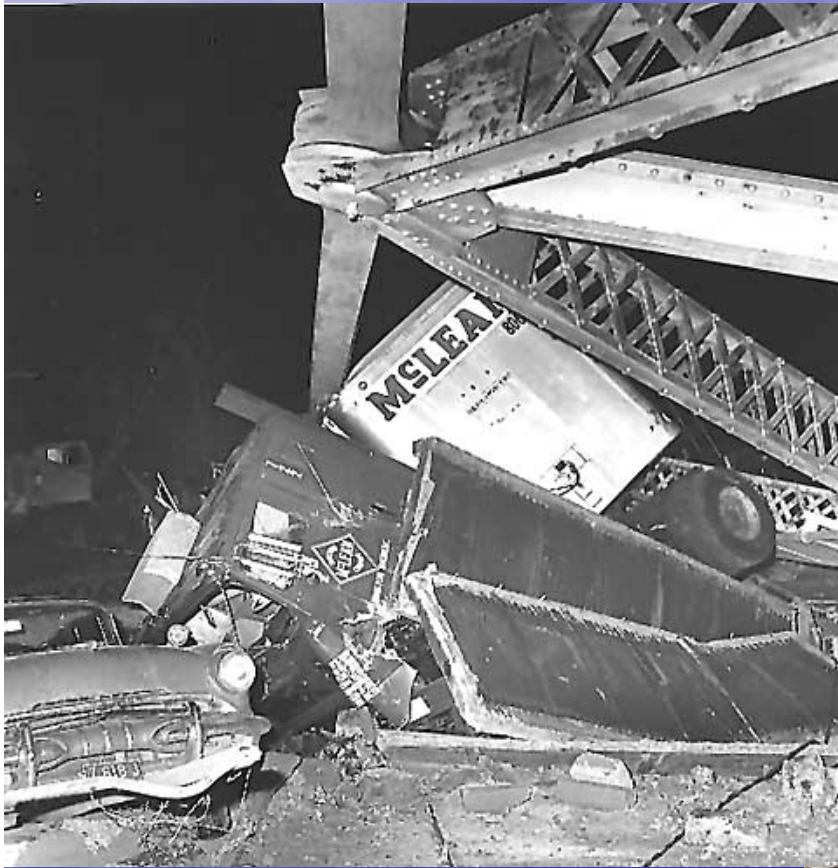
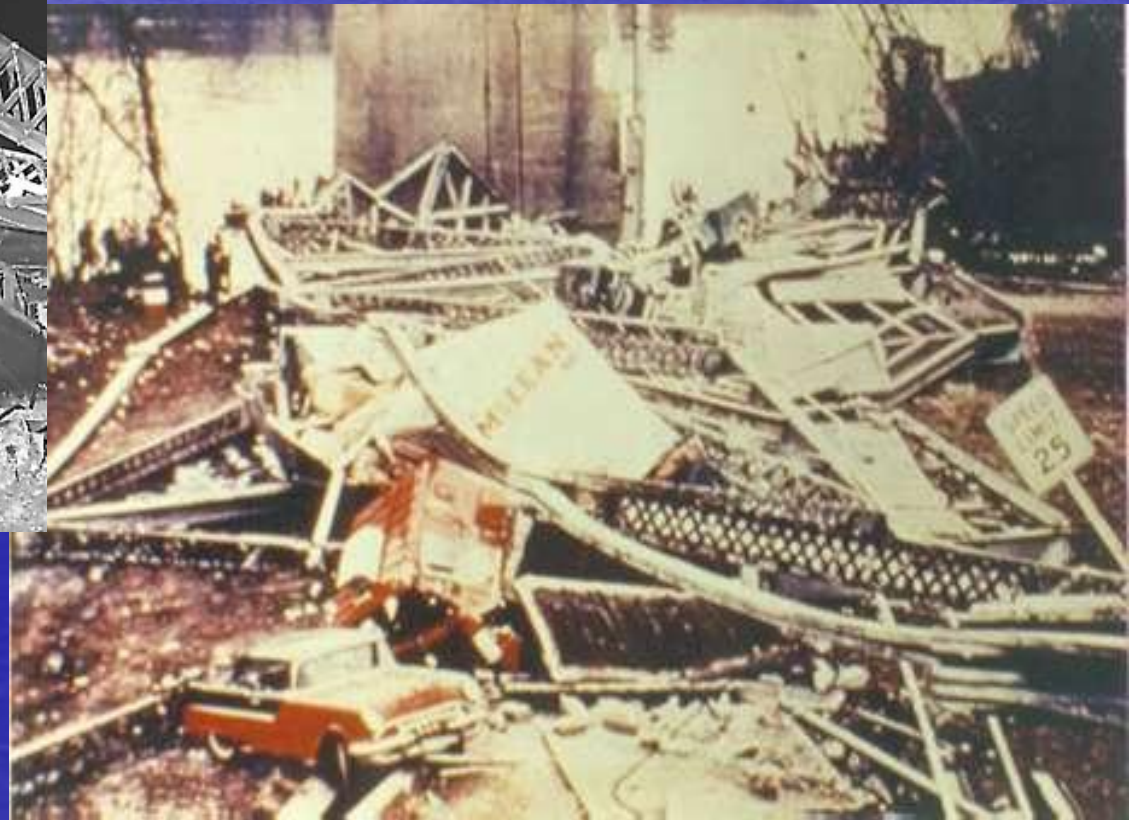
# 1967 Silver Bridge Collapse

The Silver Bridge had a pin and eyebar suspension chain instead of the conventional cable. When fatigue caused one of the eyebars to fail, the entire bridge collapsed.

In December of 1967, the Silver Bridge in Point Pleasant, West Virginia collapsed.

49 motorists were  
killed.

Because of this failure, the 1968 Federal-Aid Highway Act required the establishment of National Standards for the Inspection of Bridges (NBIS) on the Federal-Aid Highway system.

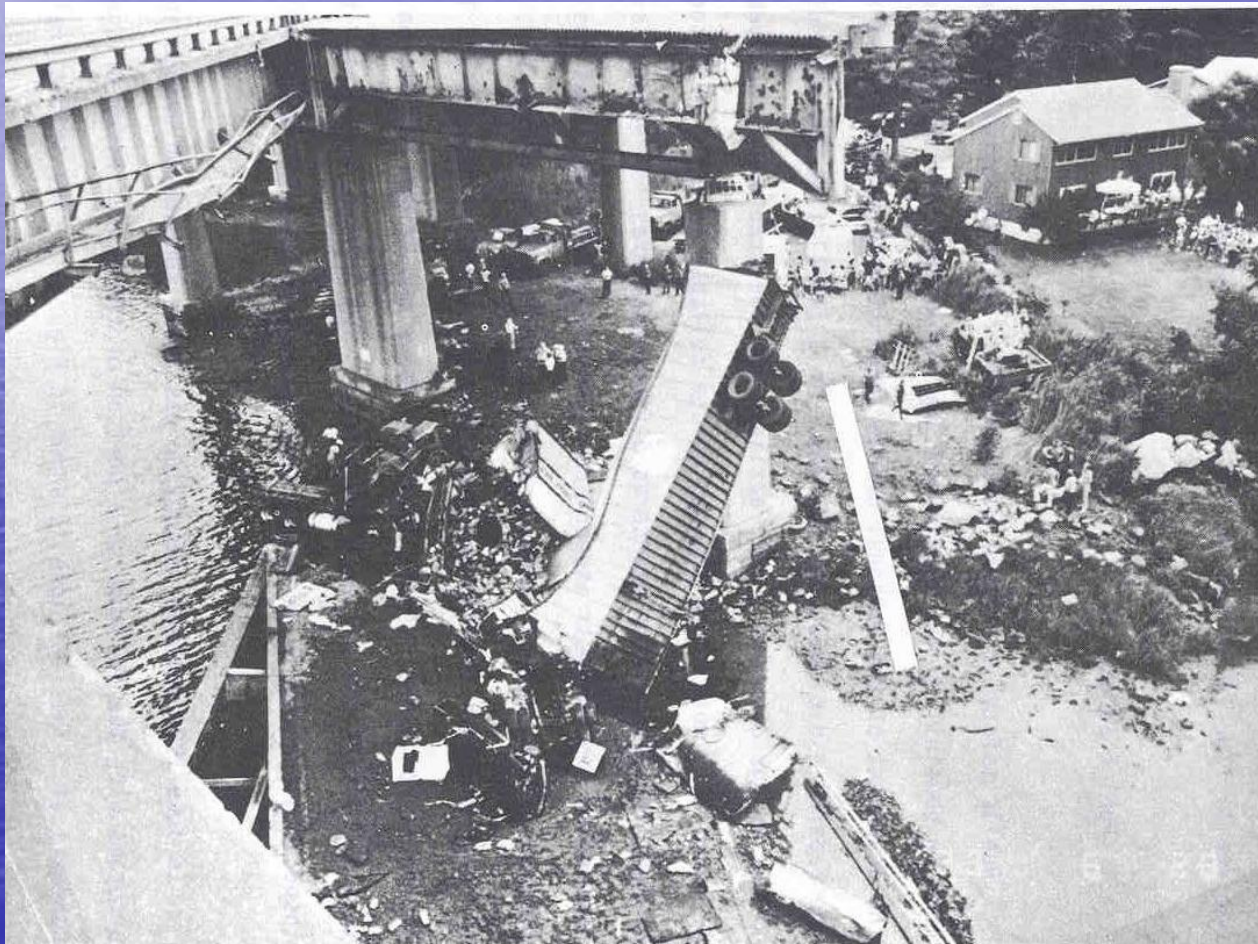
# 1983 Collapse of the Mianus River Bridge (Greenwich, Connecticut)

The Mianus Bridge was constructed in the 1950's, and consisted of two adjacent fracture critical 2-girder steel structures with suspended spans connected by "pin-and-hanger" assemblies at each corner.

The hanger plates were 6-1/2 ft. long and 1-1/2" thick.

The plates were connected to the girder webs with 7" diameter pins.

The bridge failed when expanding rust (pack rust) forced the inner hanger plate to separate from the lower pin, shifting the entire load to the exterior plate and causing the upper pin to shear.

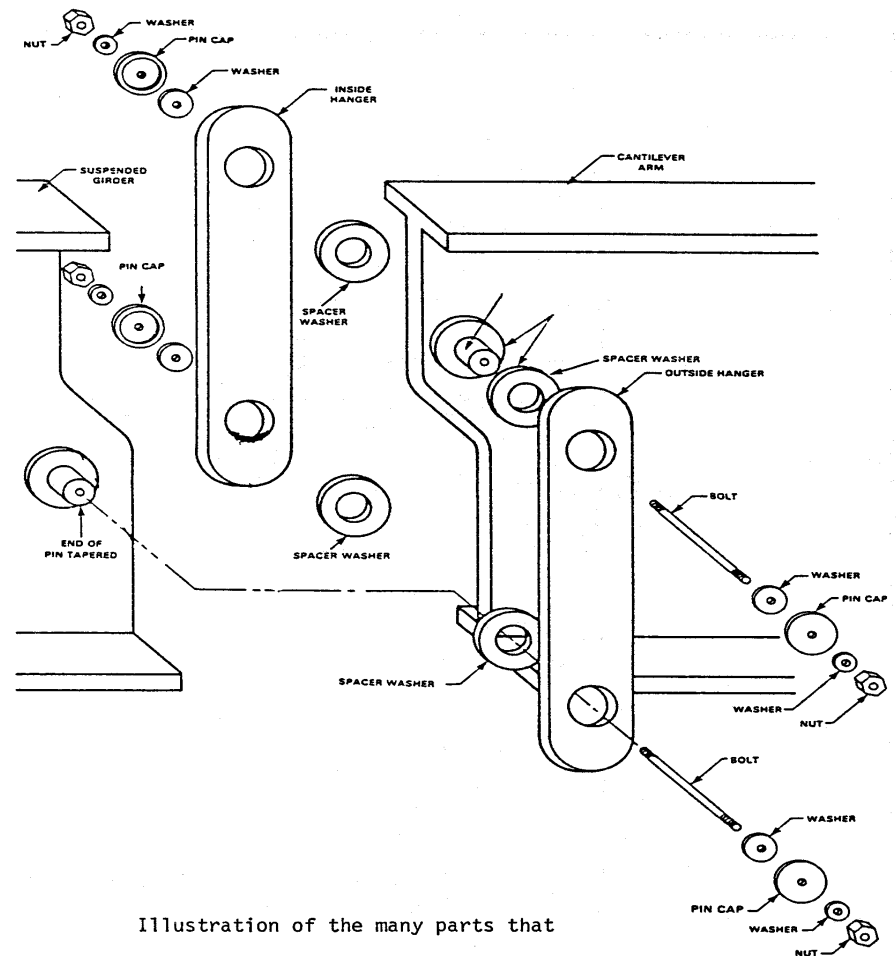
Illustration of the many parts that make up a pin and hanger assembly

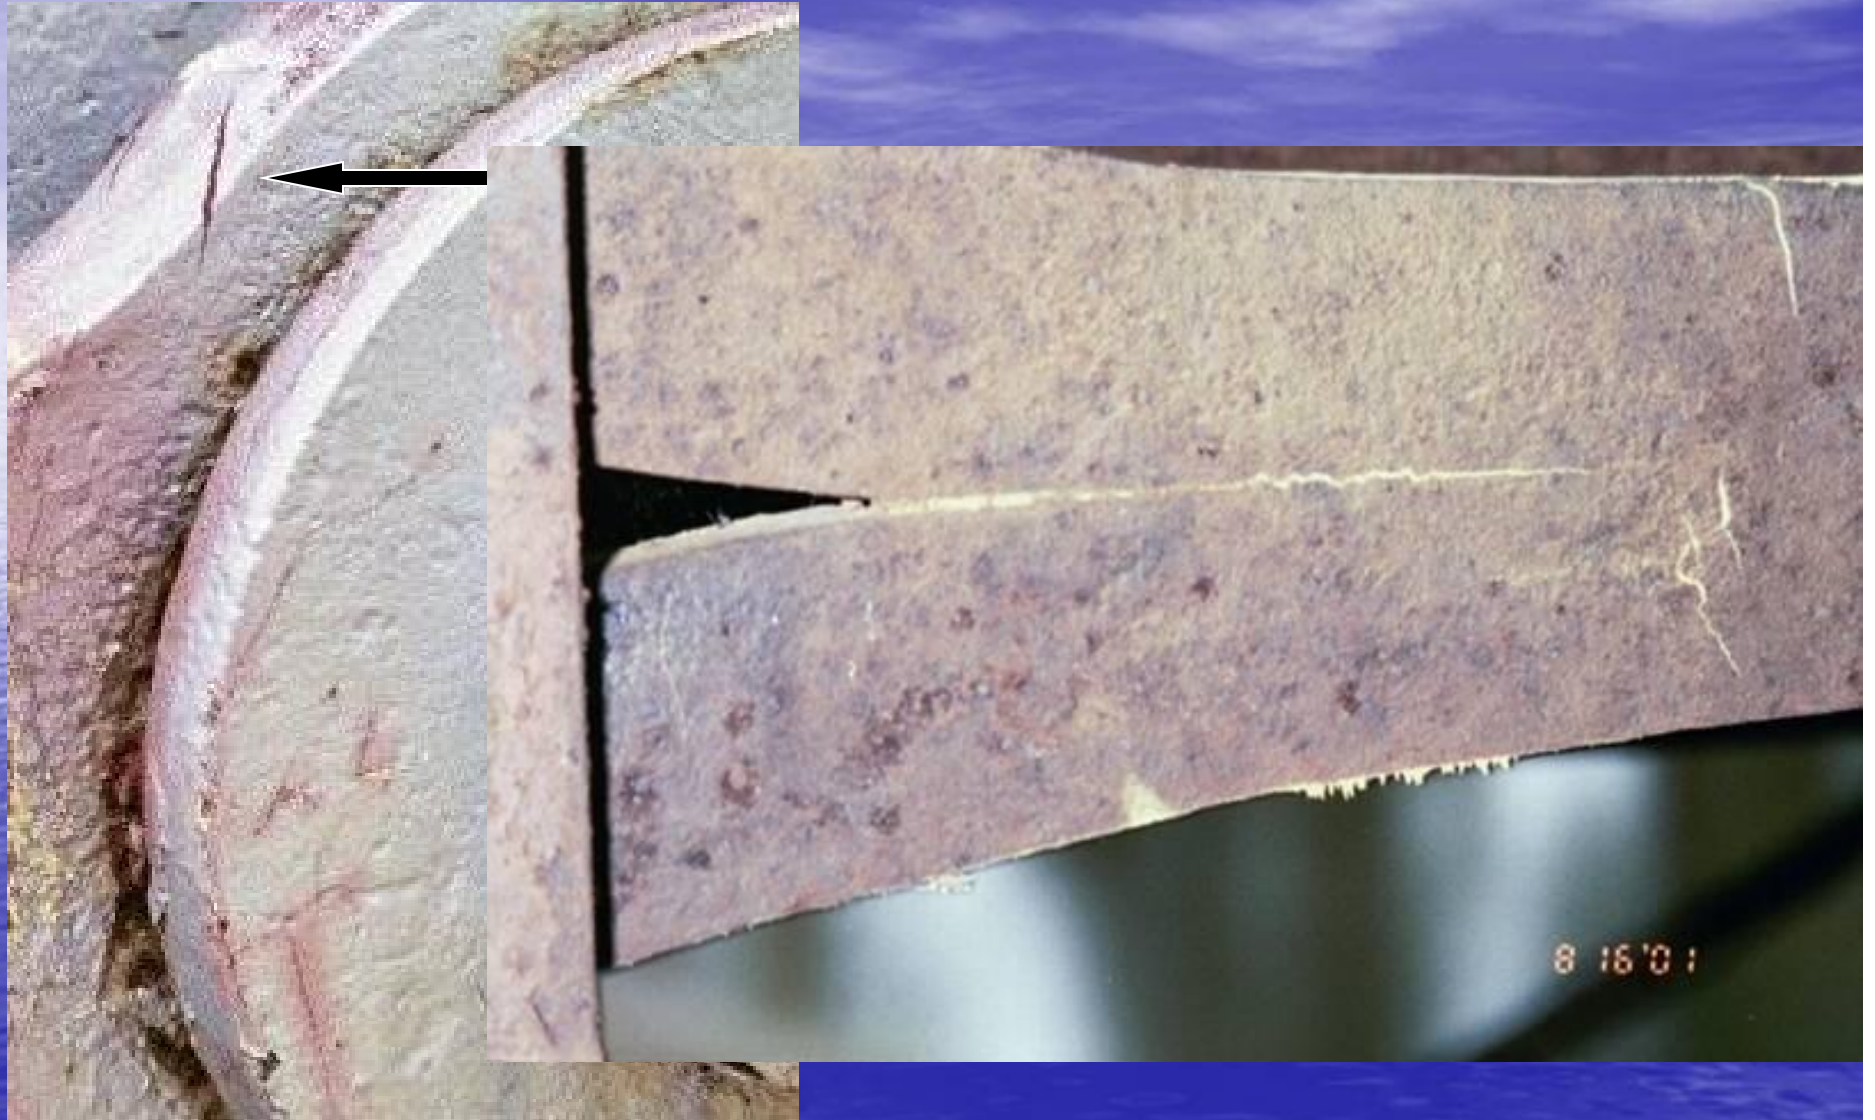
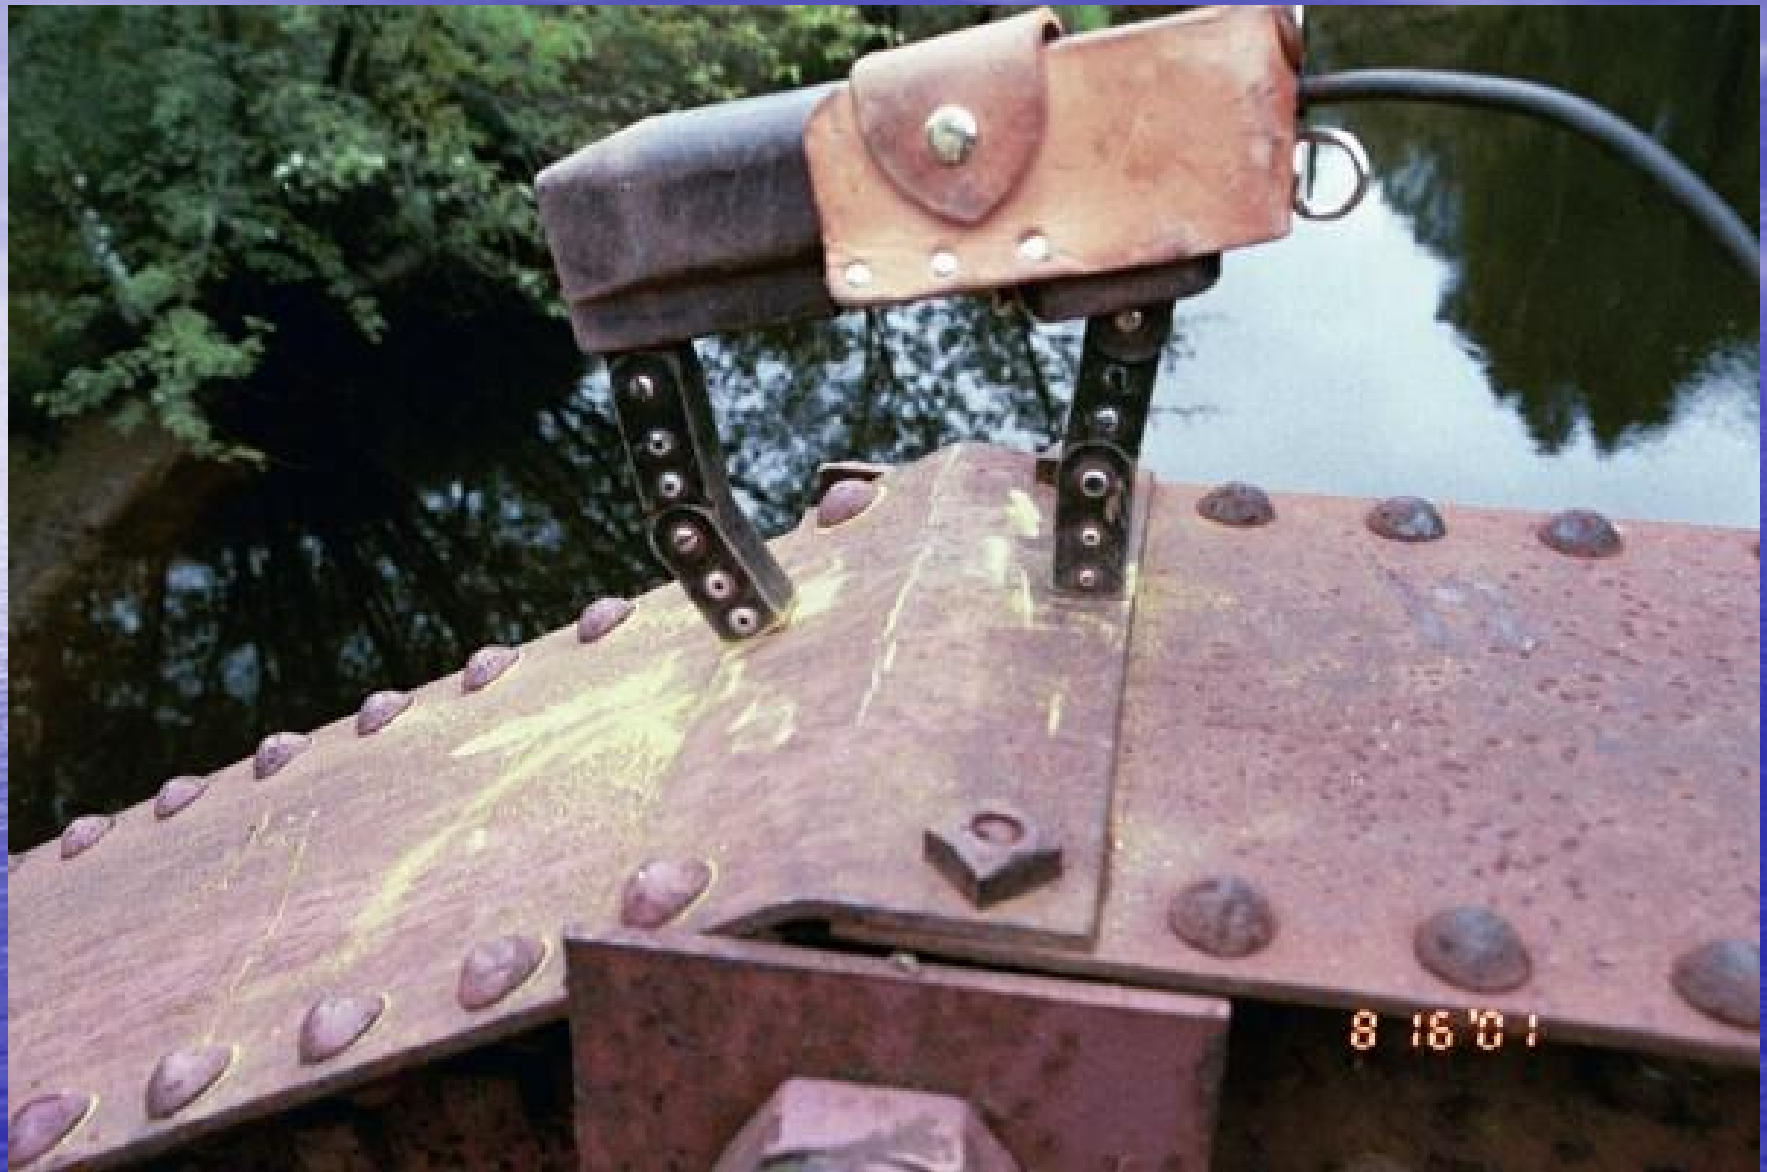
# Cracks

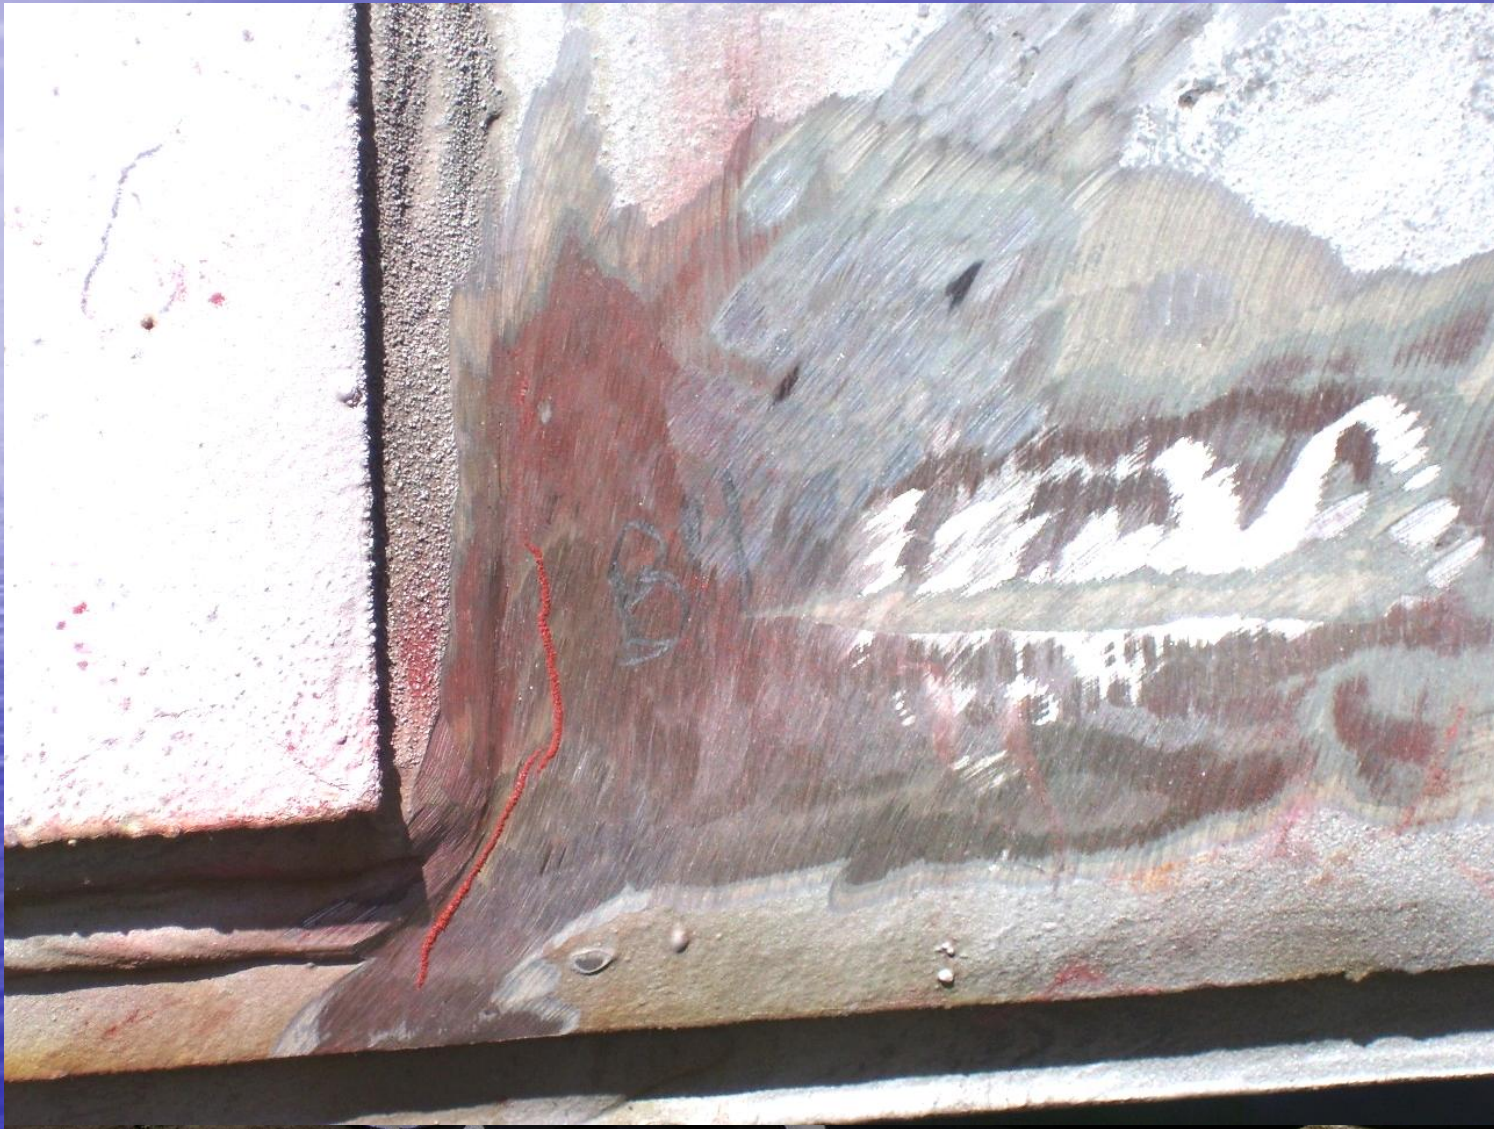
# Crack in Lower Chord Member

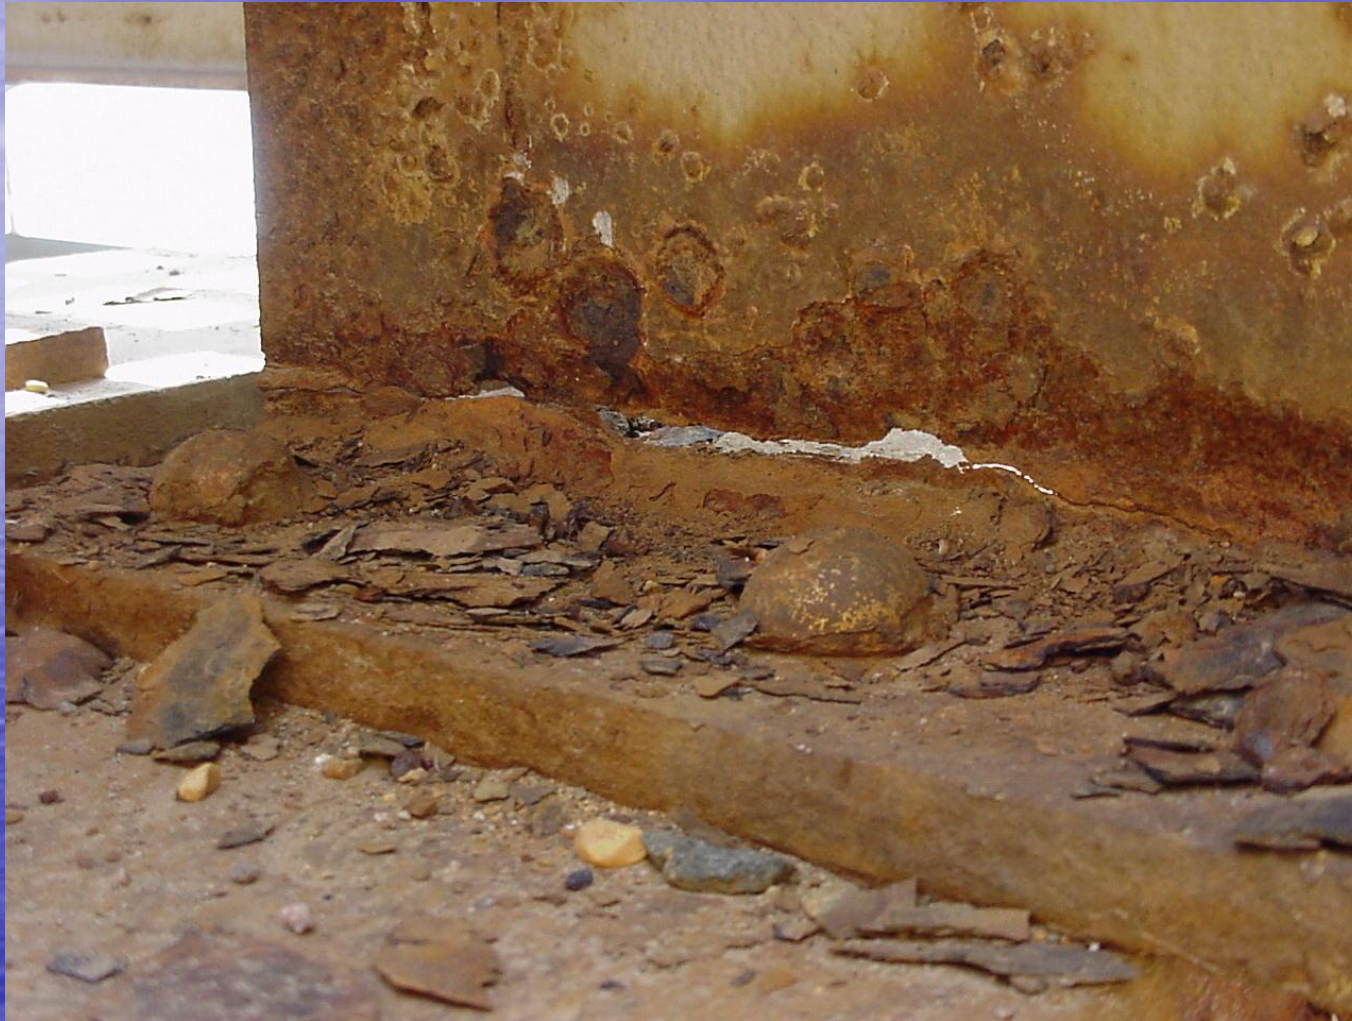
# Corrosion and Section Loss

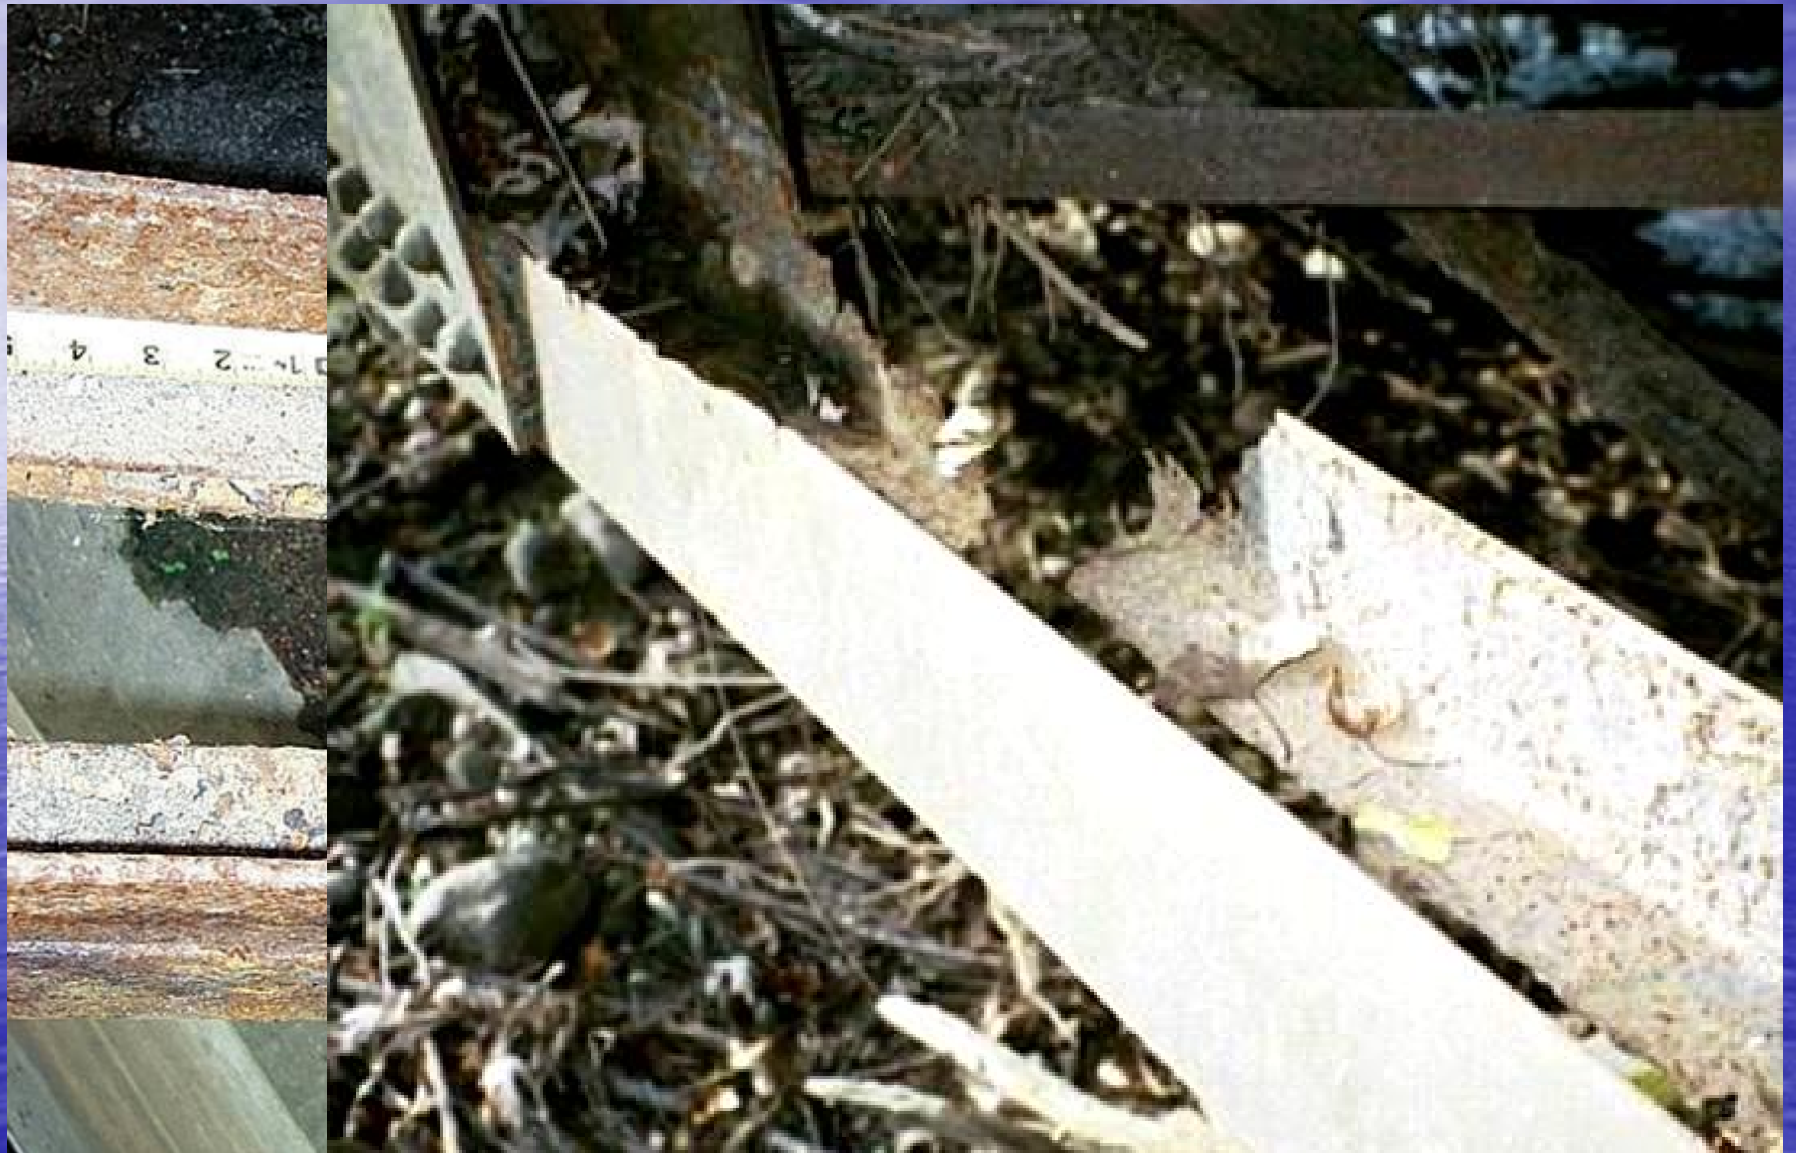
# Section Loss

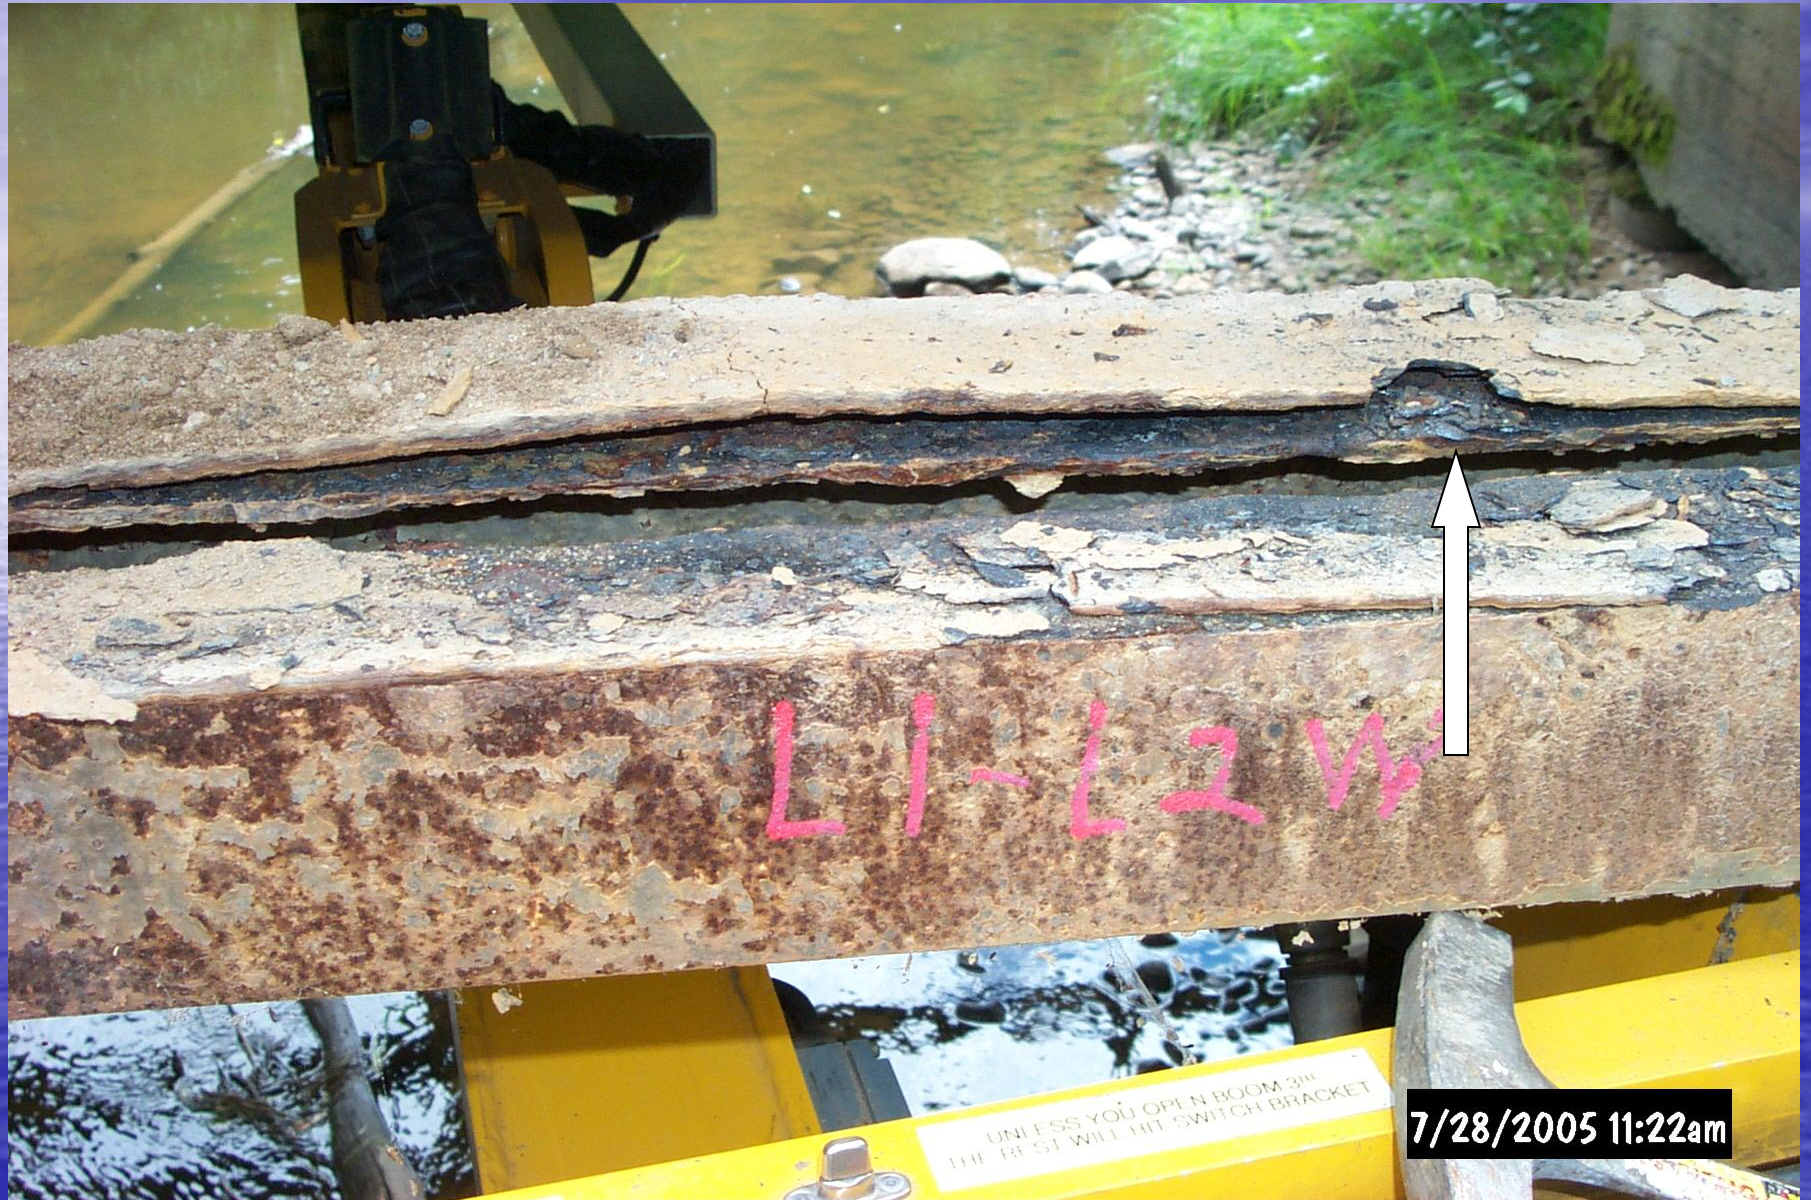
# Hammer Loosens Rust

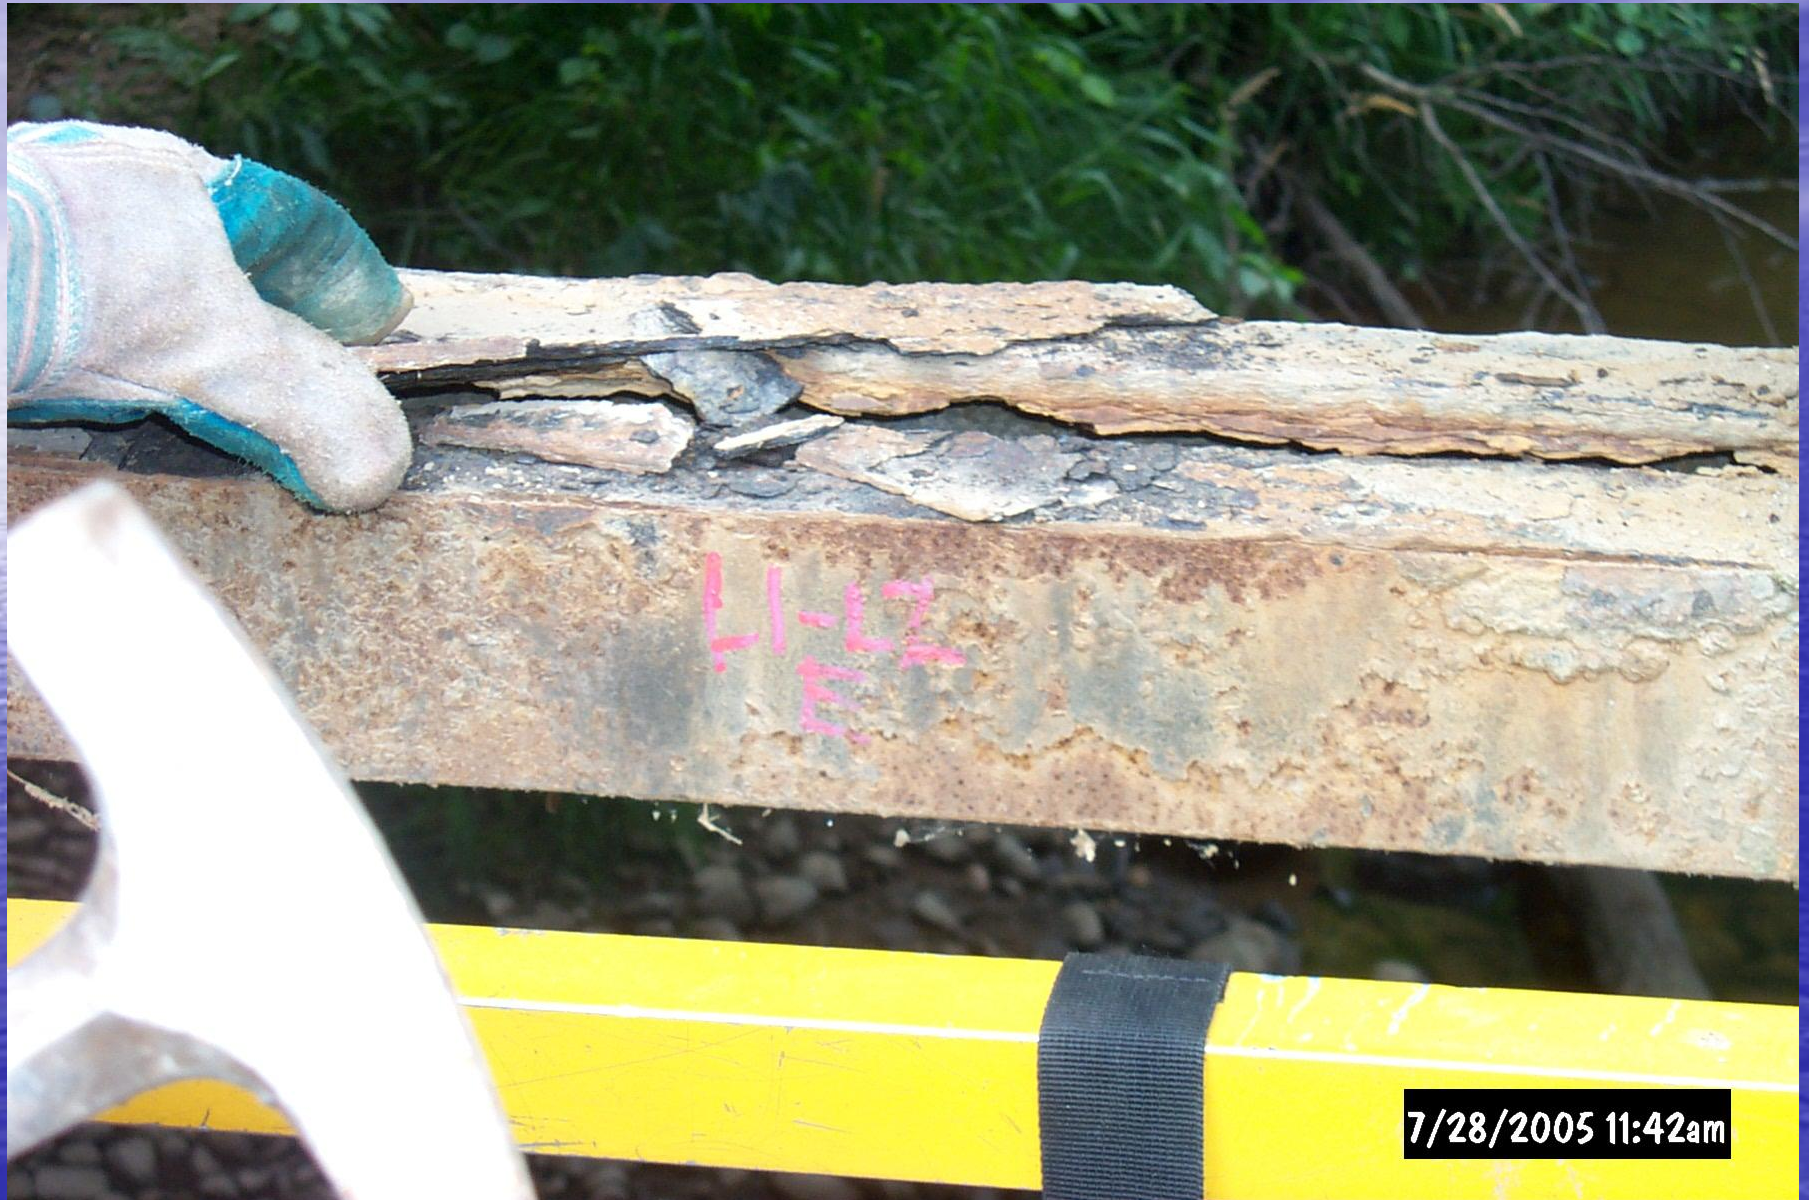
# Removing Loose Rust
