# Fracture Critical Bridge Inspection

**Presented by MN/DOT Bridge Safety Inspections**

MN/DOT's fracture critical bridge inspection team performs in-depth and special inspections for State, County and City owned bridges throughout Minnesota. All inspectors are certified for bridge inspection in accordance with Federal Highway Administration regulations. In addition, there are 3 inspectors nationally certified in nondestructive testing.

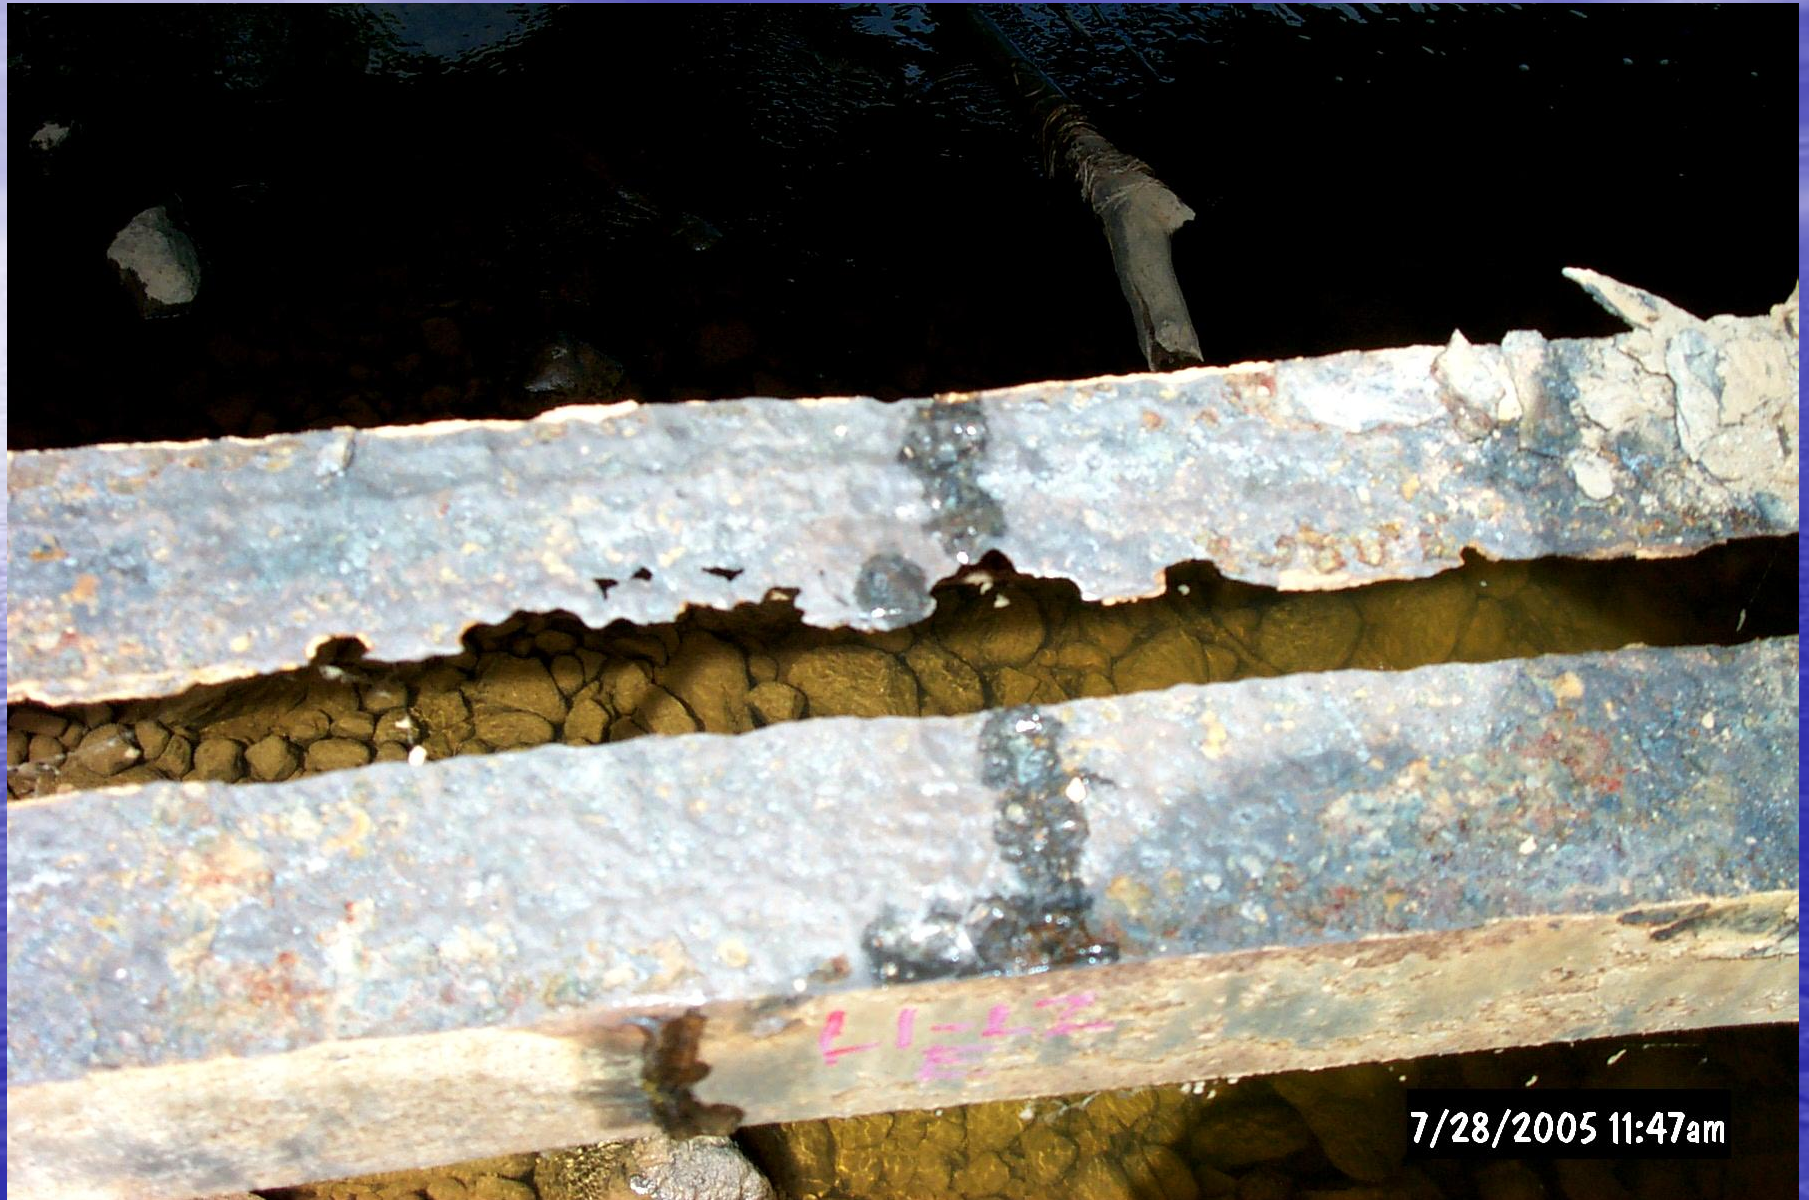
# Final Result: 30% Loss of Section

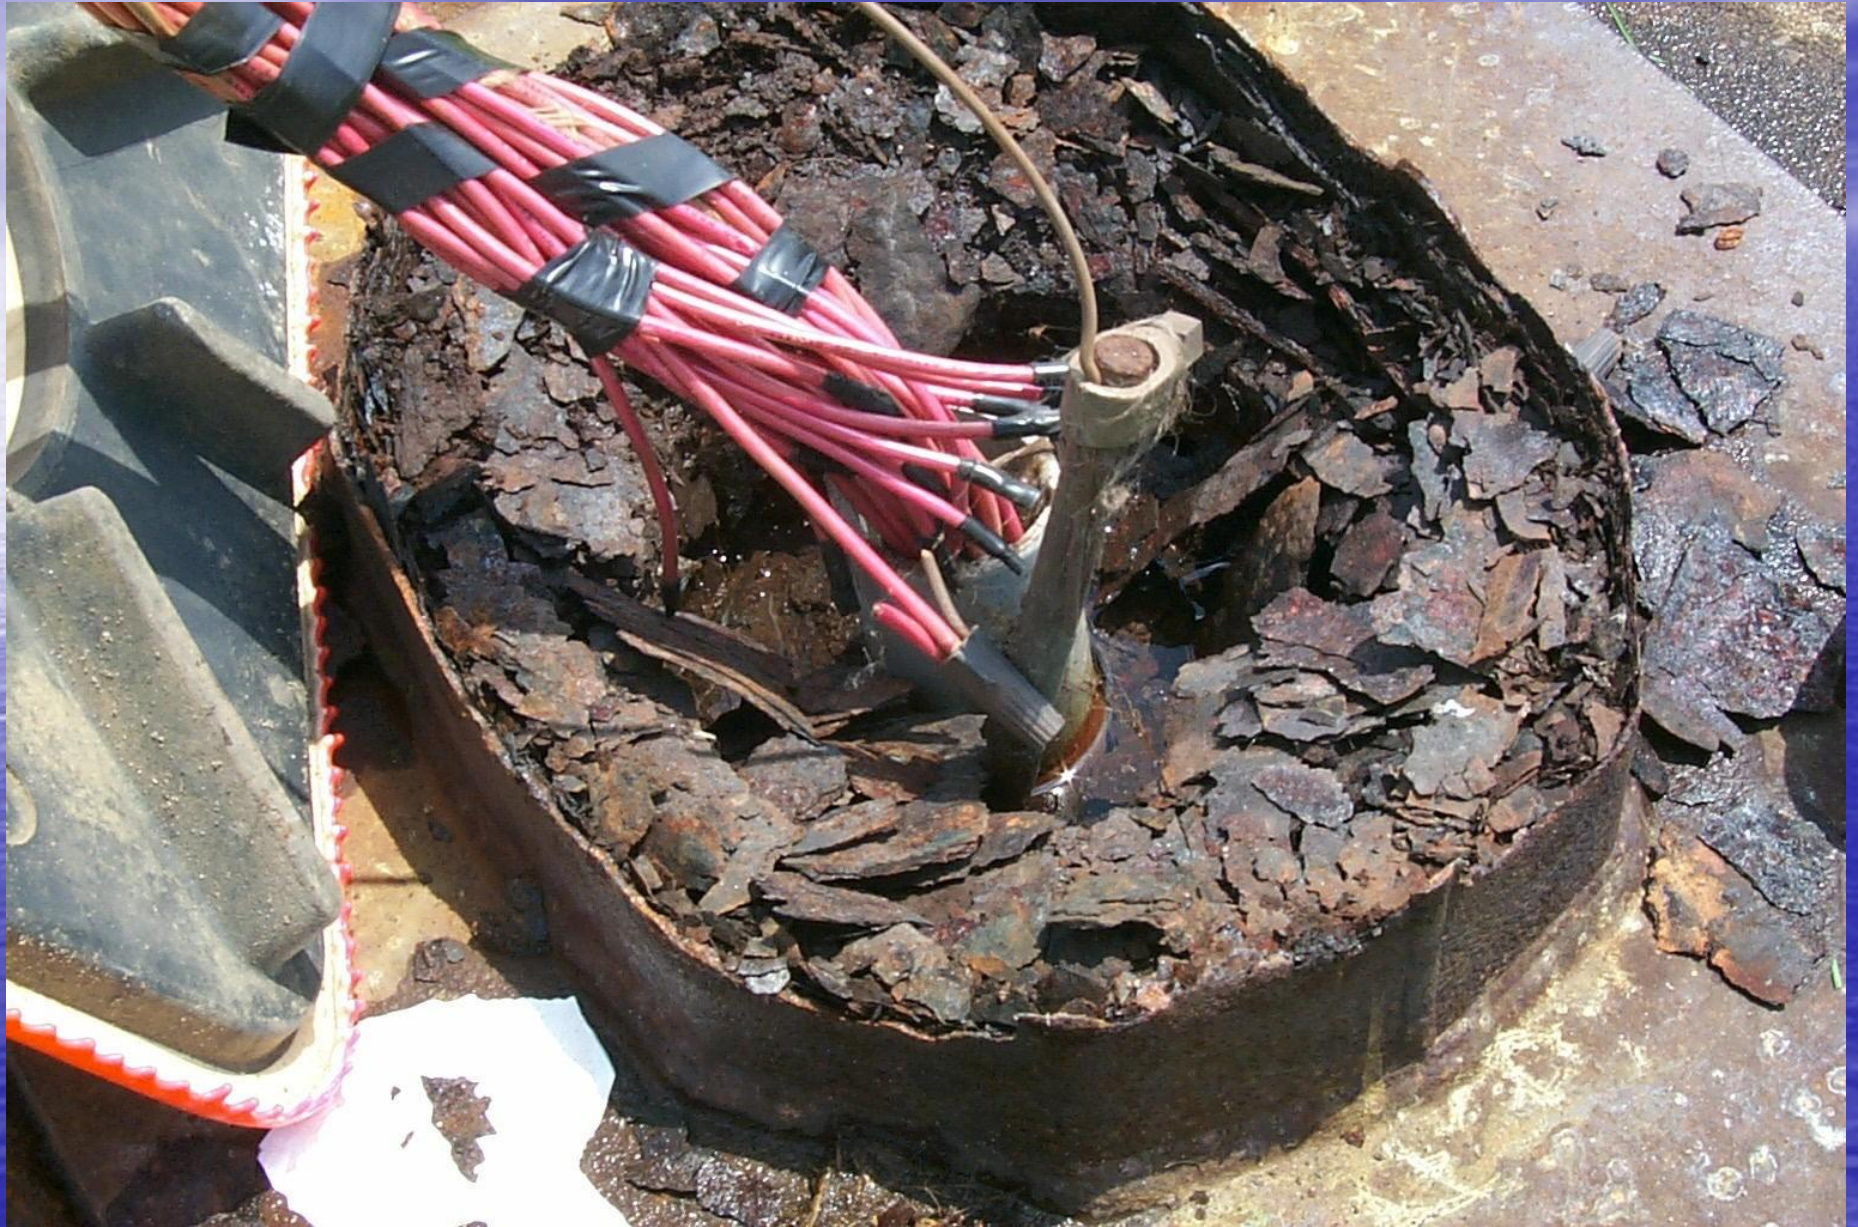
# Corrosion on Interior of Pole Causes Failure

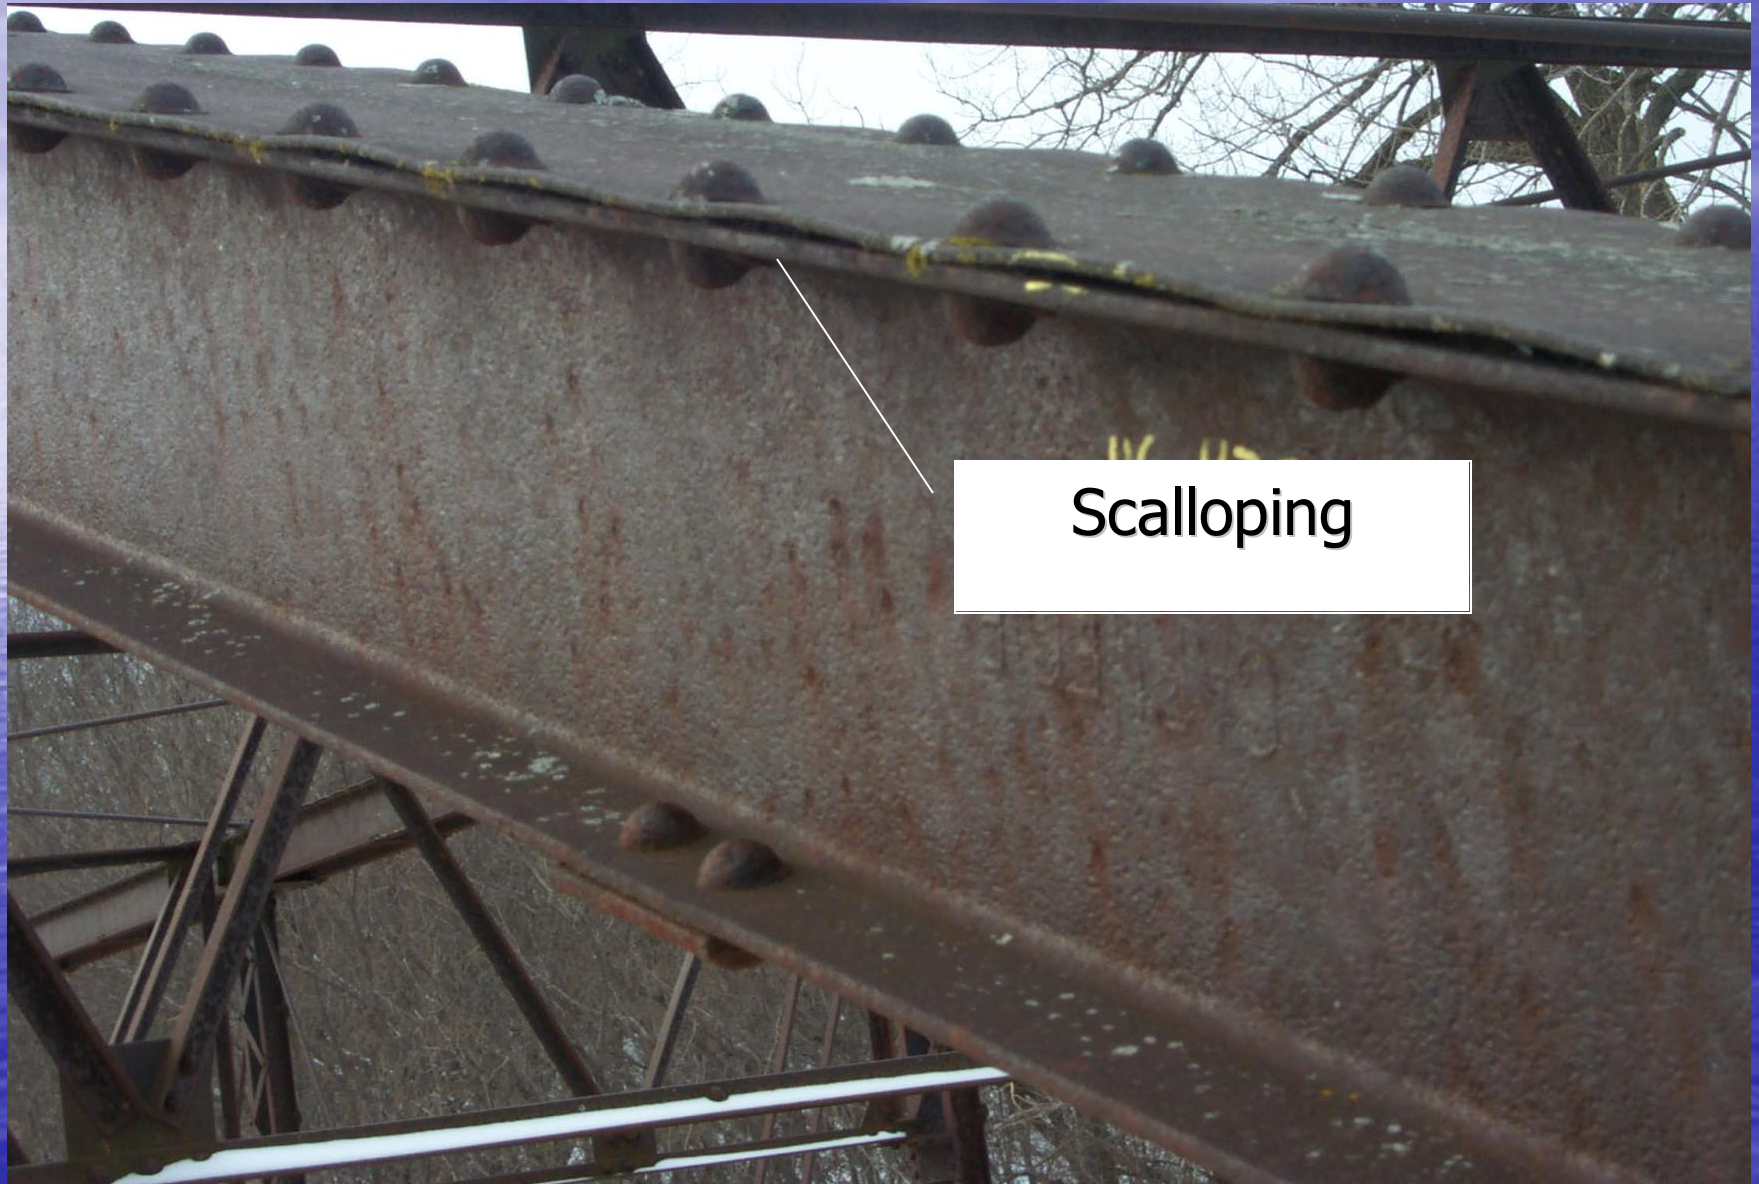
# Pack Rust

Scalloping

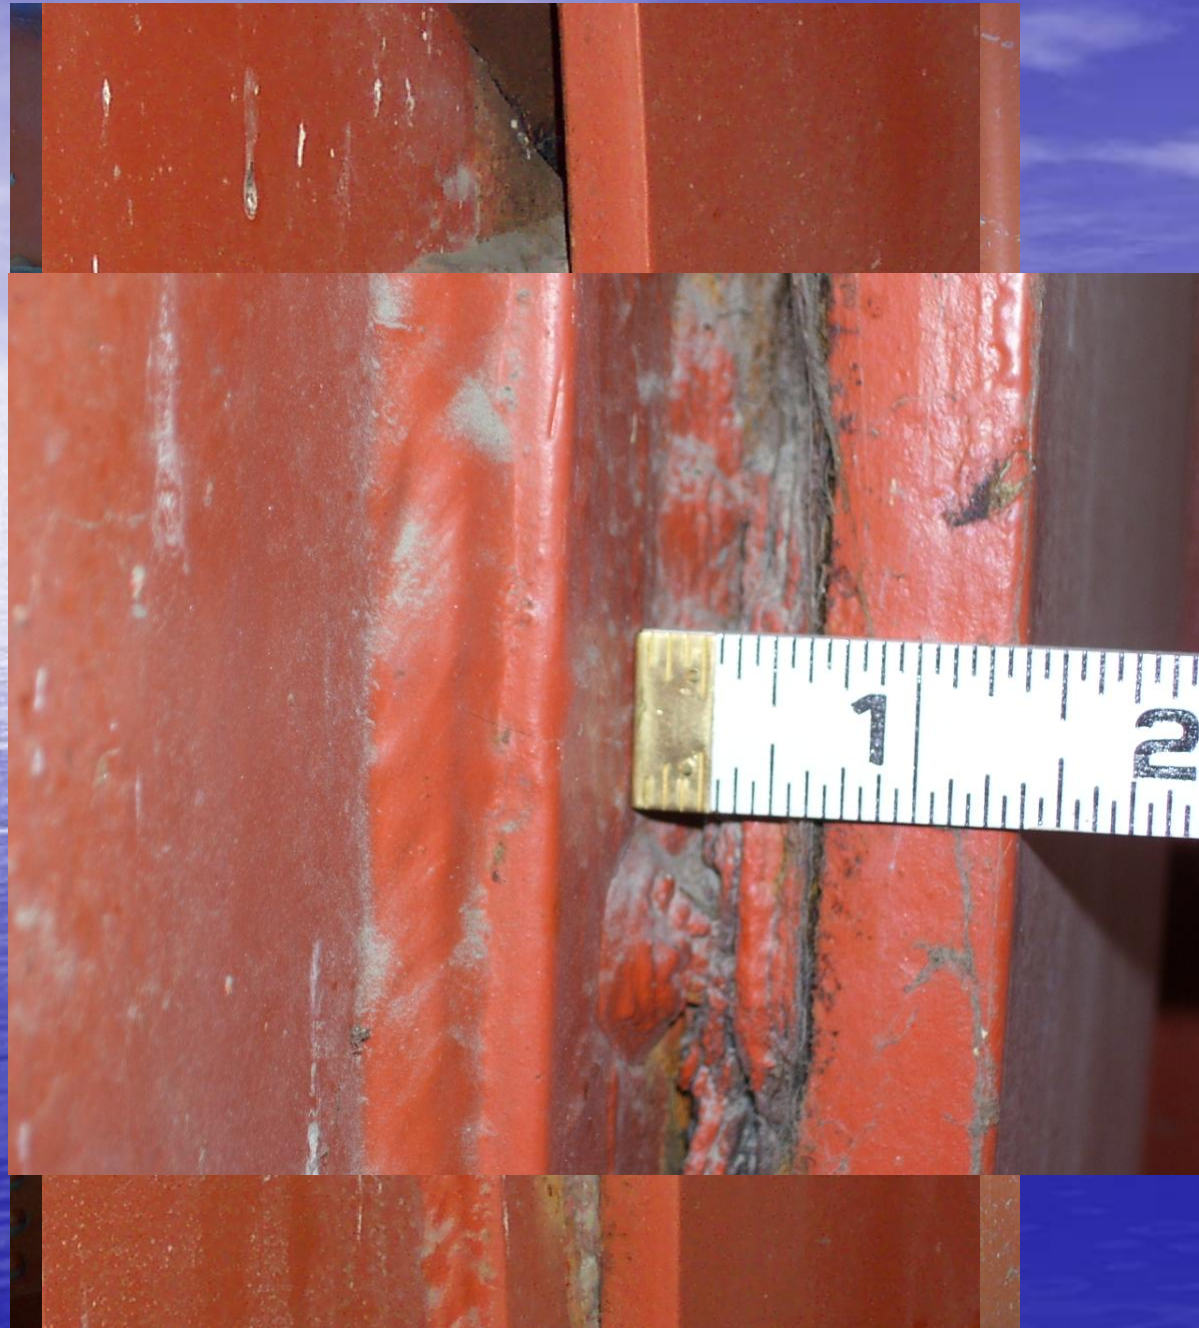
Pack rust  
causing  
distortion  
of hanger  
plate

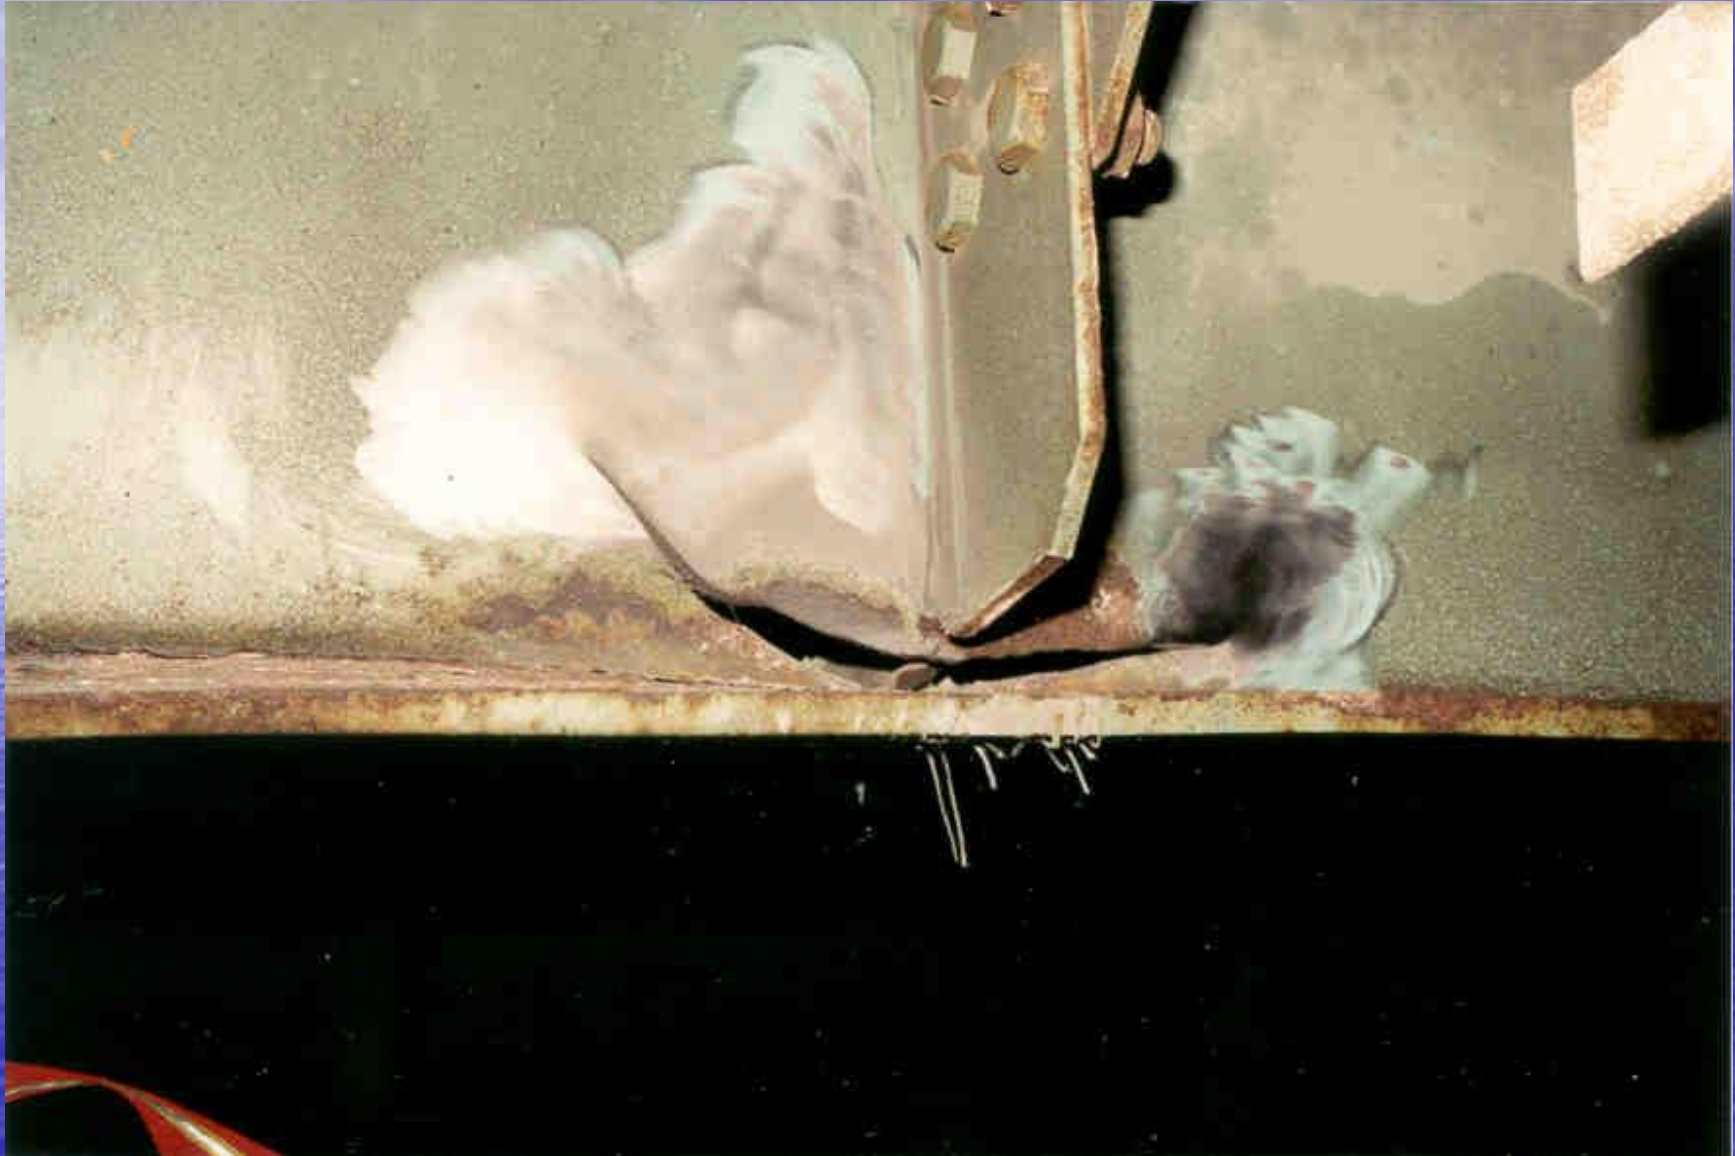
# Typical Damage from Bridge Hit

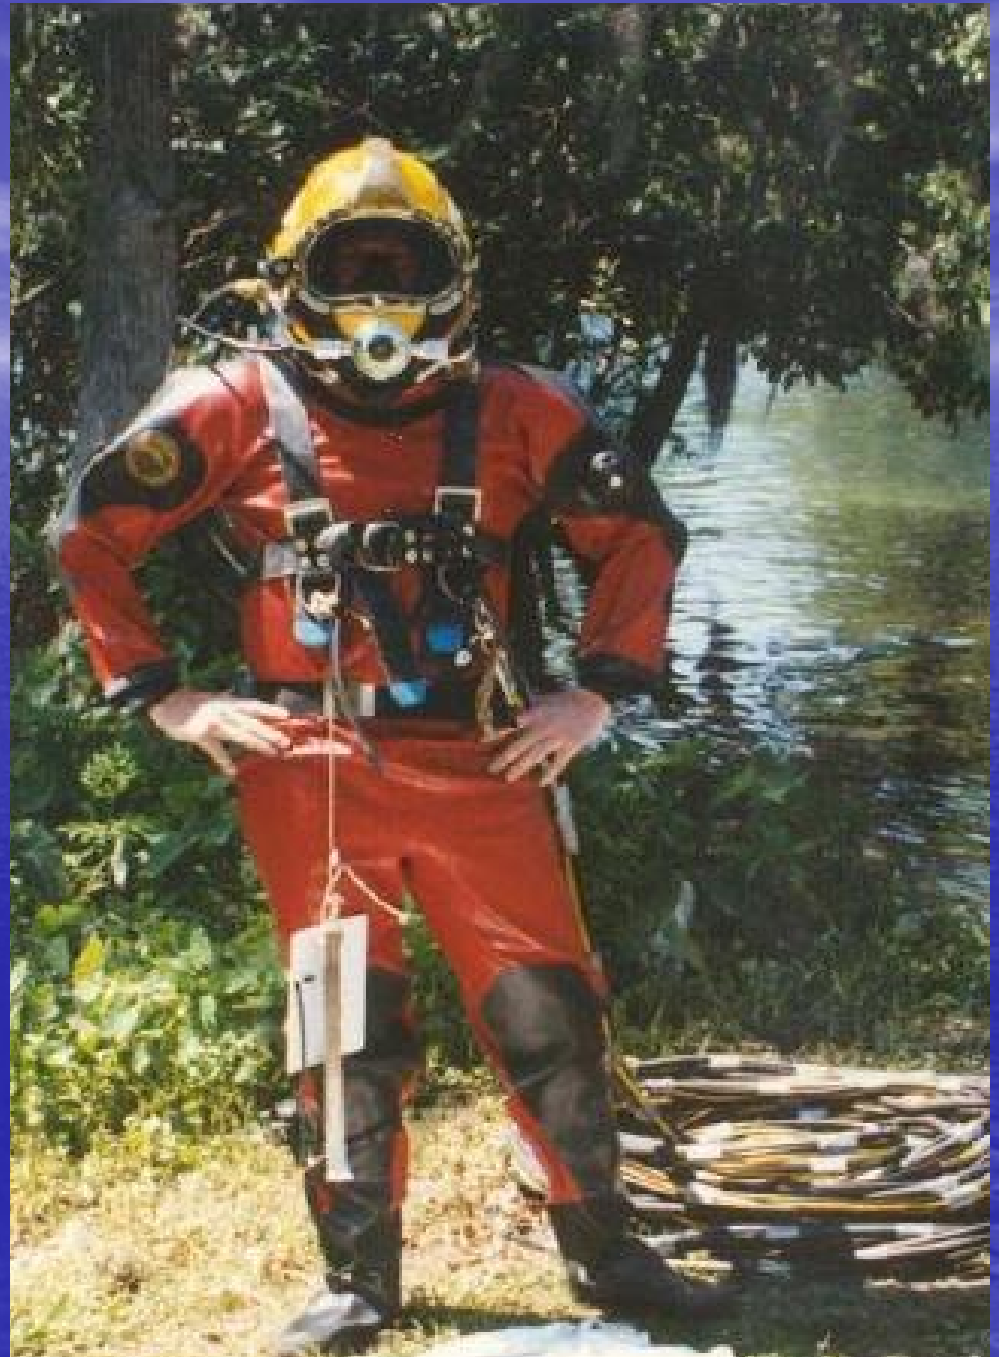
Shallow streams can be probed by wading,  
deeper water requires professional divers

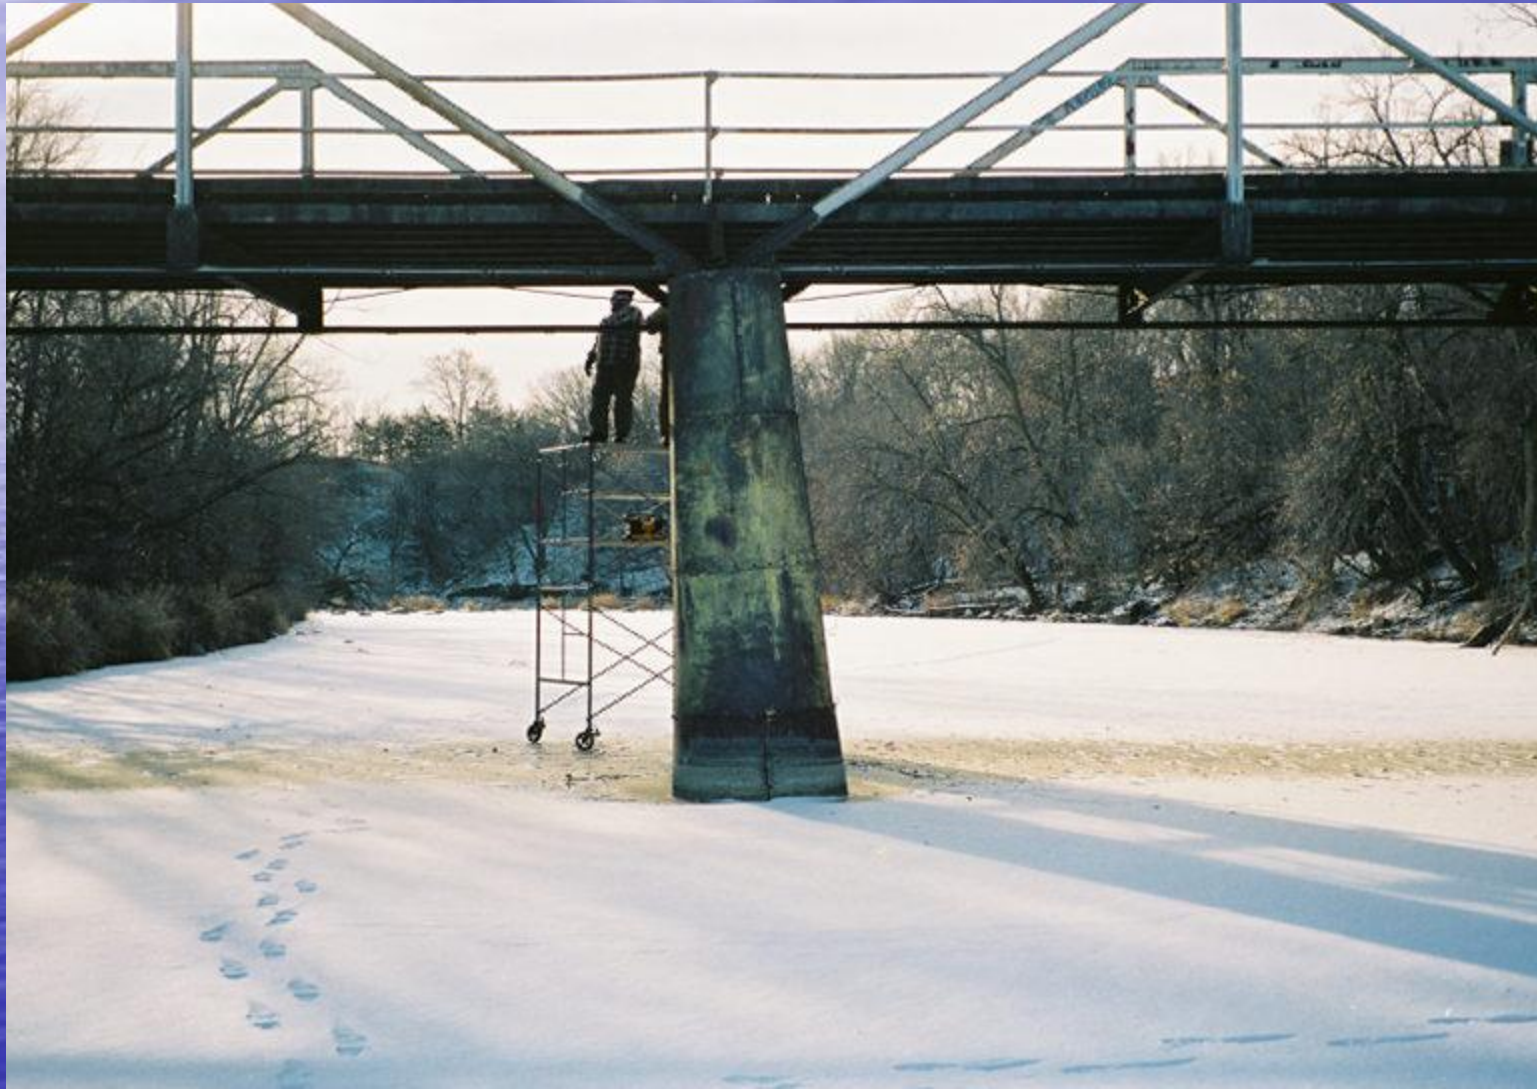
# Scour can cause piers to tip

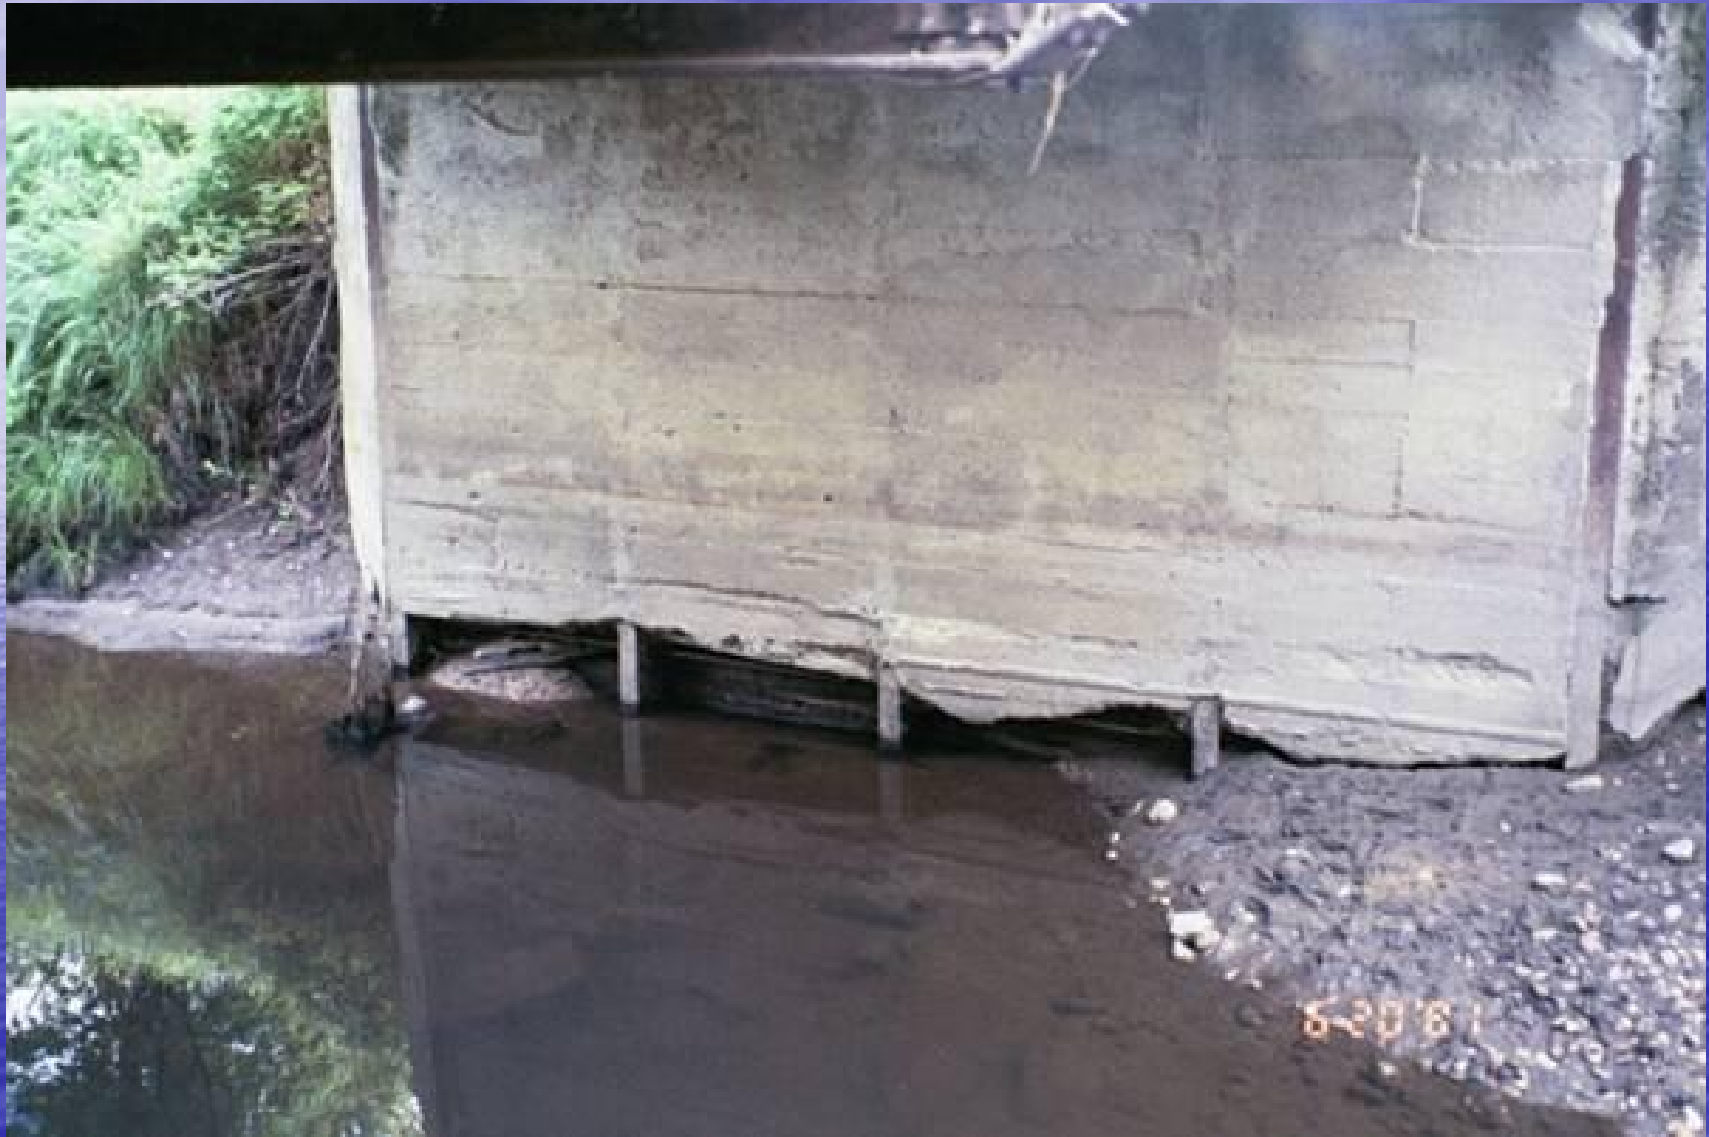
# Typical Undermining

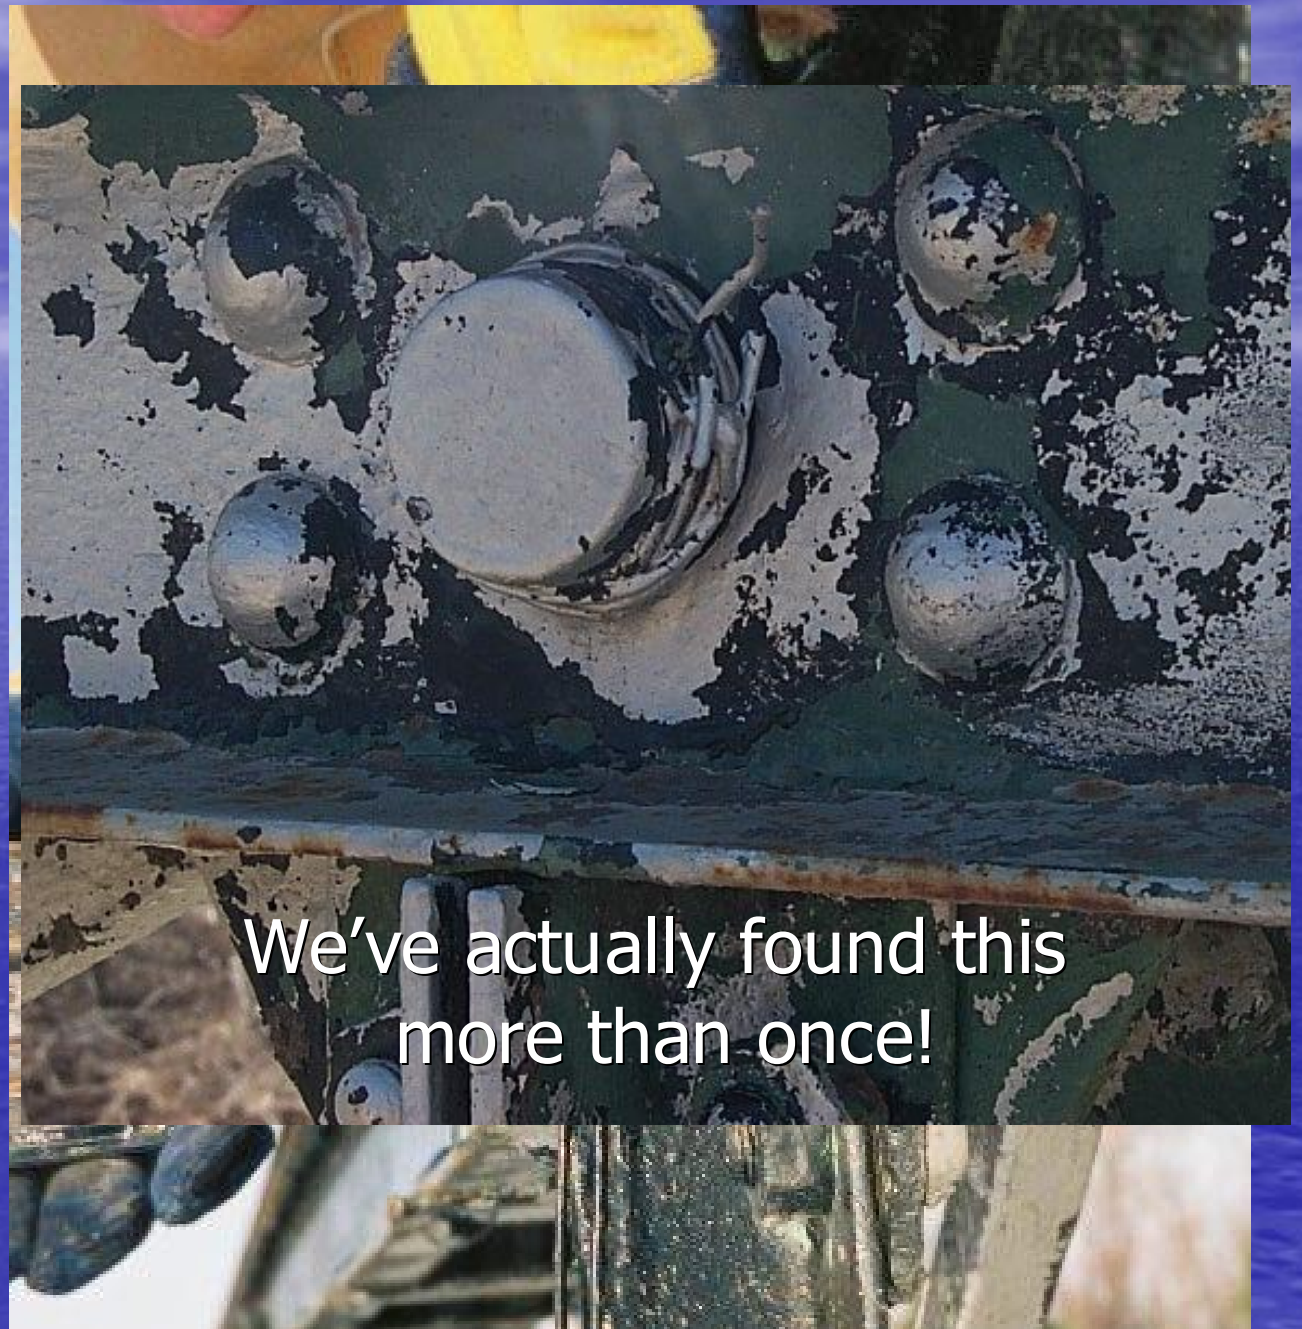
Note wire  
used in  
place of  
missing  
nut

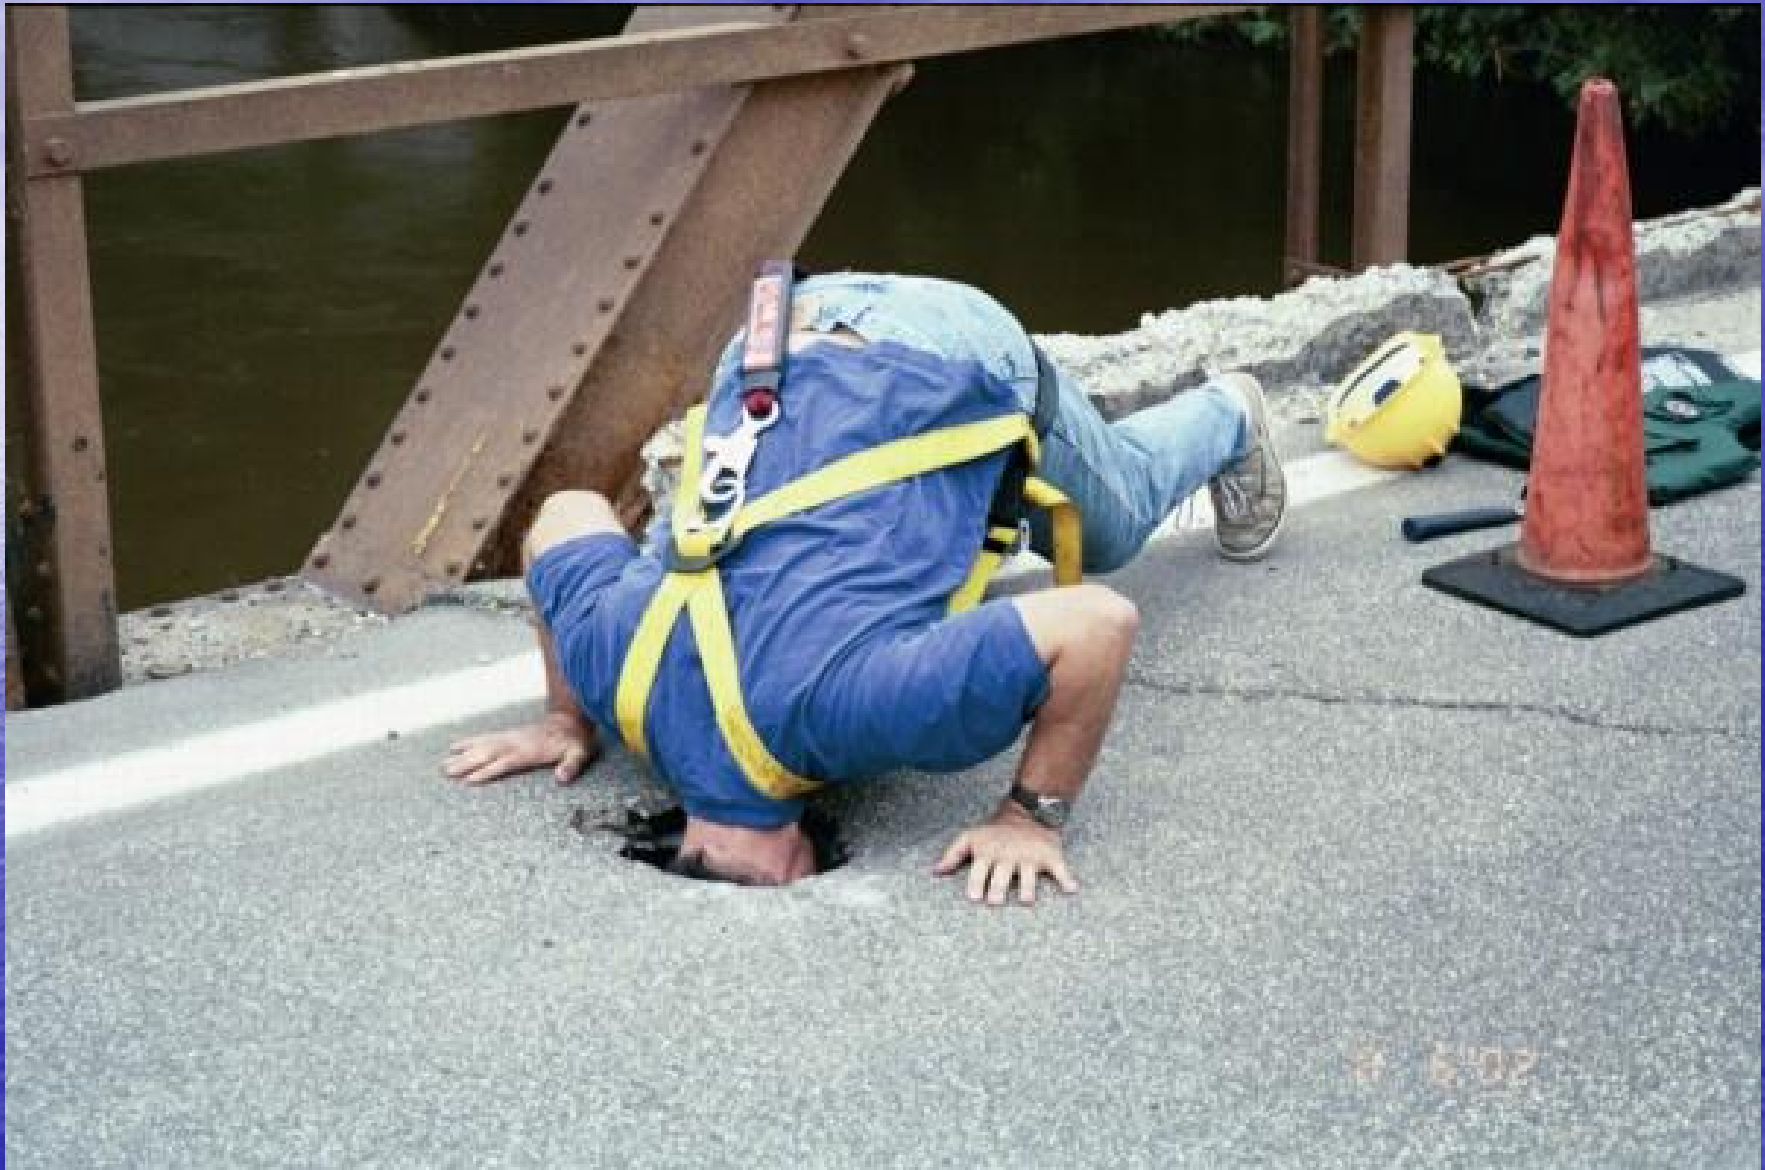
MT on Bottom Flange  
UT on Top Flange  
(SCC Creeping Wave  
Methods)

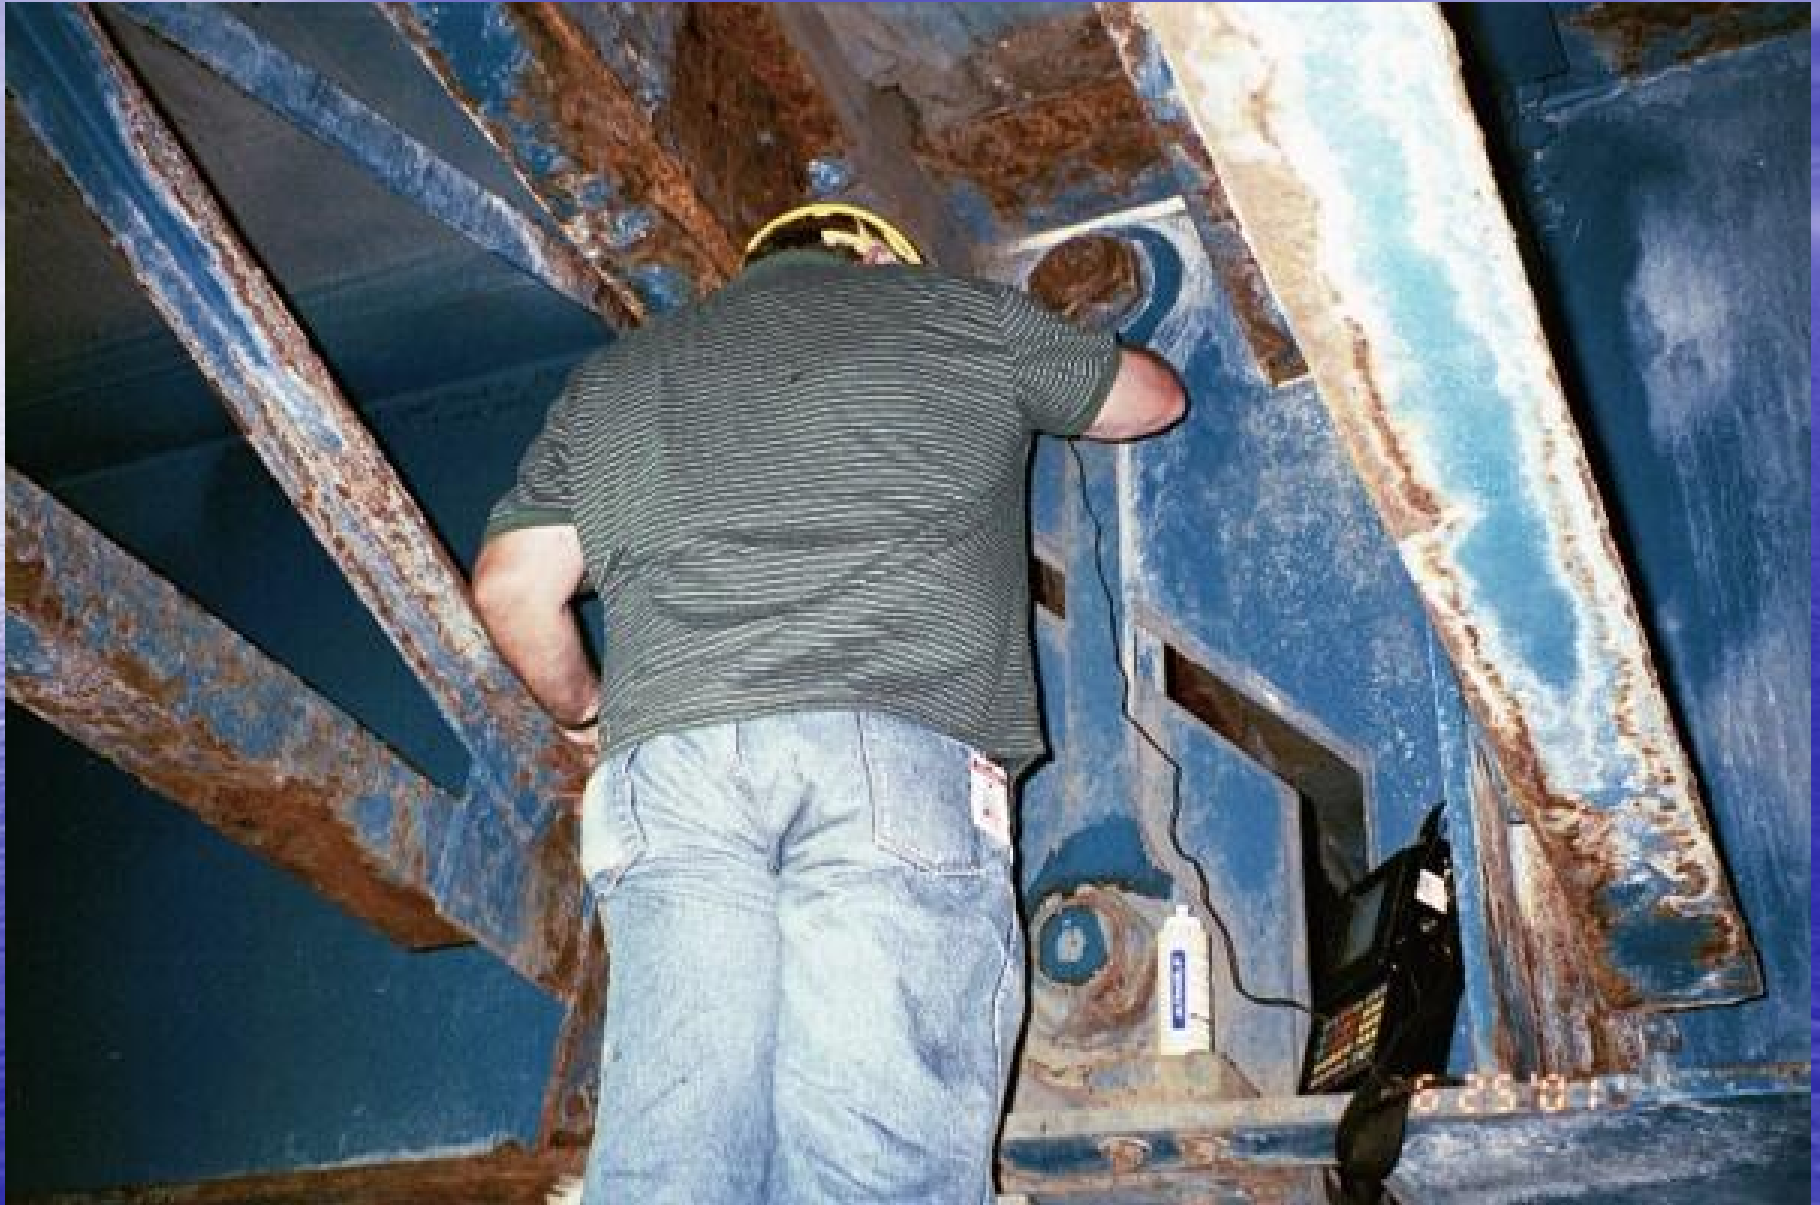
# Pins and Hangers
