# Fracture Critical Bridge Inspection

**Presented by MN/DOT Bridge Safety Inspections**

MN/DOT's fracture critical bridge inspection team performs in-depth and special inspections for State, County and City owned bridges throughout Minnesota. All inspectors are certified for bridge inspection in accordance with Federal Highway Administration regulations. In addition, there are 3 inspectors nationally certified in nondestructive testing.

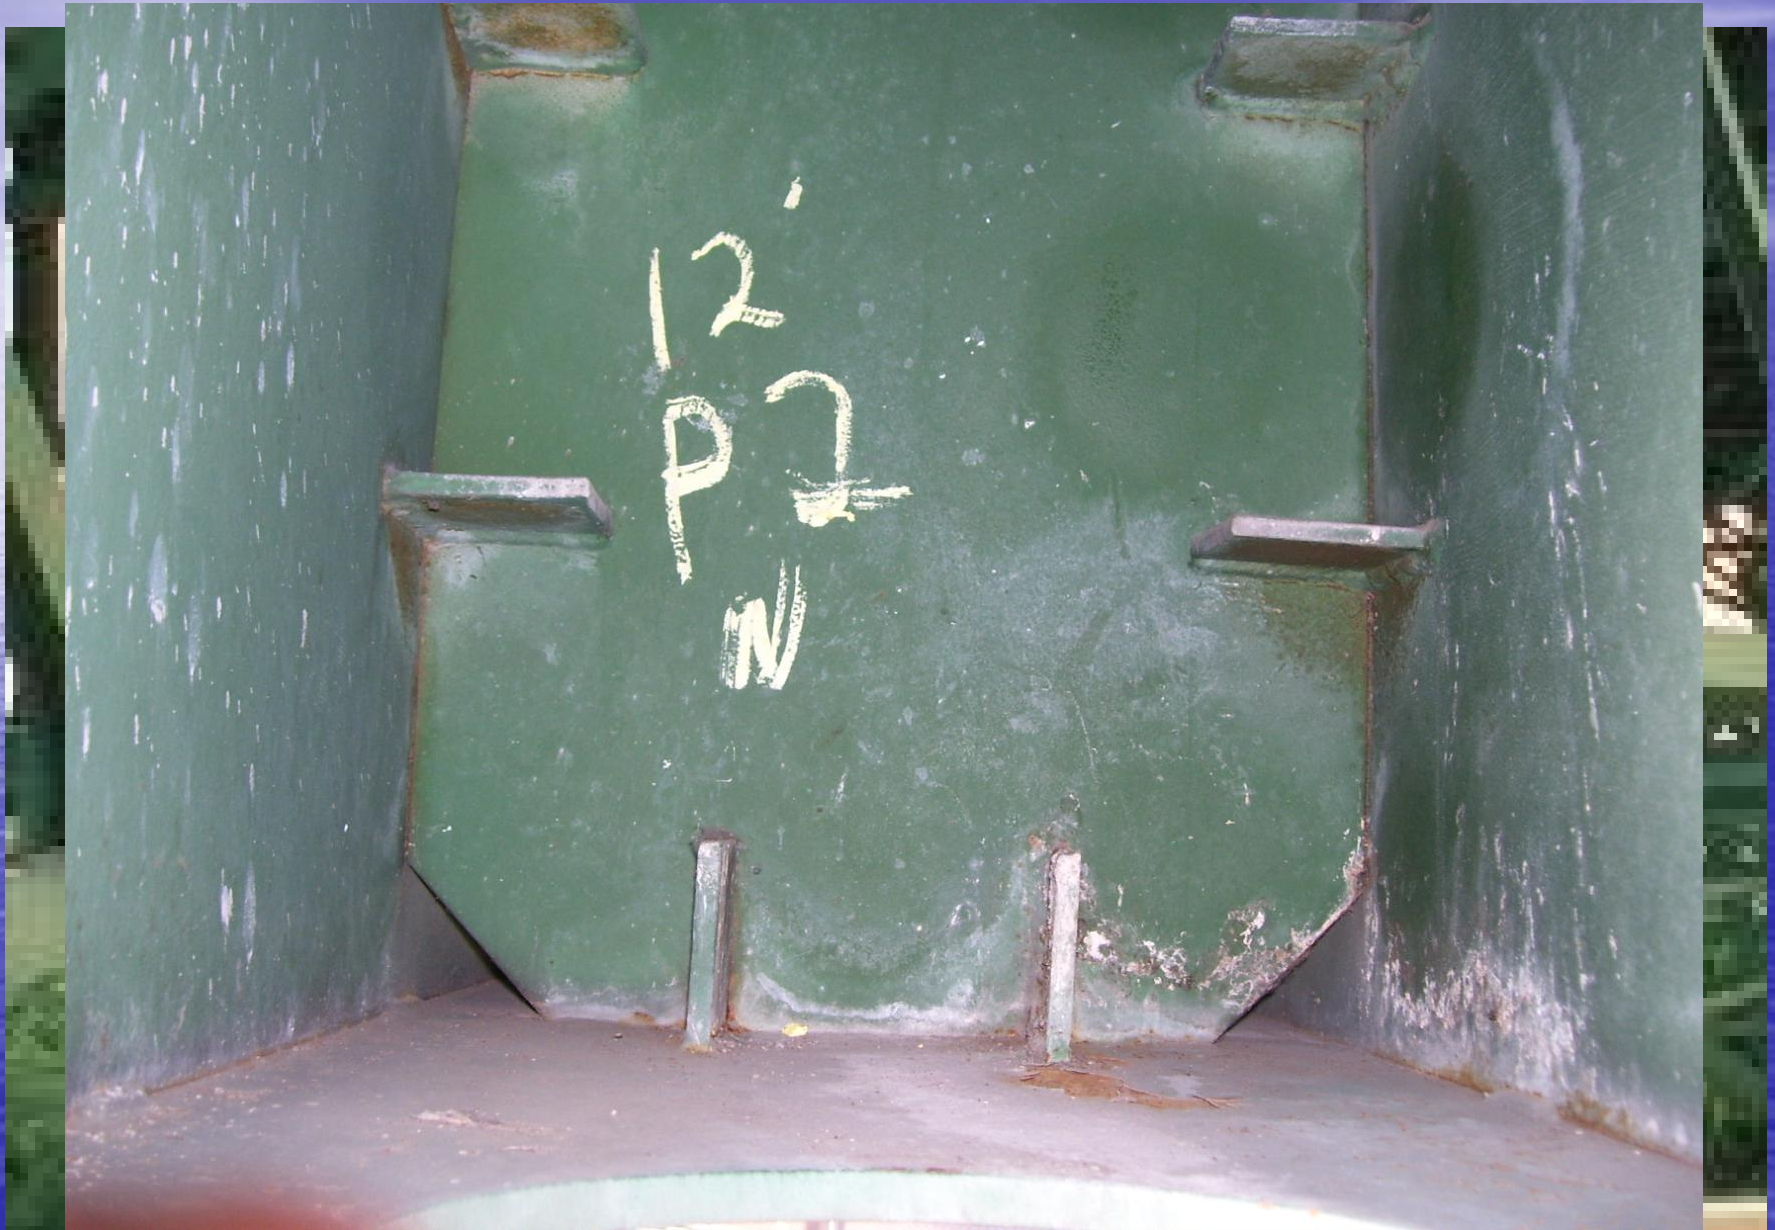
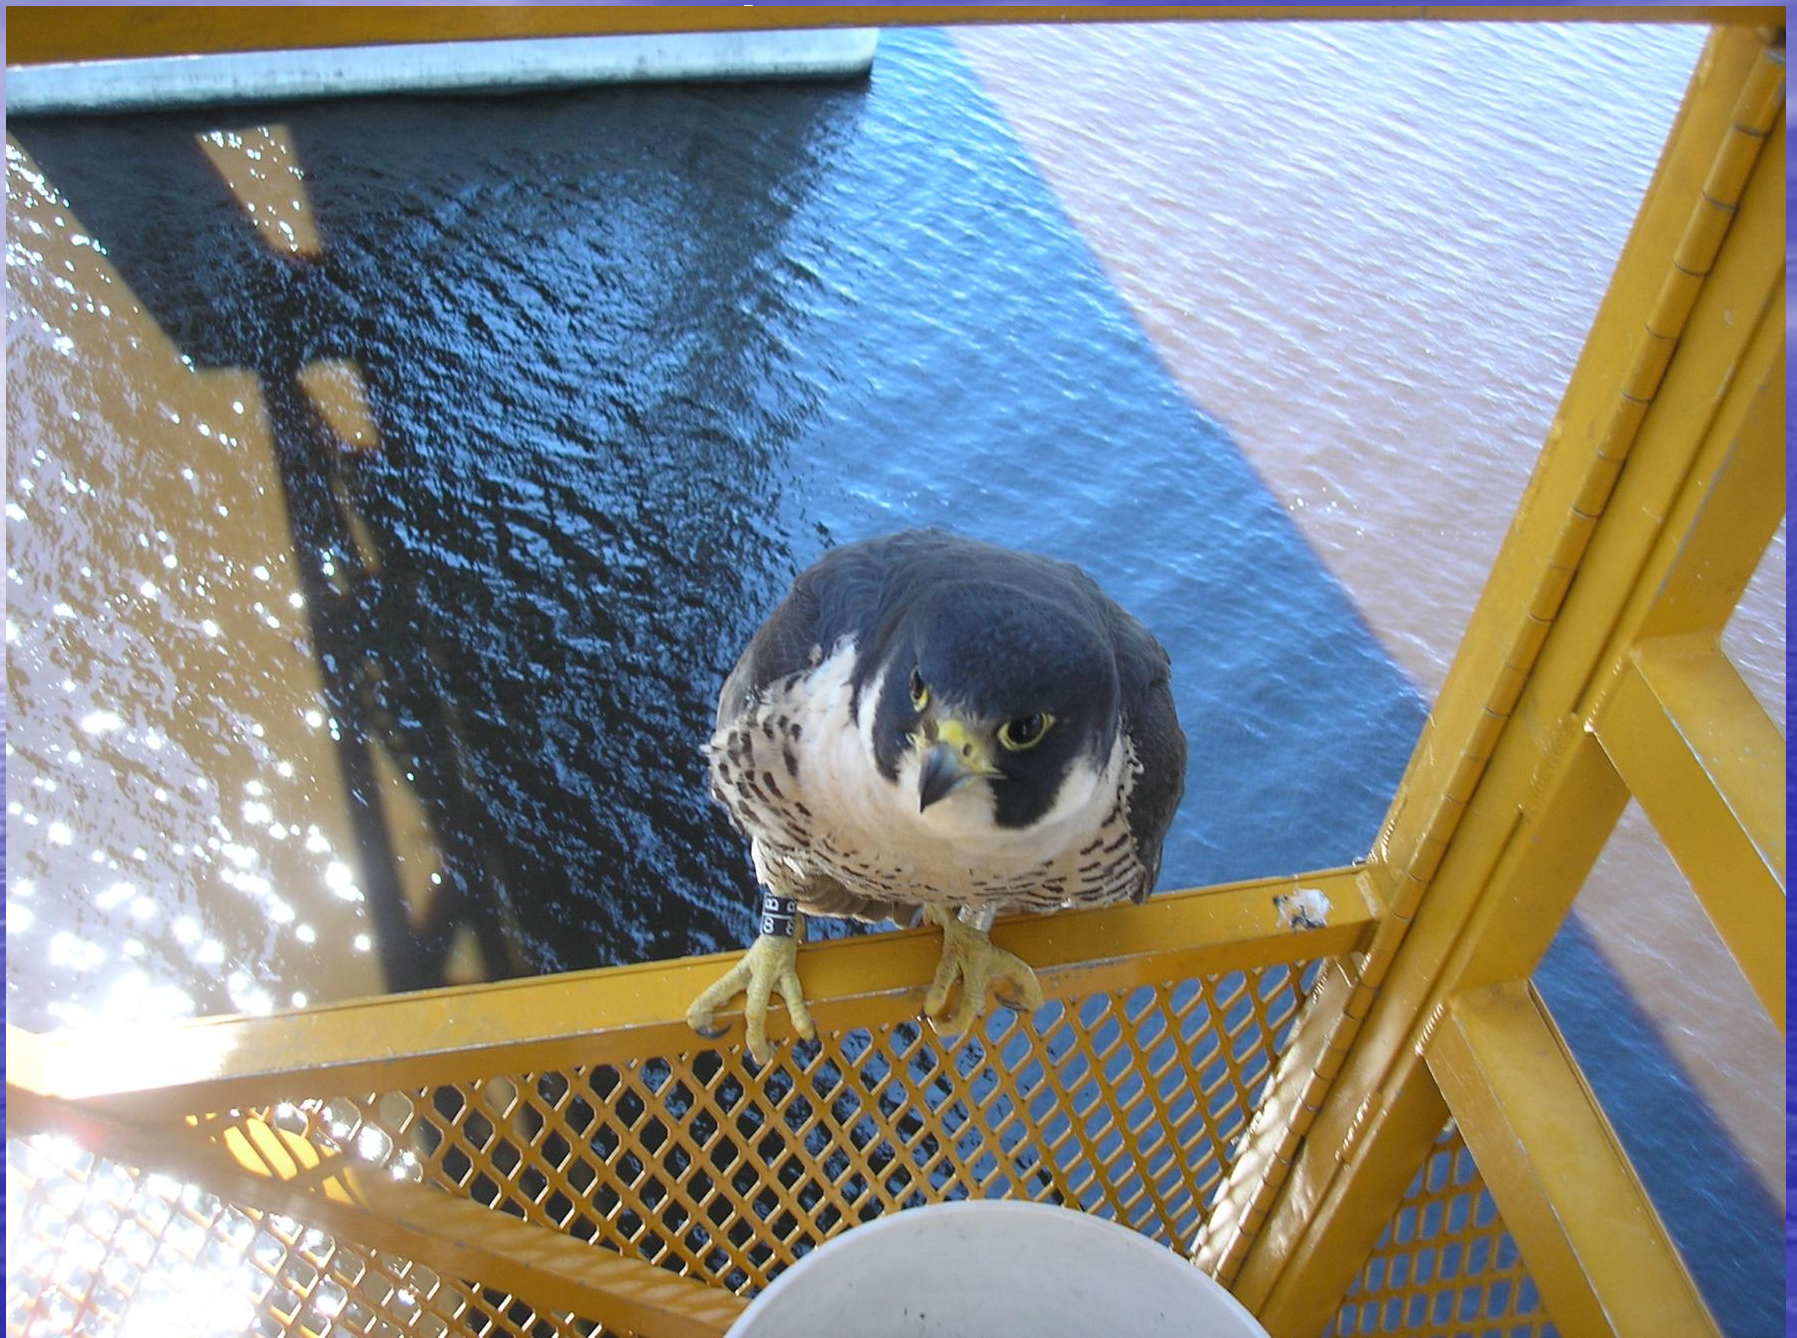
# Fatigue Prone Details
