Re: 2015 Bridge Inspections

**2015  
BRIDGE INSPECTION  
AND  
MAINTENANCE REPORT**

CITY OF WAVERLY, IOWA

# CITY OF WAVERLY 2013 ROADWAY BRIDGE INSPECTION

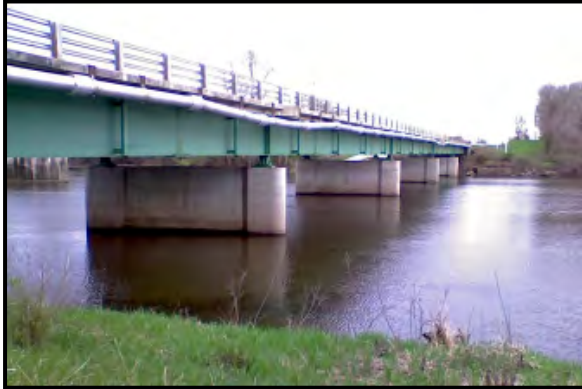
## 1<sup>st</sup> Street NW (Adams Pkwy) - FHWA No. 12240

**Deck and Joints:** There are some areas in the top of deck with small spalls and transverse cracks. The spalling is more pronounced adjacent to the joints at each abutment. Approximately 2% of the top of deck was delaminated; however the rate of increase is minimal, when compared to previous inspections. Most of the delamination occurs adjacent to the abutment expansion joints and above the piers where there is high negative flexure. We consider the deck to be in fair condition with some minor cracking and spalling.

**Curb and Sidewalk:** The curb along the full length of the bridge has some spalling and deterioration, however is quite minor.

**Abutments and Berms:** The bearings at each abutment are rusty. The base plates under the bearings at the south abutment have some pack rust with minor section loss (*See Figure 2 in Appendix A*). The base plates and bearings at the north abutment are also rusty but not as bad as the south abutment. There are a few hairline vertical cracks in abutments.

**Piers:** All piers have minor vertical cracks, particularly at the top and center of each pier, with up to 1/16" separation at the top, narrowing to just hairline at the waterline. Form tie holes in the piers either were not filled in or the grout has fallen out.

**Superstructure:** Due to the development of previous fatigue cracks, dual sets of holes have been drilled in the top of the girder webs near the transverse stiffeners directly over the piers and at each inflection point. The original fatigue cracks are still apparent between the dual holes, but no further cracking is apparent. The exterior side of the east girder has some surface rust spots in spans 1 and 2, possibly caused by rocks thrown at the bridge. Two top bolts in 2<sup>nd</sup> floor beam north of pier 3 at the inside of the West girder are missing, but likely not placed at construction.

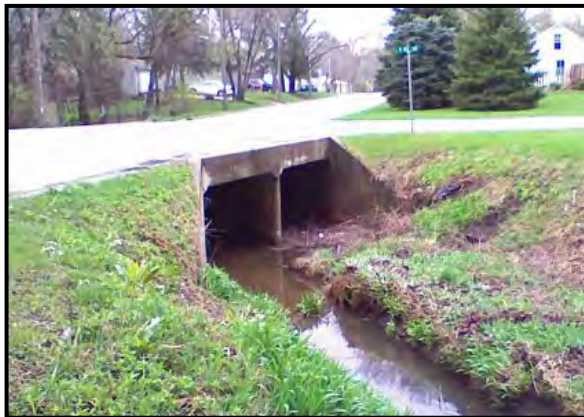
**2<sup>nd</sup> Street SW - FHWA No. 502300**

There are hairline cracks in walls. The SE headwall has cracks with leaching and spalling on the roadway face that extend all the way through the headwall. The asphalt roadway near the NW headwall is broken up and has some depressions. There is a 3/8" wide crack at the south end of the NW headwall. There are cracks with leaching at the construction joints. There is minor settlement of the approaches adjacent to the culvert. Both barrels have minor silt in them.

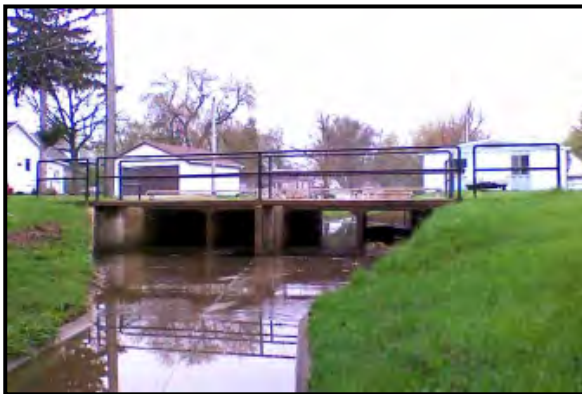
**5<sup>th</sup> Ave. NW – FHWA # 502270**

There are spalls in the south end of the 3<sup>rd</sup> wall from the west with reinforcing steel exposed. There are vertical cracks in the south corners of the culvert with reinforcing steel exposed. The sidewalk slab bridge has a transverse crack near the center support. There is visible deflection of the sidewalk slab due to concrete creep.

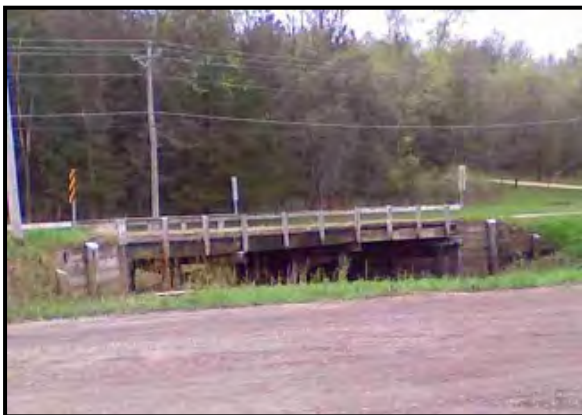
**12<sup>th</sup> Street SE – FHWA # 79040**

The bridge is posted “Semi Traffic Prohibited” on the north end. There are seven inches of asphalt and gravel with a chip seal surface on the bridge. The ends of all caps are split and some of them have begun to rot. The east end of the north abutment pile cap has rotted extending approximately 12”+/- deep. Piles in the south abutment are leaning slightly. The 1<sup>st</sup> pile from the East leans approximately 6” in 6’, but movement seems stable from past inspections. Many piles have minor vertical splits in them. There is minor section loss of some stringers but is minor There is minor section loss in the 3<sup>rd</sup> pile

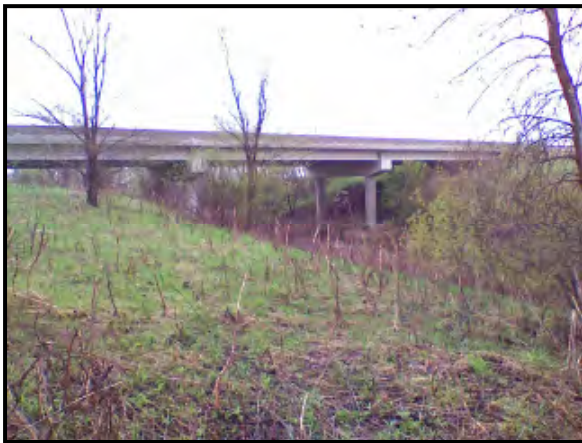
### **35<sup>th</sup> St. NW (Over Abandoned RR) – FHWA # 15511**

There are minor hairline cracks in the top of deck and two small areas with exposed reinforcing near the center of the deck. There are minor diagonal cracks with leaching in bottom of deck at all four corners. The north approach is beginning to deteriorate near the joint. There is minor spalling in the concrete at some of the pier diaphragms.
